AP - 111

**EVAPORATION
POND REPAIRS
REV. 1 (2 of 4)**

2017

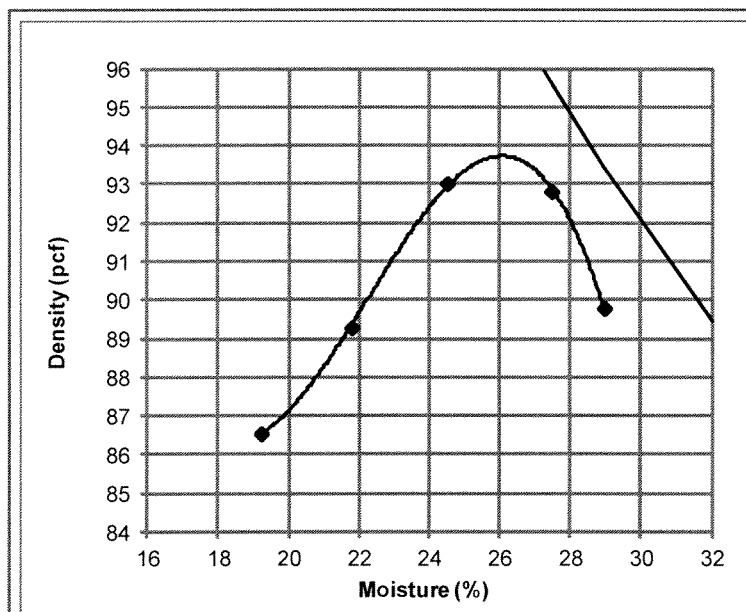
200 Wash Procedure: A

Sieve Size	Passing
3/4in.	100%
1/2in.	98%
3/8in.	95%
#4	80%
#10	73%
#40	67%
#50	66%
#100	63%
#200	61%

Moisture Density Relationship: (ASTM D698-07)

Optimum Moisture: 26.1

Moisture Content (%): 12.5%

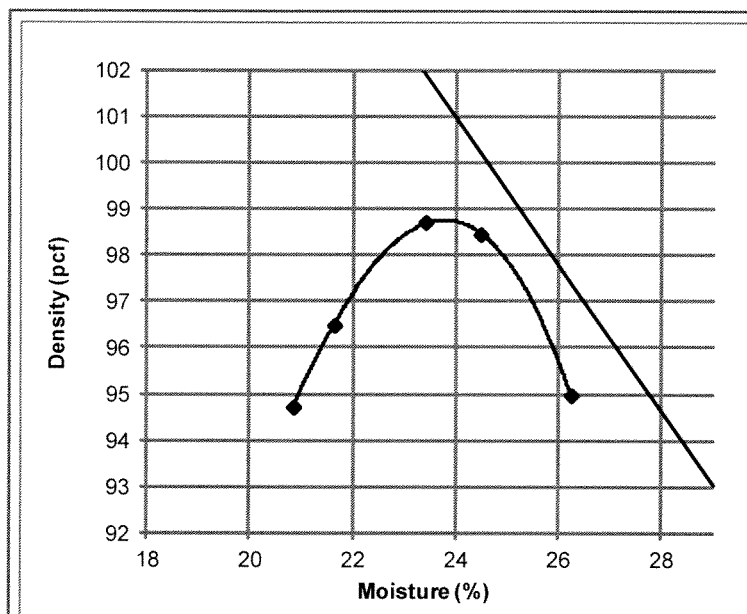
200 Wash Procedure: A

Sieve Size	Passing
#4	100%
#10	96%
#40	88%
#50	84%
#100	78%
#200	74%

Moisture Density Relationship: (ASTM D698-07)

Optimum Moisture: 23.8

Moisture Content (%): 26.9%

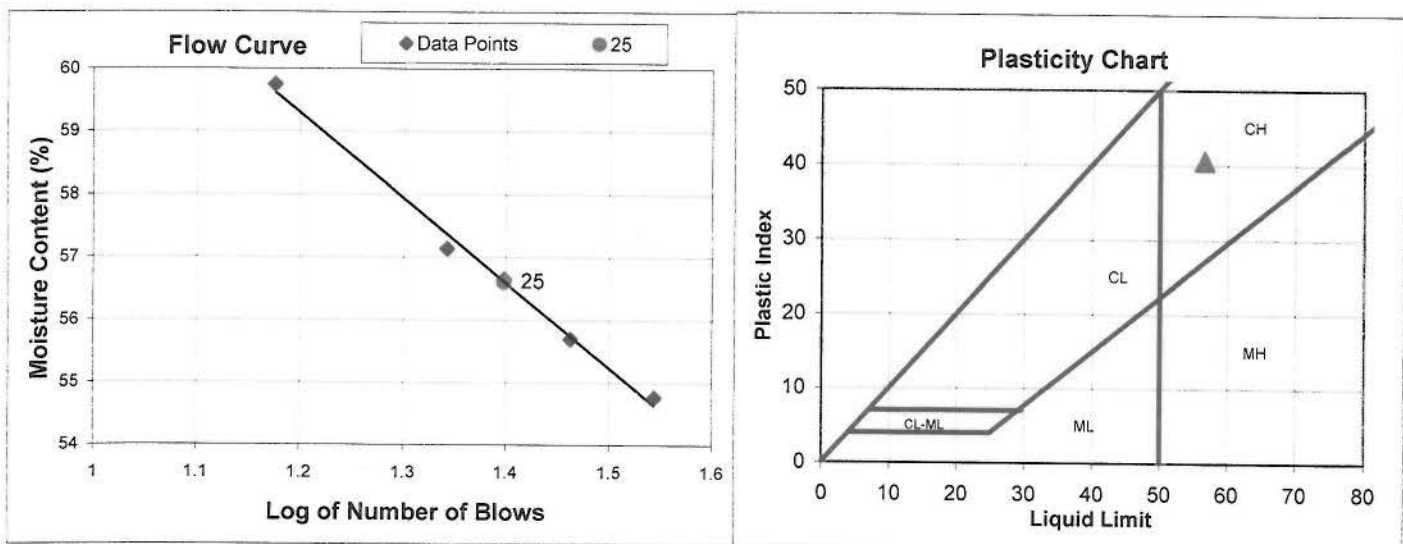
Plastic Index: 41

Atterberg Classification CH

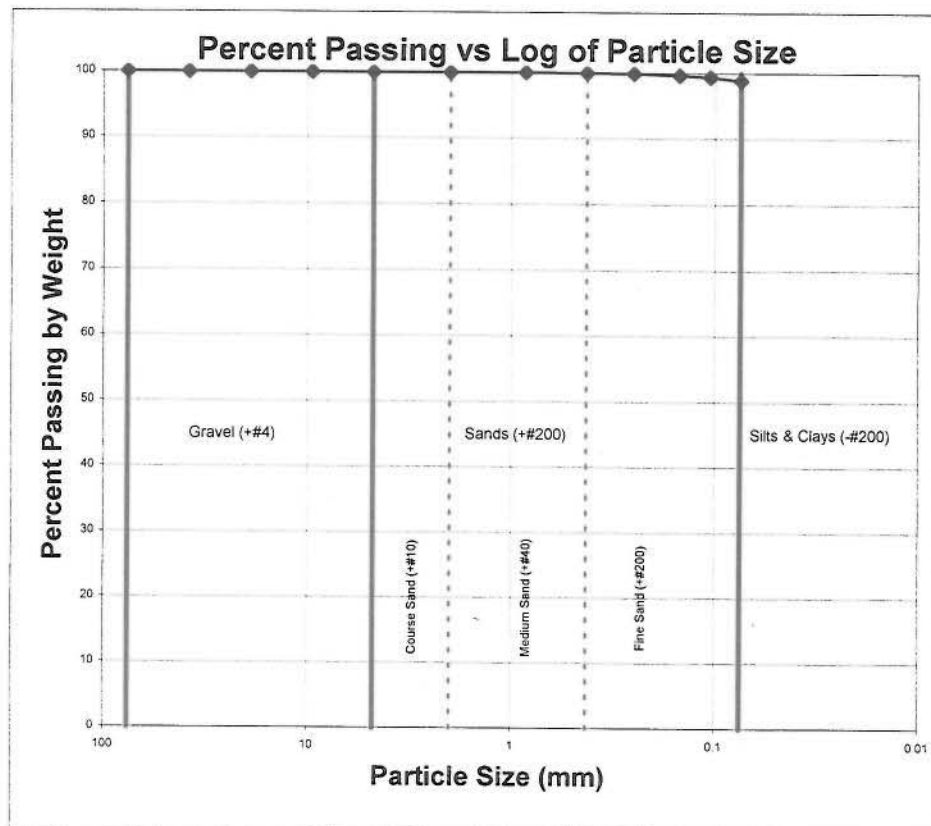
USCS Classification

Fat Clay

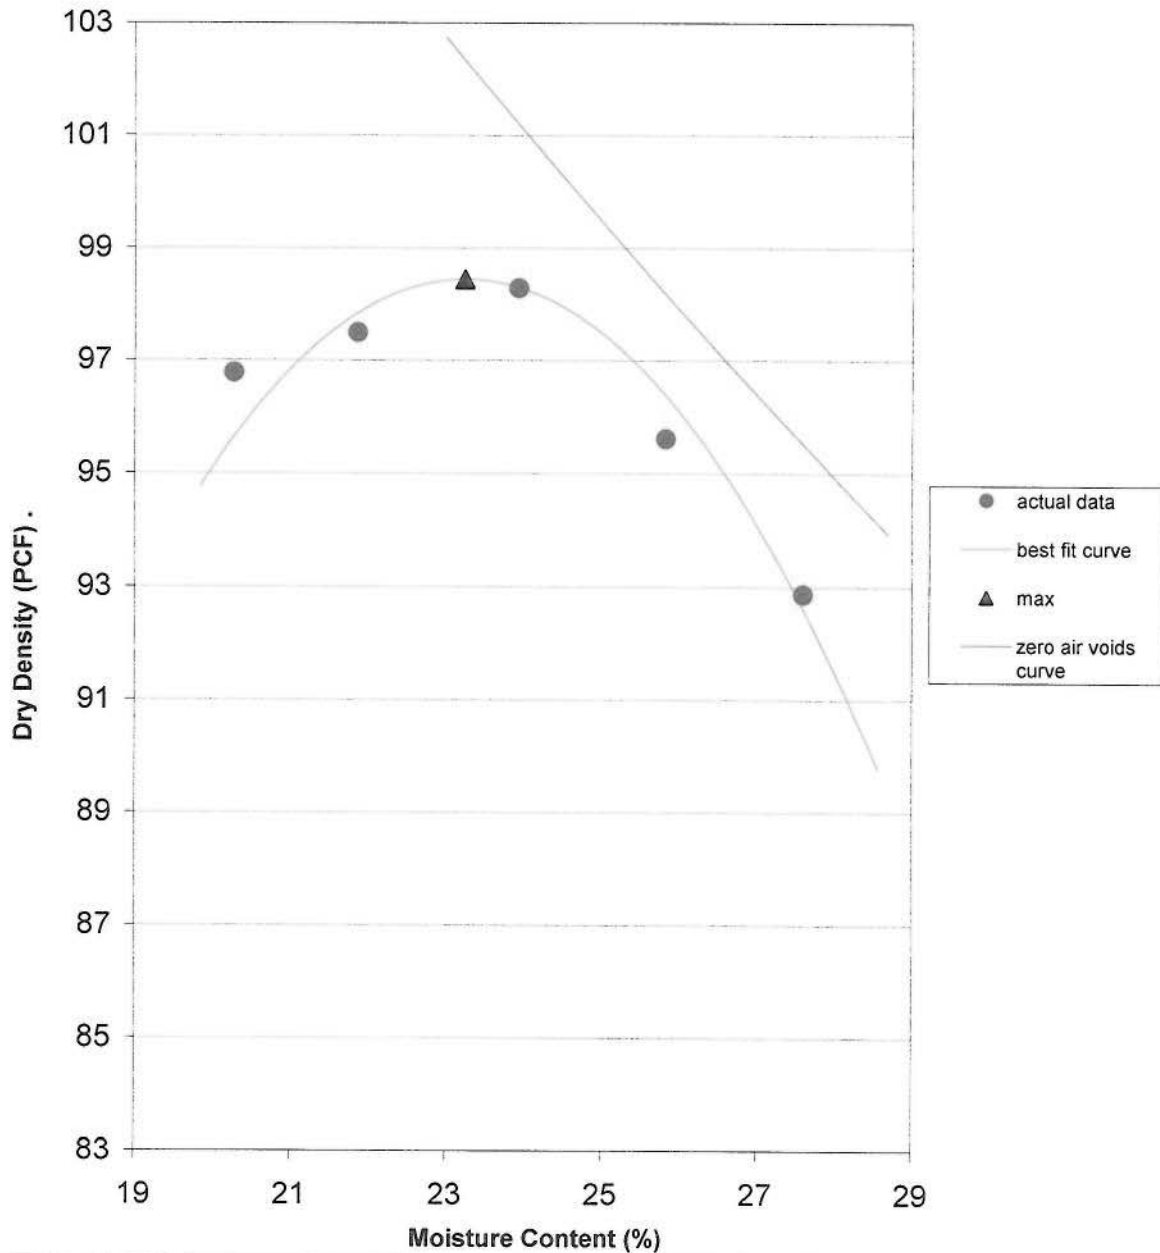
ASTM D 698 - A

Client:	Axis Group Inc	Job number:	2905-3
Project Number:	14-107		
Project:	Western Refinery	Boring:	Gallup Borrow
Sampled by:	--	Depth:	--
Tested by:	BDF	Sample Id:	--
Location:	--	Test date:	10/13/2015

Optimum Moisture content: 23.2 Maximum dry density: 98.4

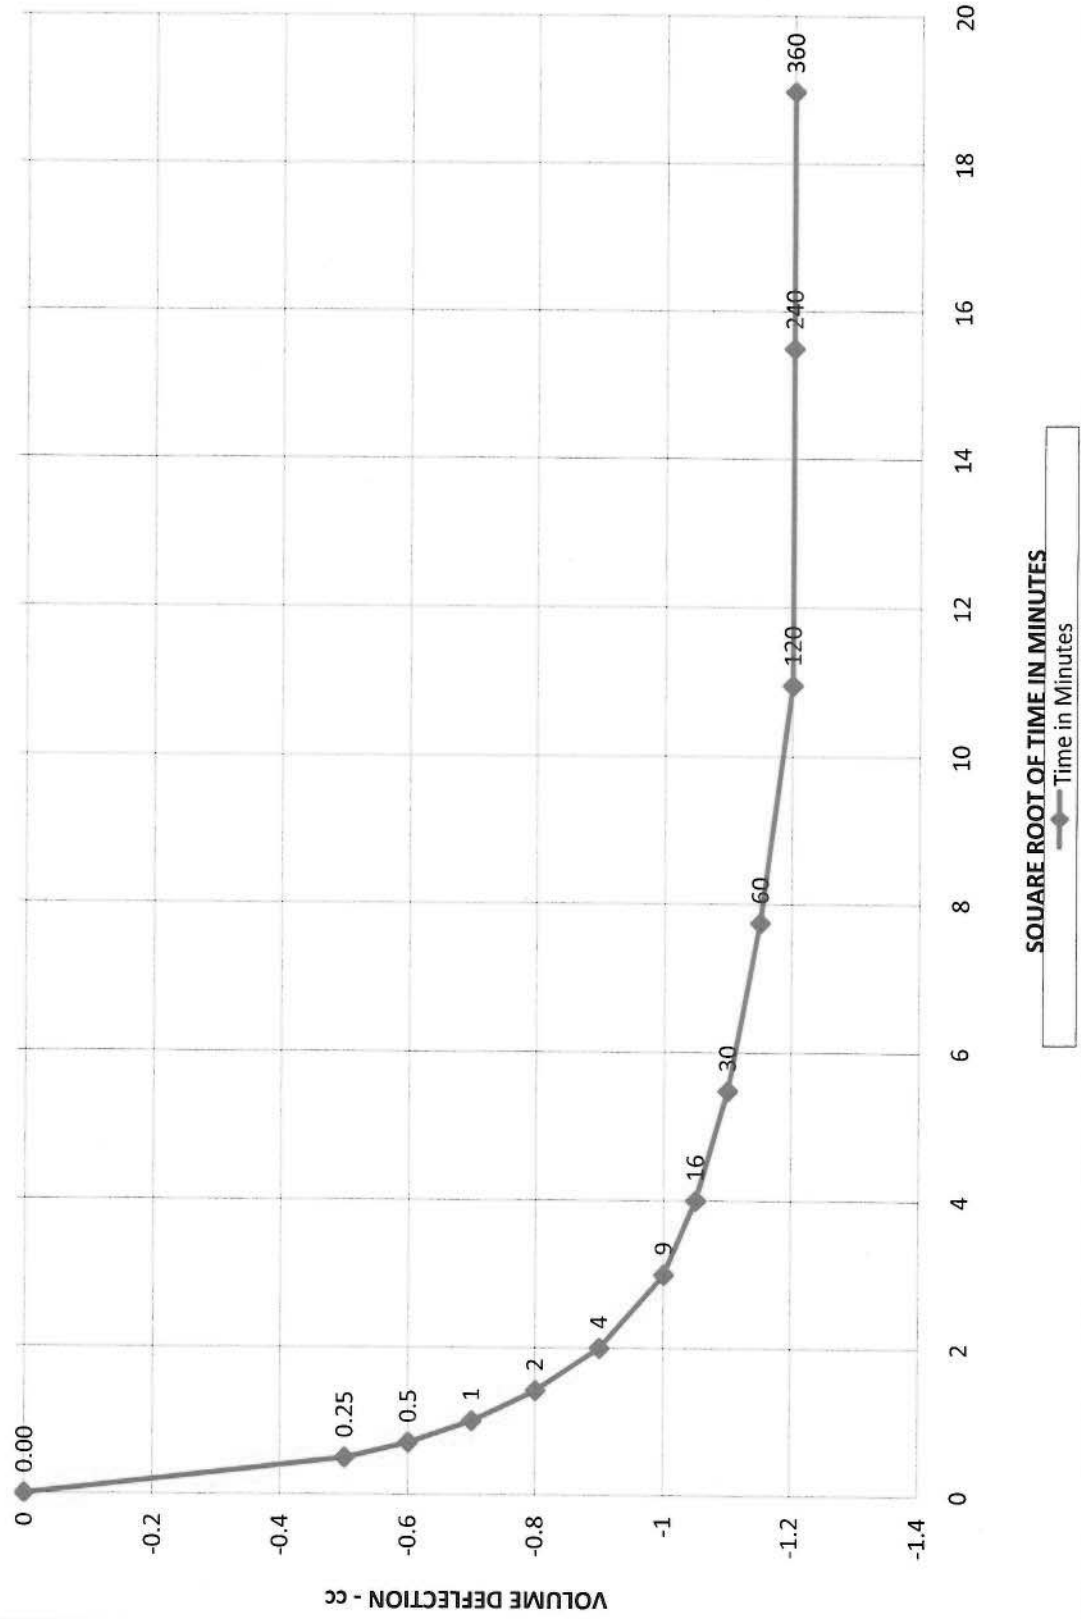
CONSOLIDATION DATA

Gallup Borrow, --, --

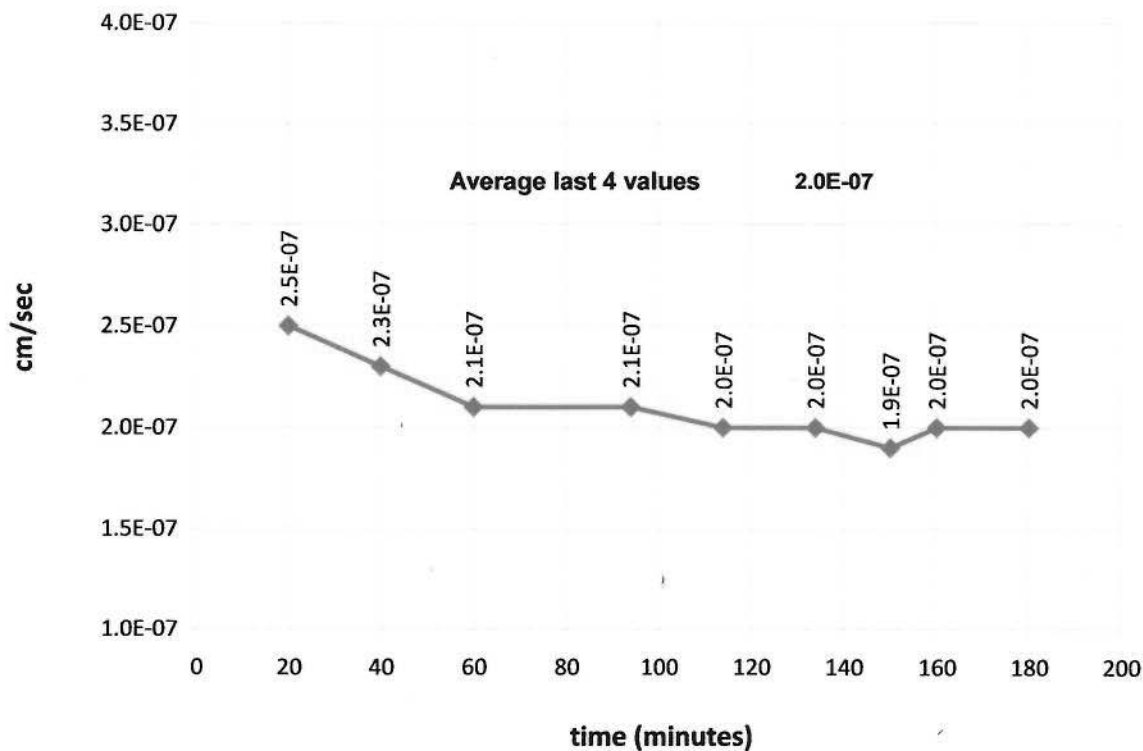
Preliminary Flow Pump Test Data ASTM D5084 Method D

Boring Number: Gallup Borrow
Depth: --
Sample Number: --
Sampled Date: --
Test Date: 10/29/2015

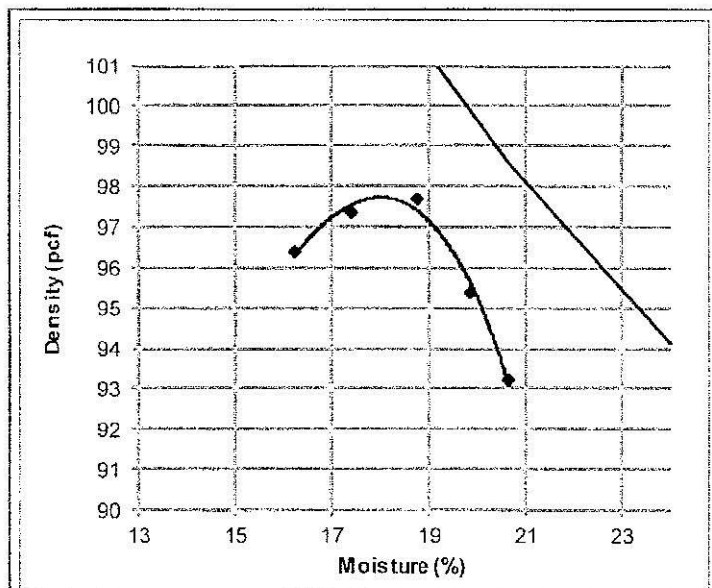
200 Wash Procedure: A

Moisture Density Relationship: (ASTM D1557-09)

Optimum Moisture: 18.0

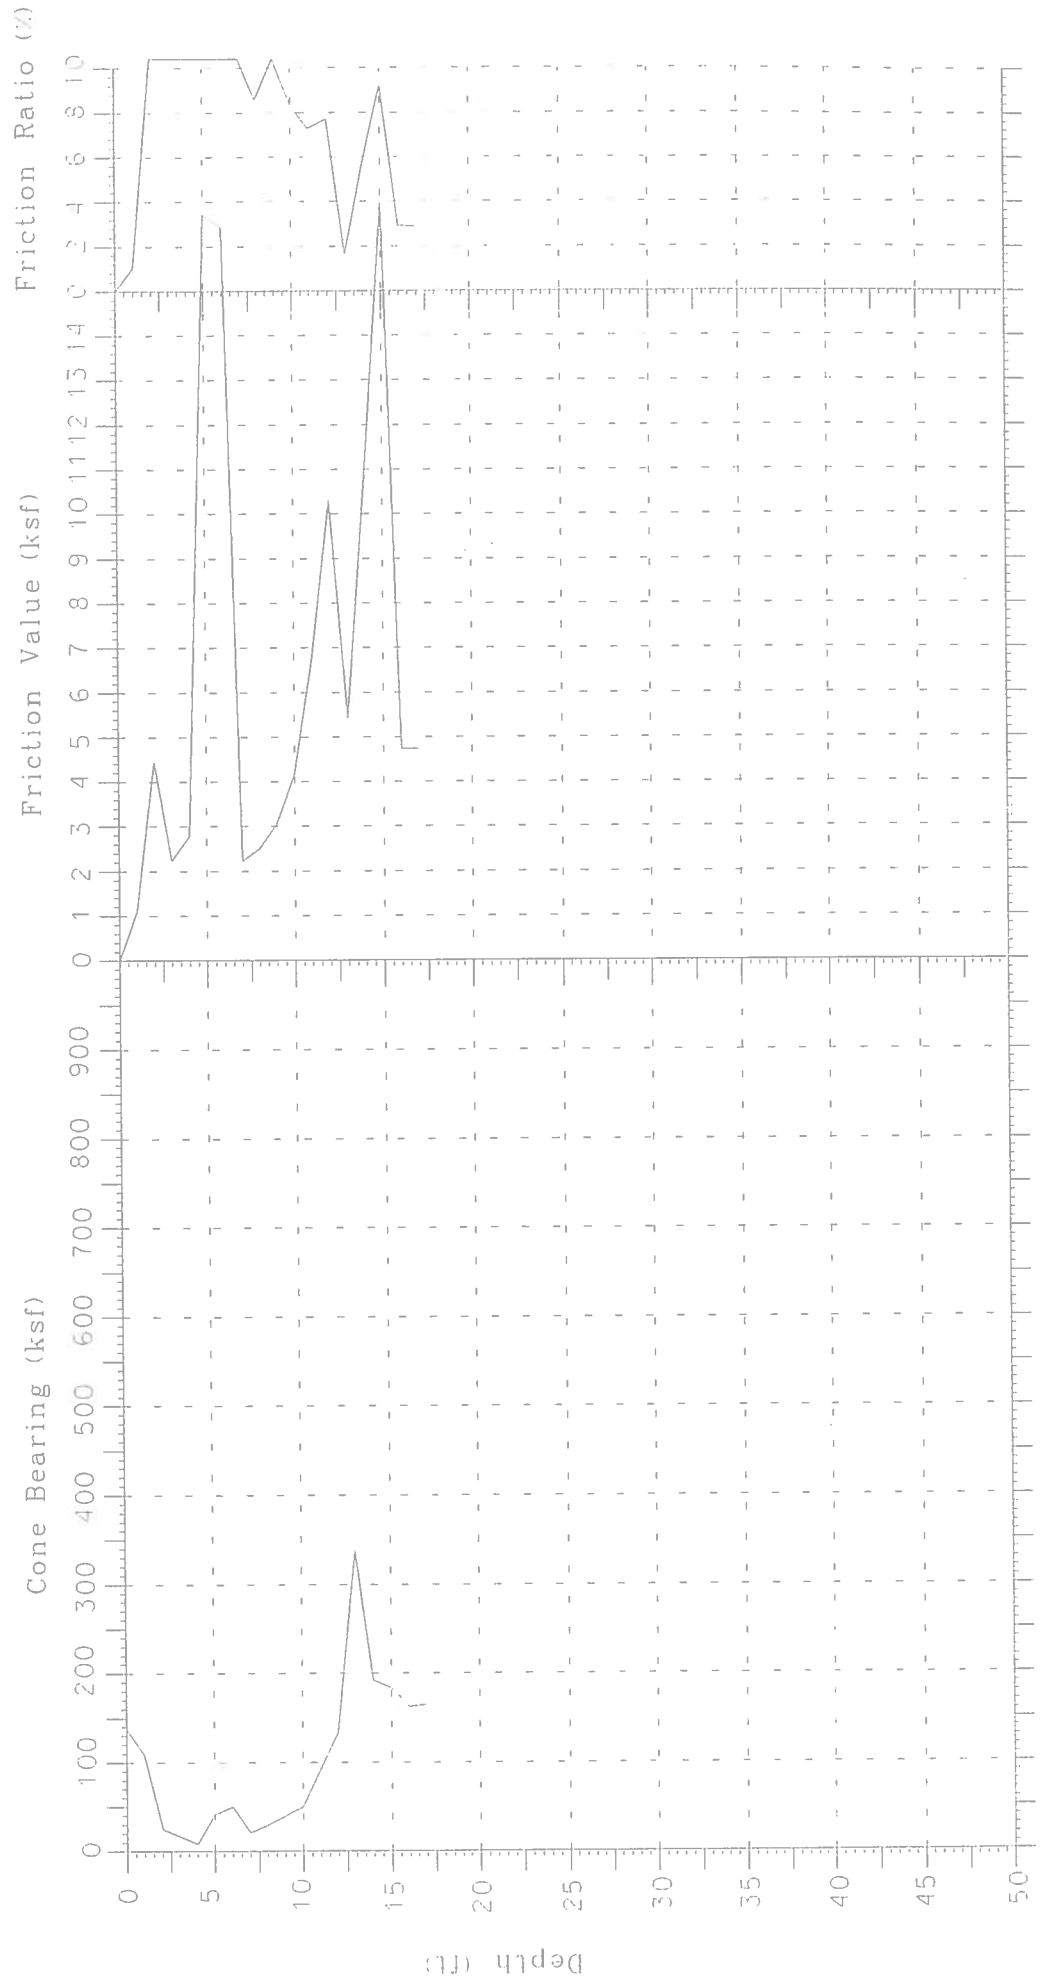
Project Location: CINIZA EVAPORATION PONDS Sounding Number: 4
Sounding Date: December 6, 2000 Sounding Location: see plan
Project Number: 00-141

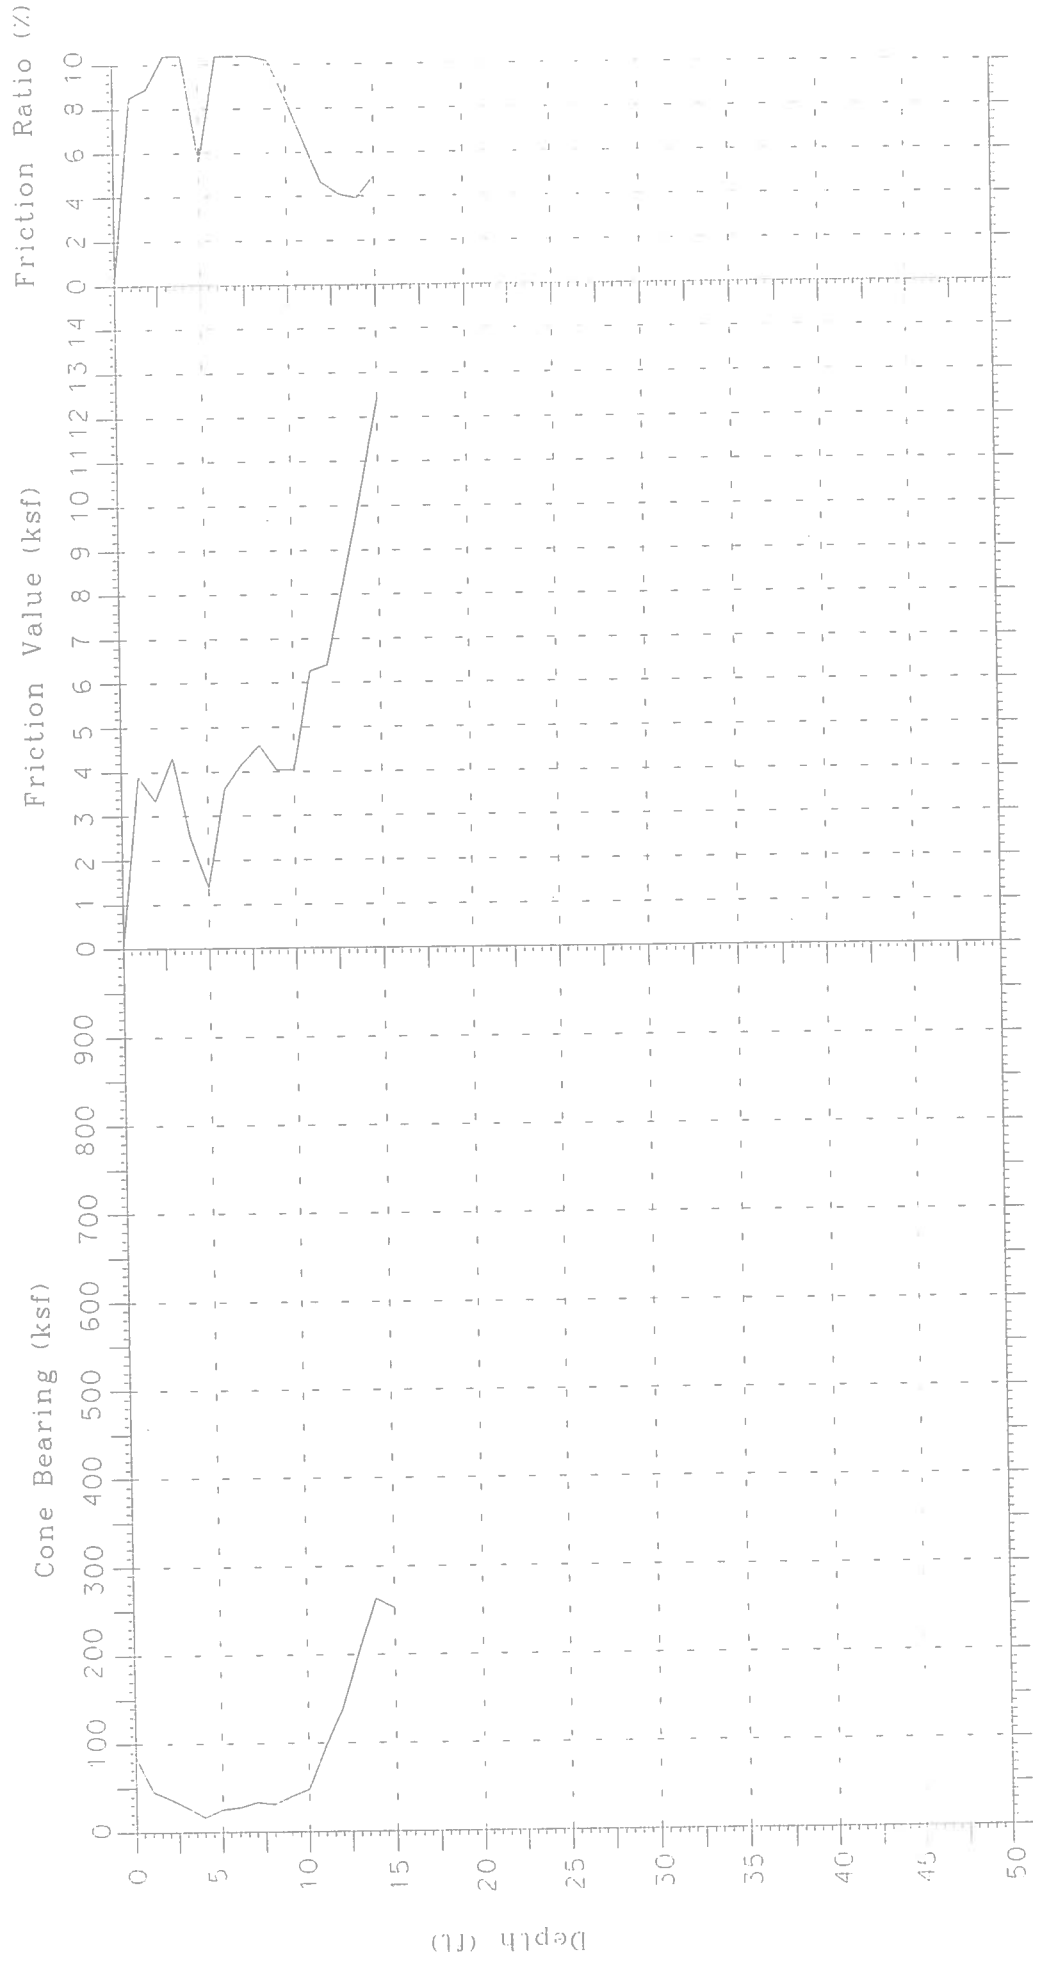
Project Location: CINIZA EVAPORATION PONDS Sounding Number: 5
Sounding Date: December 7, 2000 Sounding Location: see plan
Project Number: 00-141

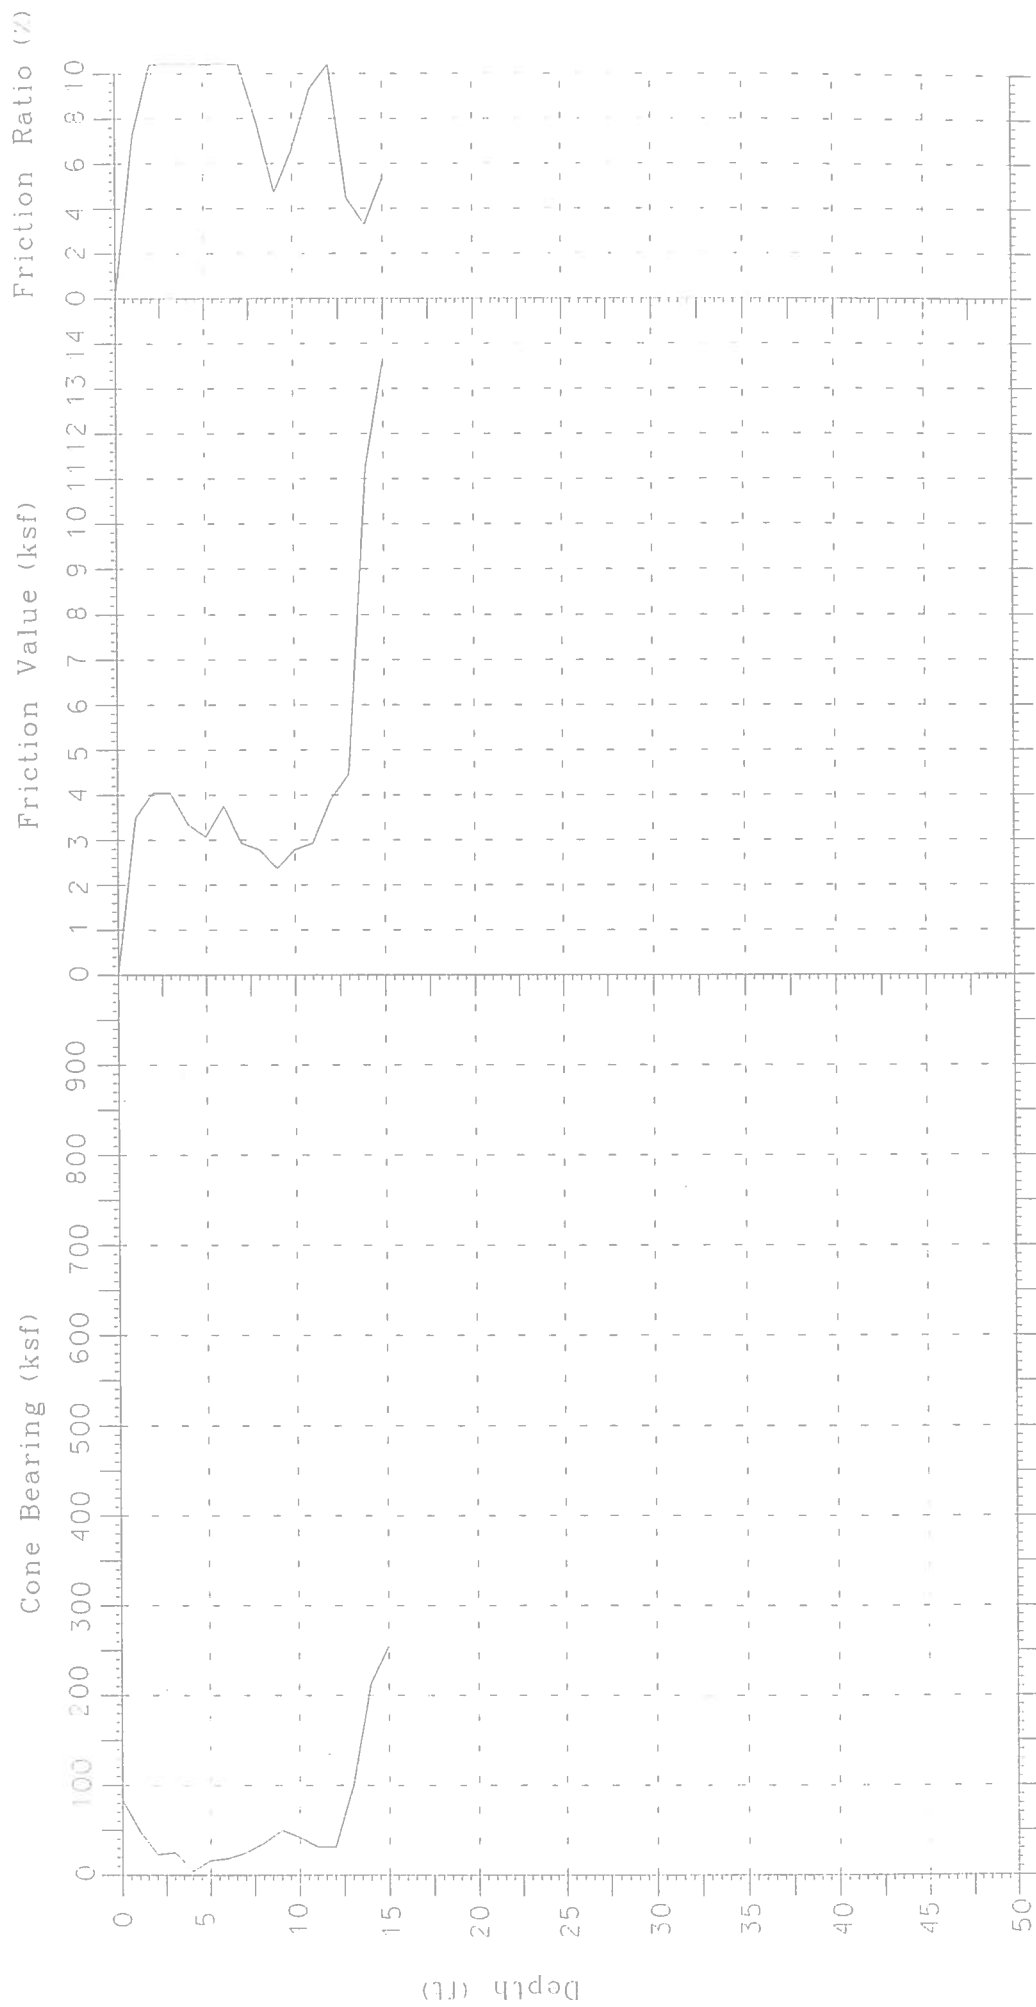
Project Location: CINIZA EVAPORATION PONDS Sounding Number: 6
Sounding Date: December 7, 2000 Sounding Location: see plan
Project Number: 00-141

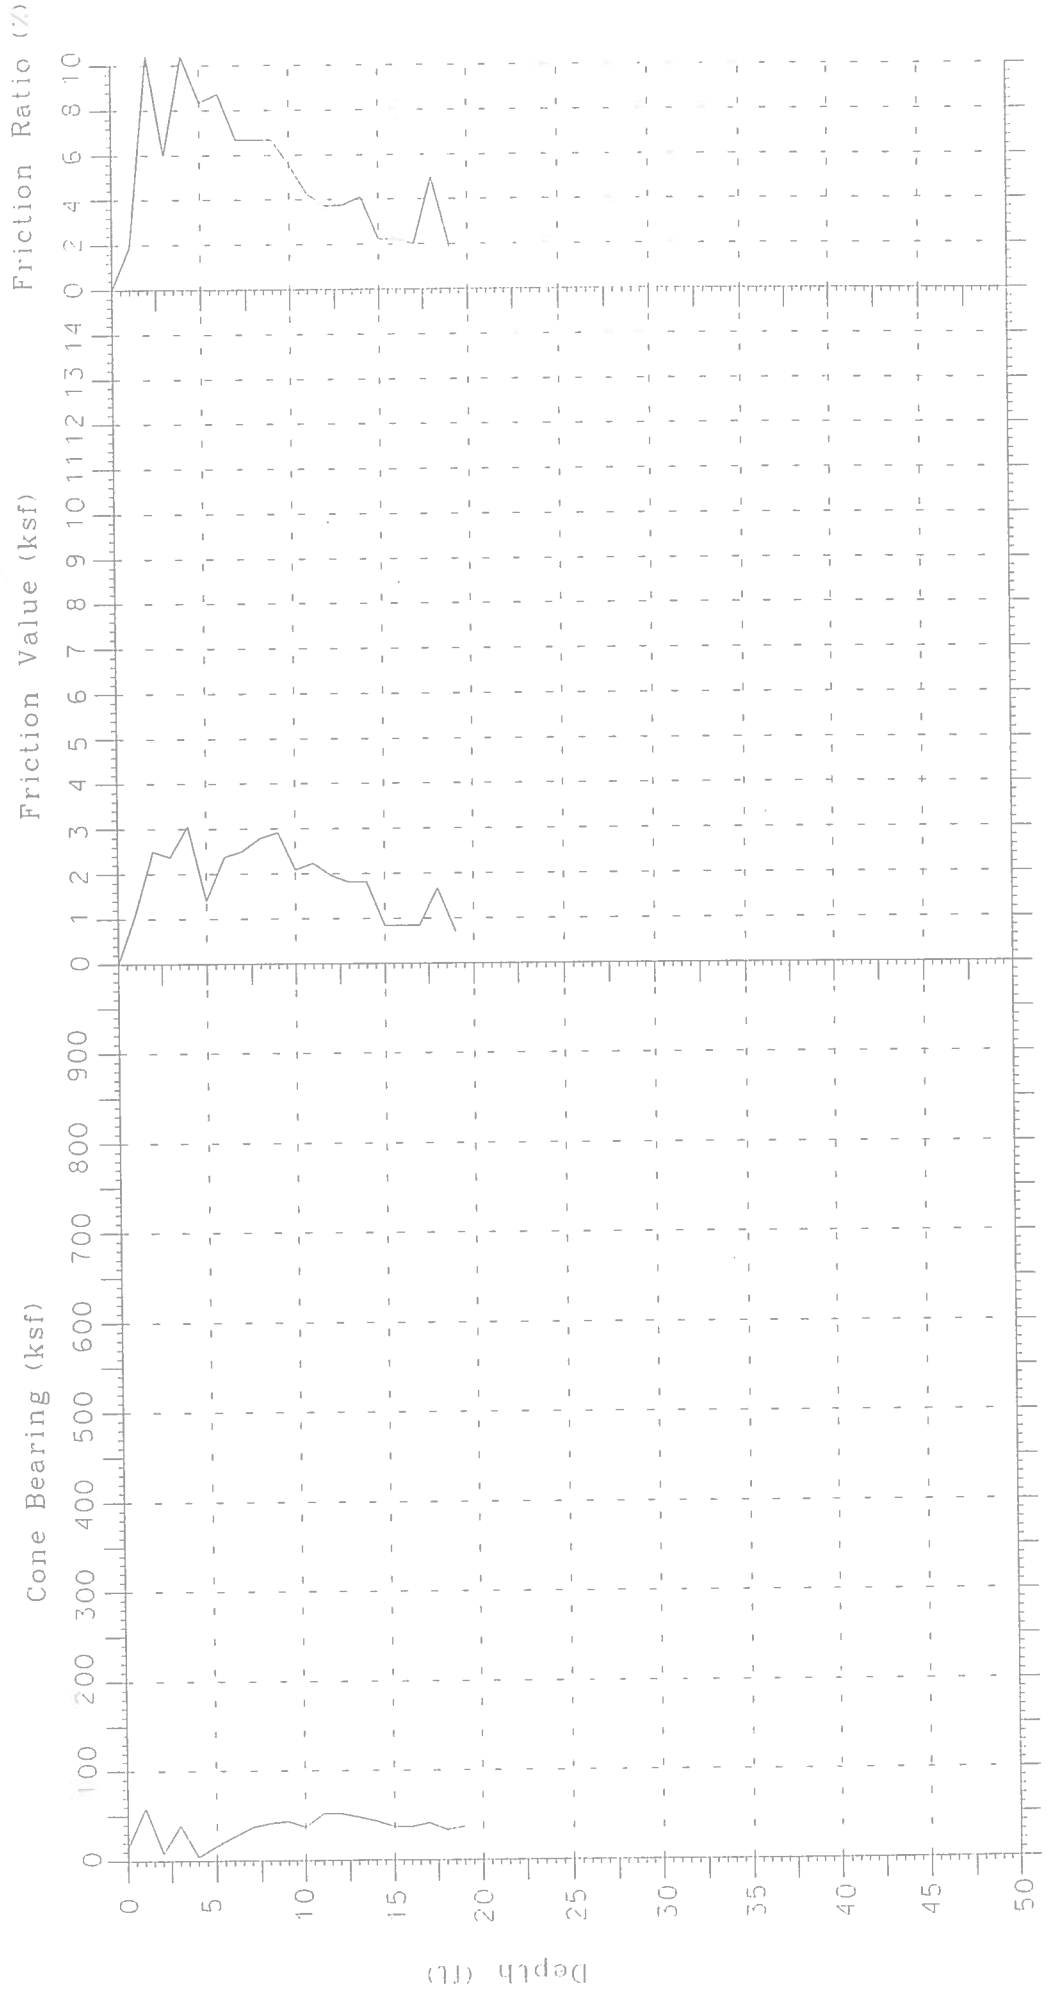
Project Location: CINIZA EVAPORATION PONDS Sounding Number: 7
Sounding Date: December 7, 2000 Sounding Location: see plan
Project Number: 00-141
