Release Notification

Site Name: MC 5 COM 112H	Site Type: Wellsite
Date Release Discovered: 6/16/2020	API# (if applicable) 30-045-35605

MC 5 COM 112H Narrative

Enduring Resources, LLC
MC 5 COM 112H Photo Page

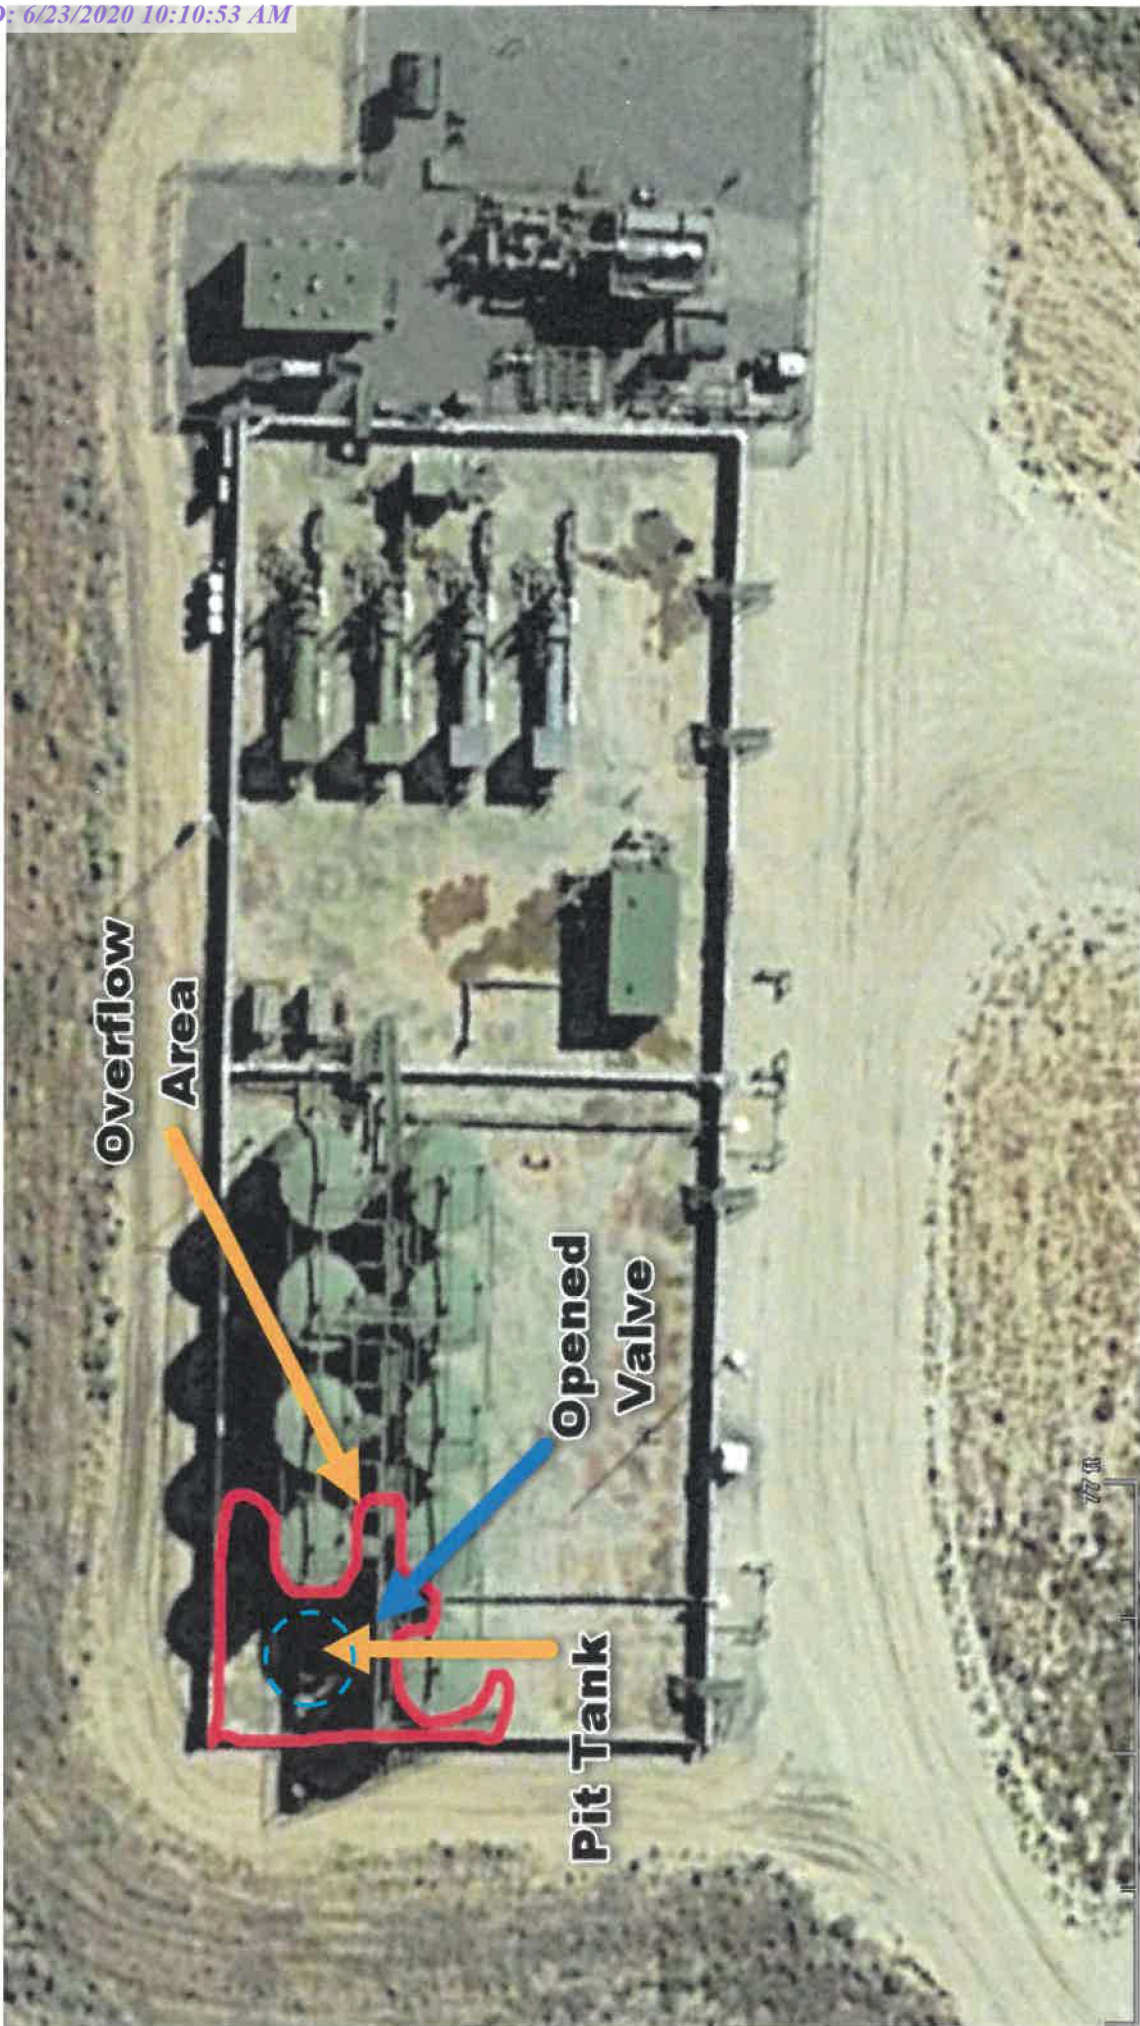
NRM2017557881

The Enduring HSE Supervisor was on-site at 9 AM to perform the liner inspection. A representative from the NMOCD was not present. The liner was inspected, and no evidence of a liner integrity issue was found during the inspection. Pictures were taken of the liner during inspection and are attached to the closure report for reference.

Yesterday around 1:00 PM, a pit tank overflow was reported at the MC 5 COM 112H wellsite, API 30-045-35605, located in Section 33D, 24N, Range 8W, San Juan County, NM. A valve on the drain line from the water tank is believed to have been opened by vandals, emptying the contents of the water tank into the pit tank, causing it to overflow. The volume of the water/oil that was overflowed onto the liner was 6 bbls. This volume was found by measuring the size and depth of the liquid on the liner, and calculating the volume. All liquids were contained within the lined secondary containment for the tank battery, and has been cleaned up. Enduring will perform an inspection of the liner for integrity on Monday, June 22, 2020 at 9 AM. Pictures of the liquid on the liner are attached for reference.
