PHASE II ENVIRONMENTAL SAMPLING ASSESSMENT

EnerVest Operating, LLC

Abalone “AMB” State #1 Tank Battery
(Saltwater and oil release from separator)

February 24TH, 2012

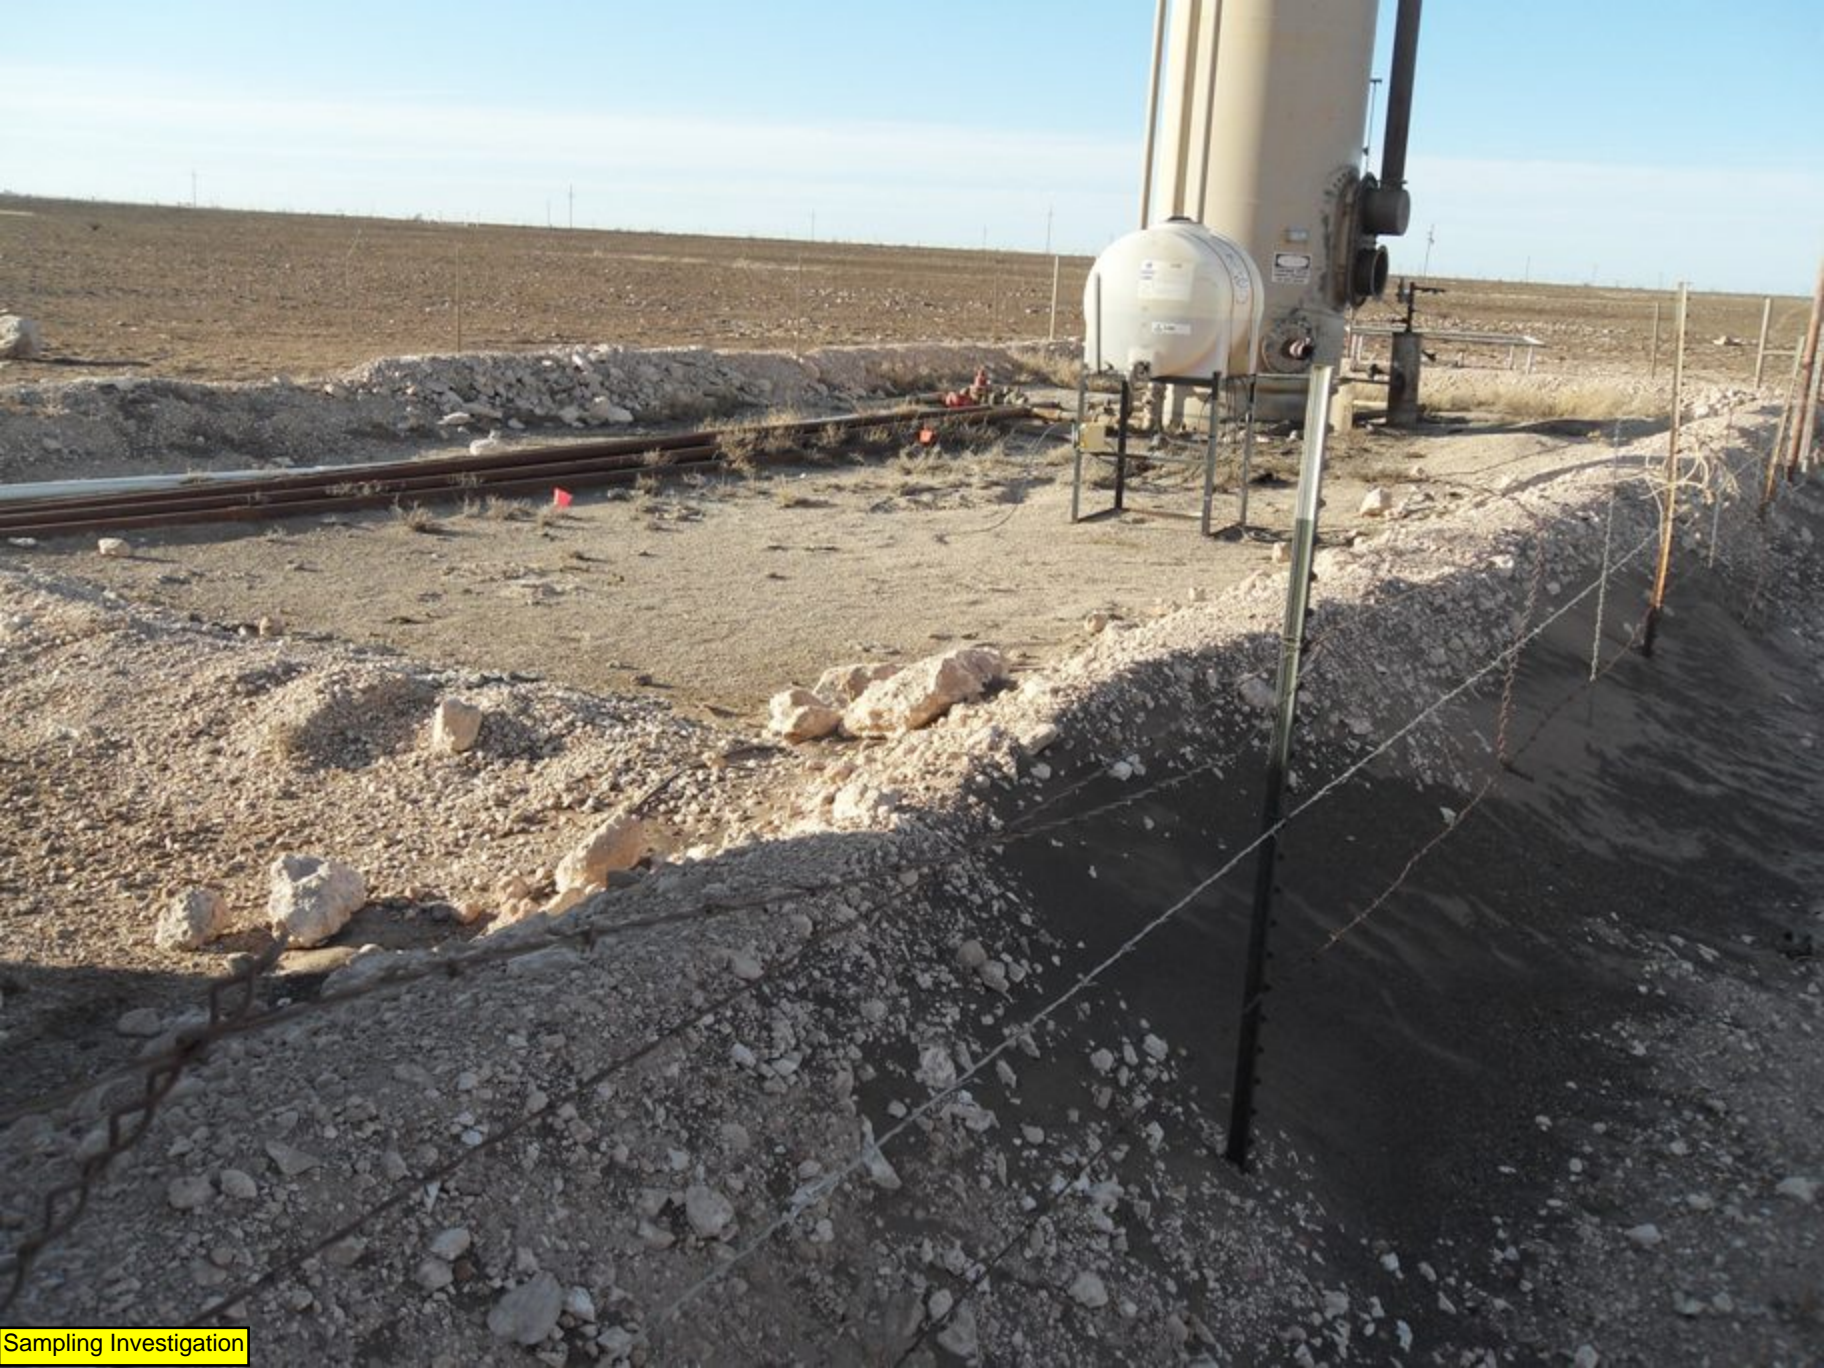
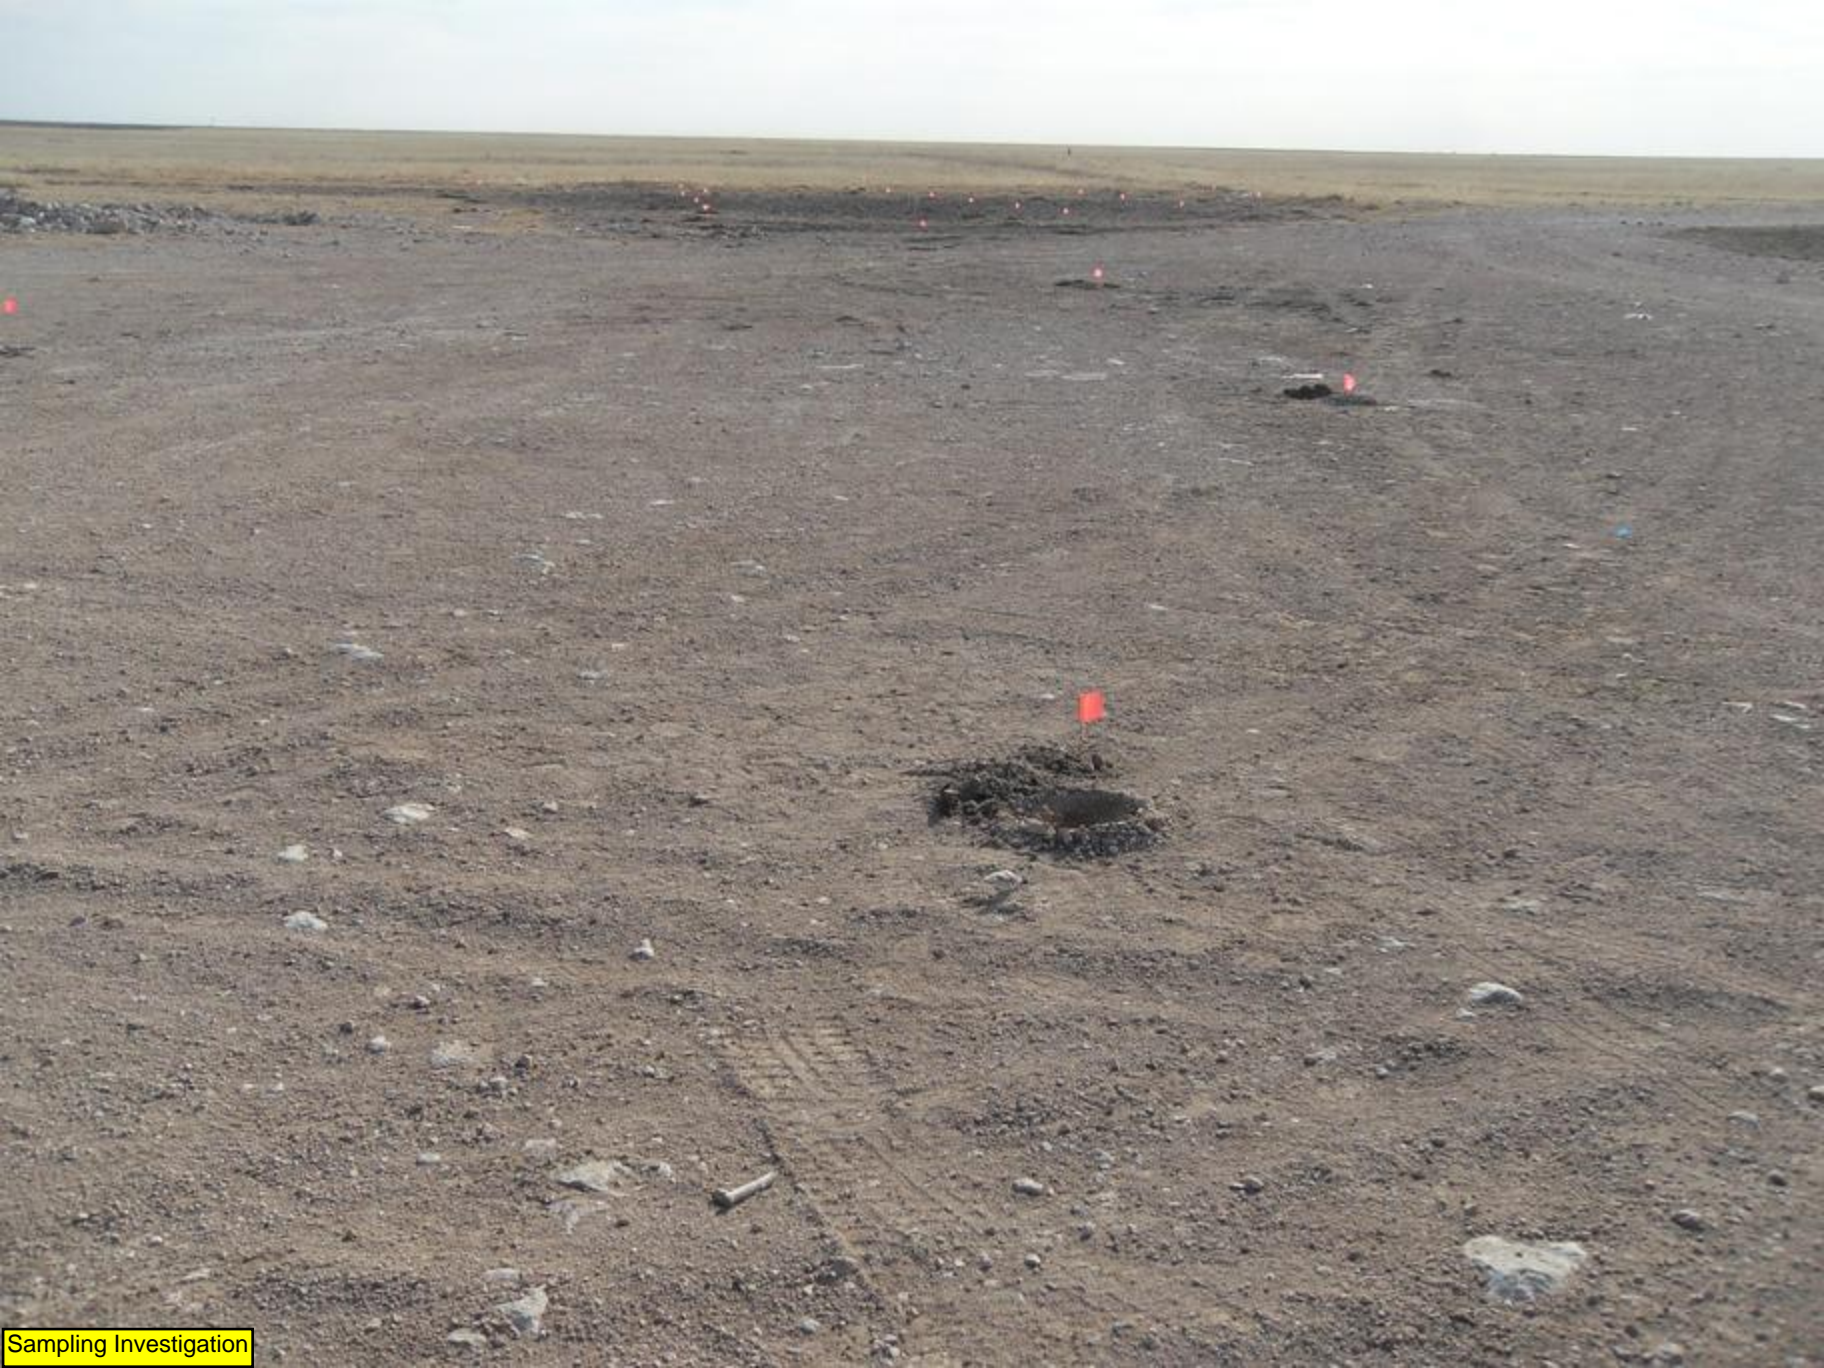
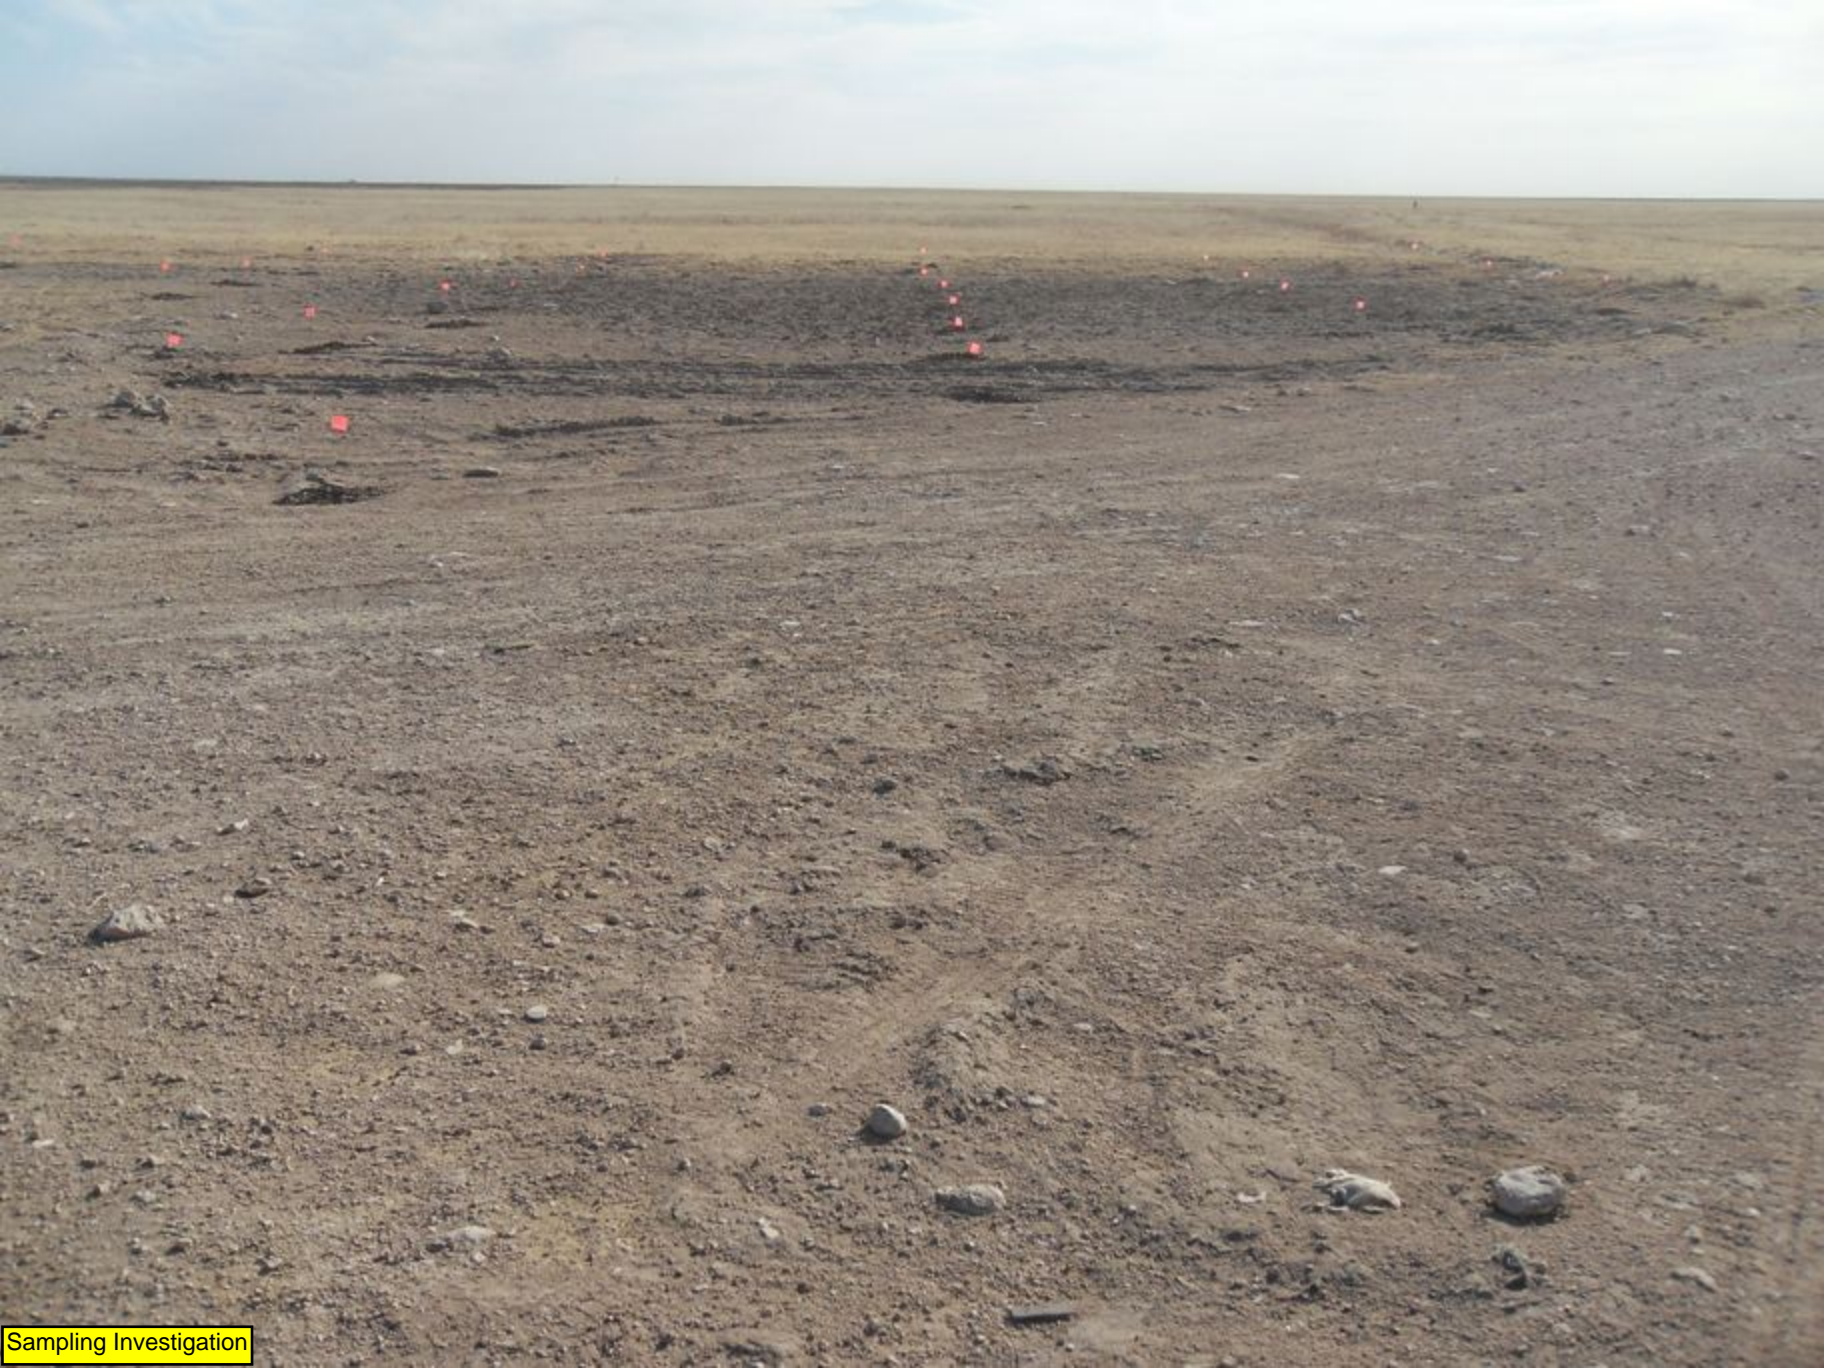
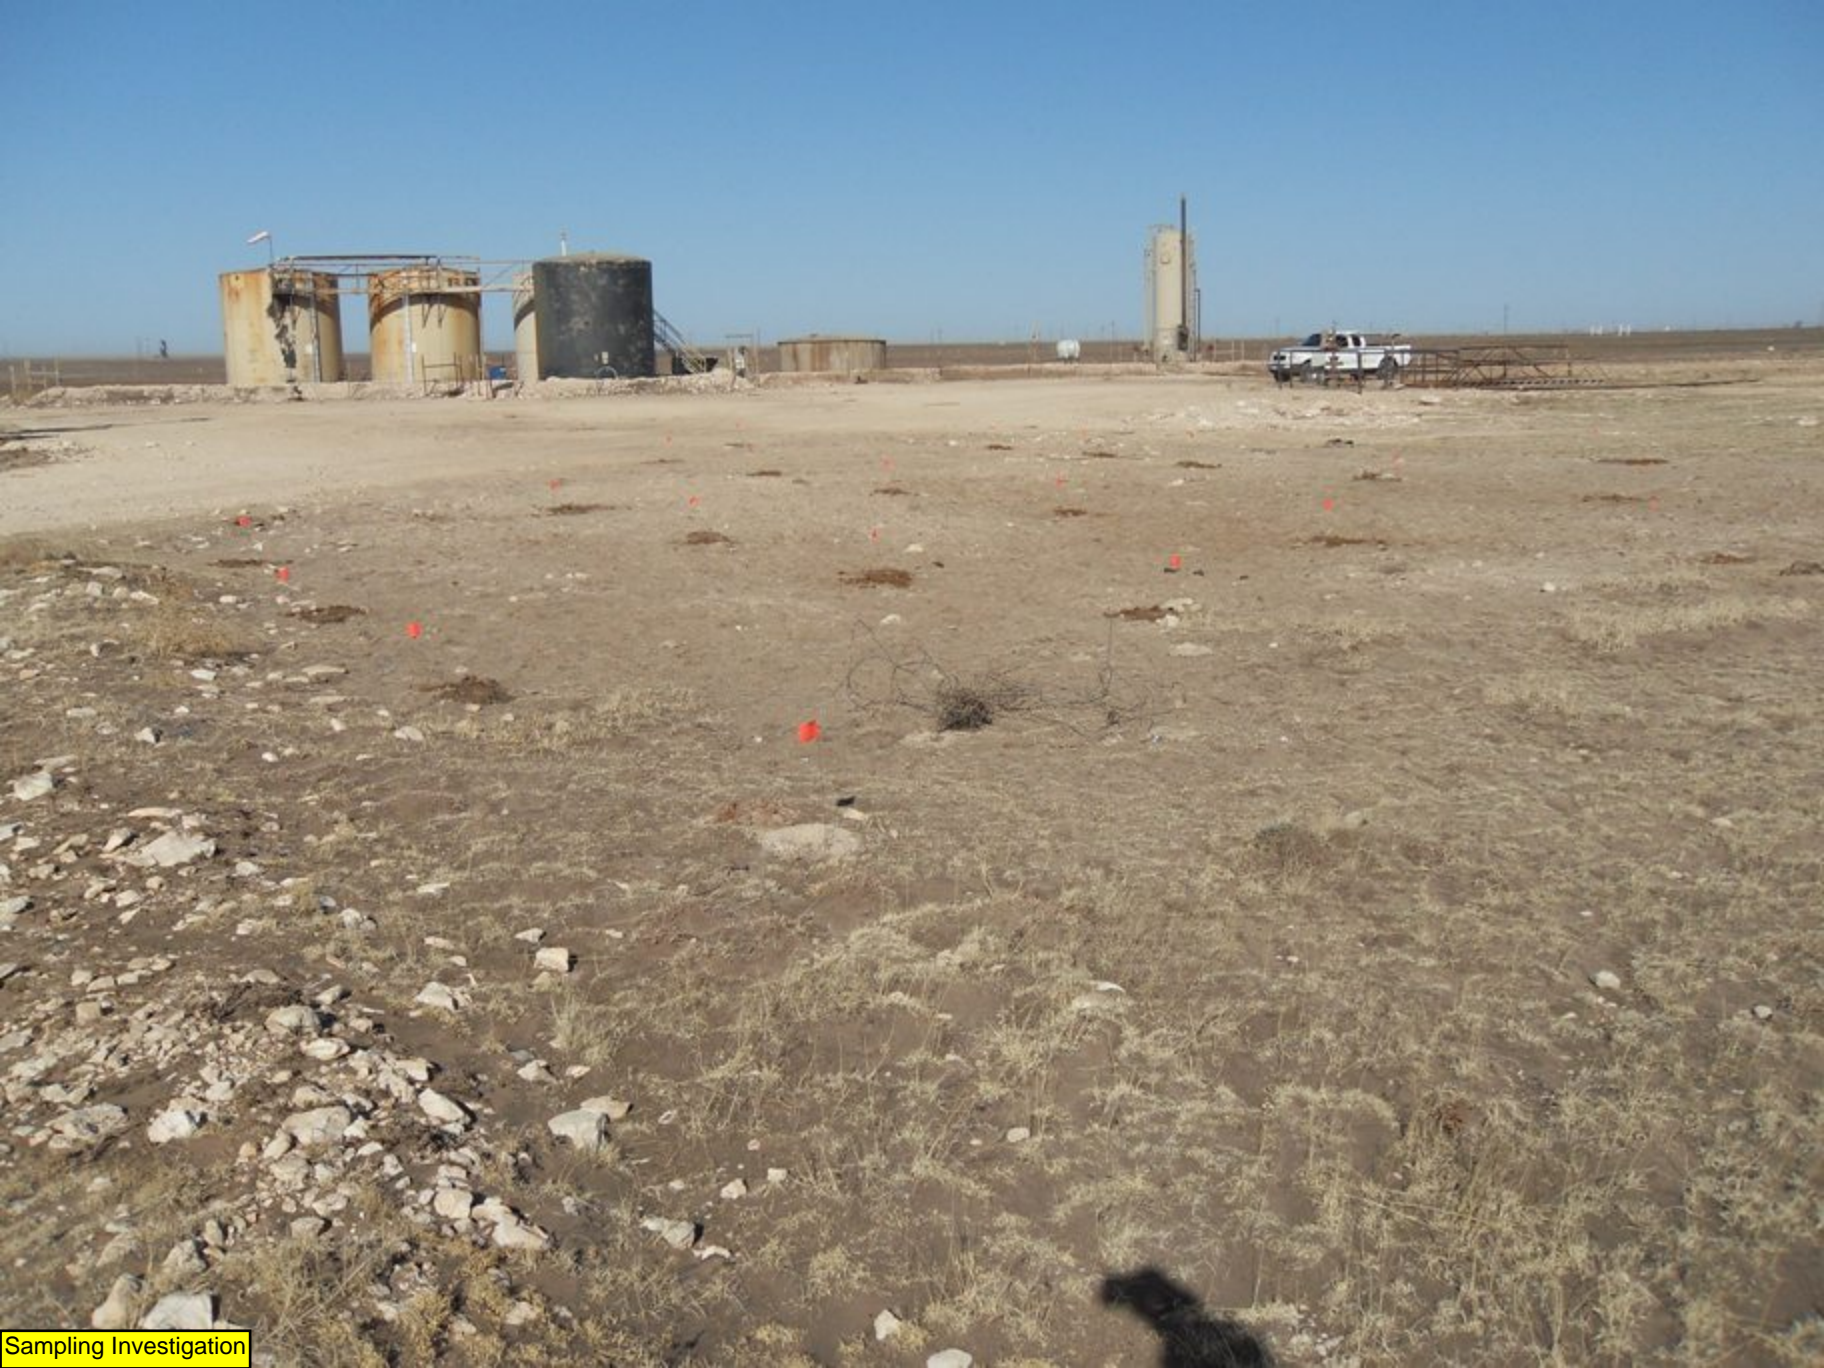
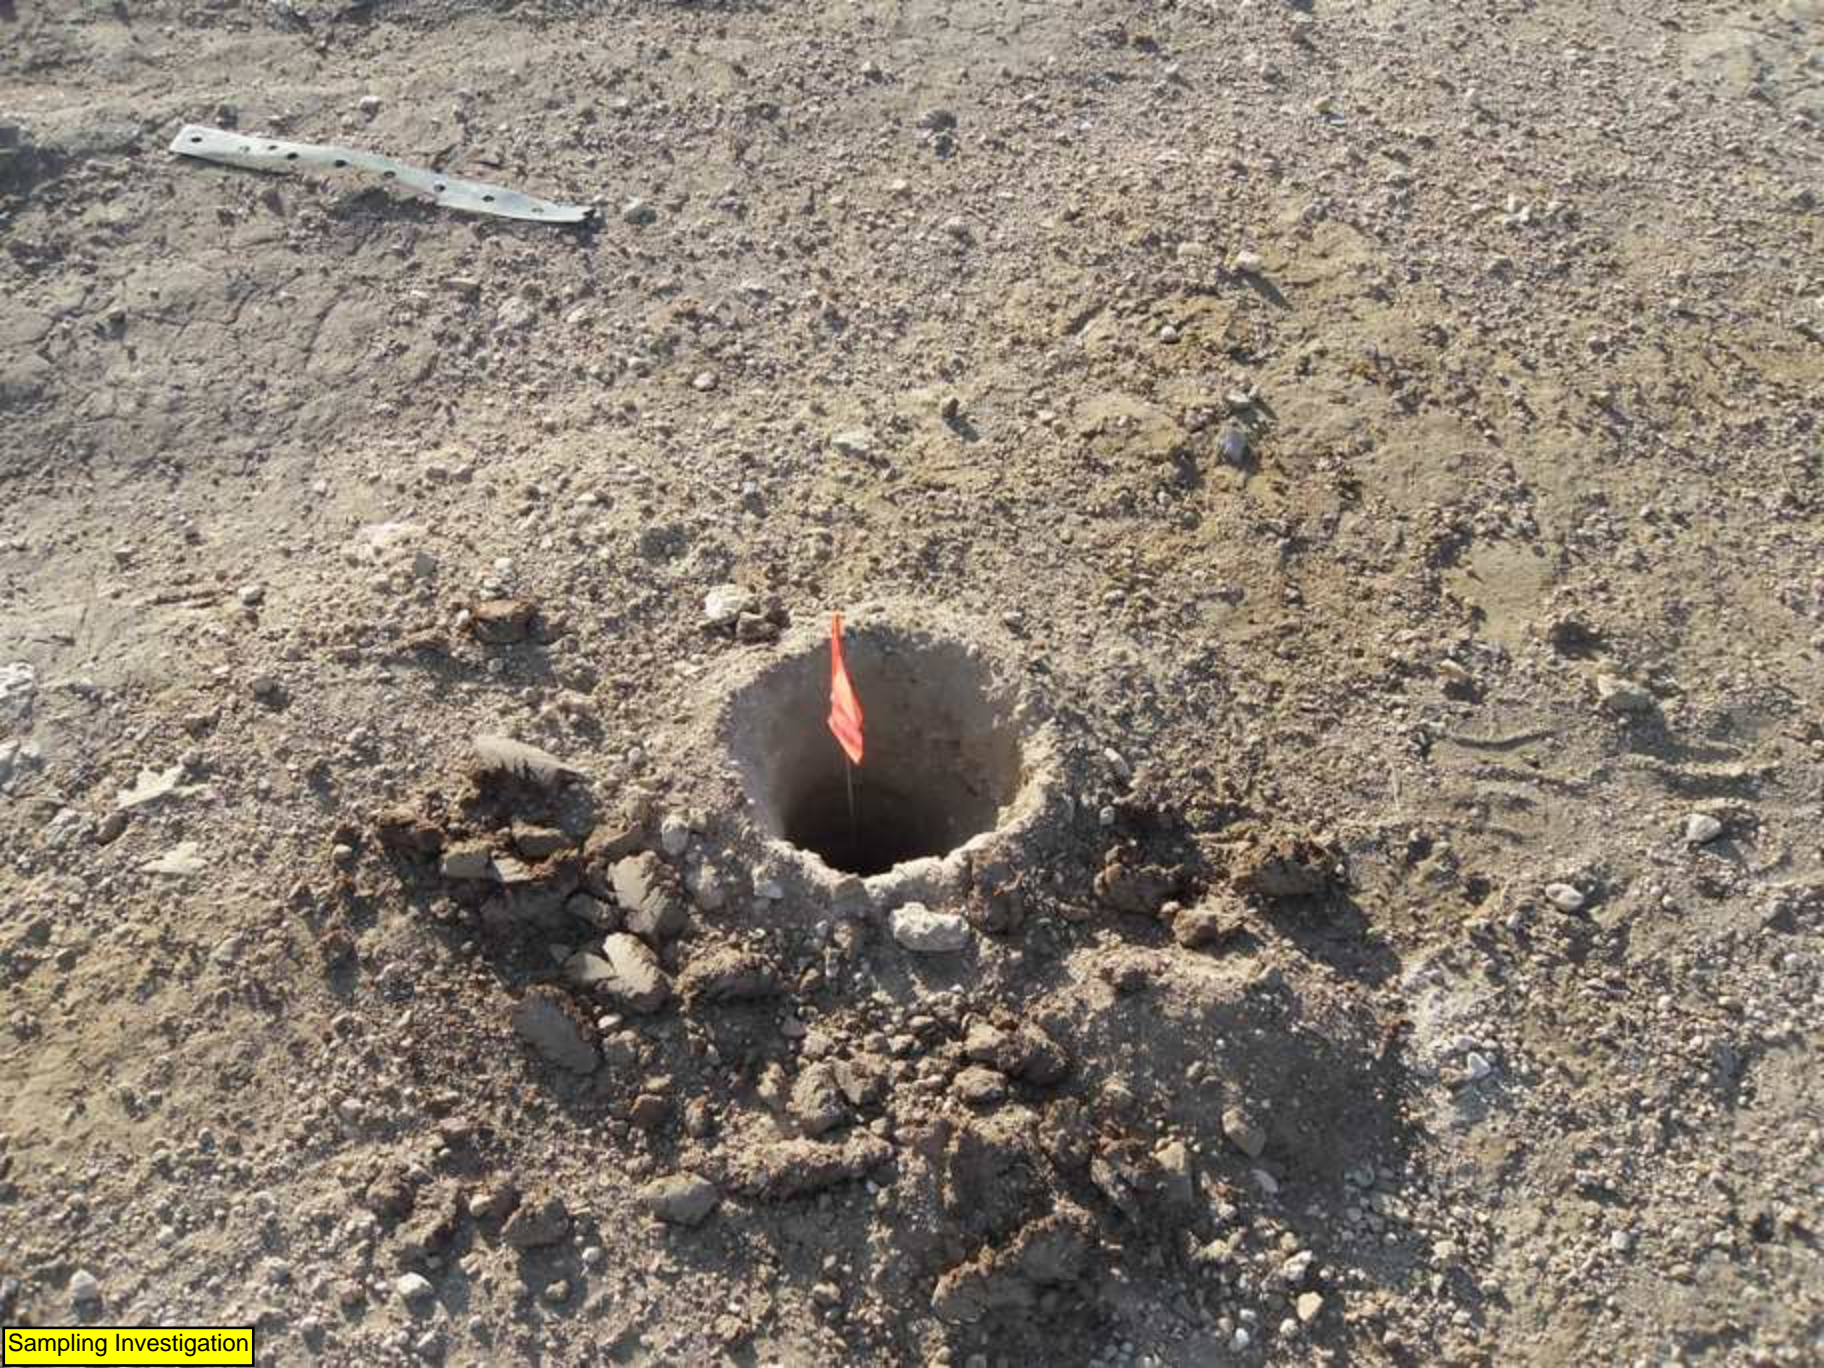
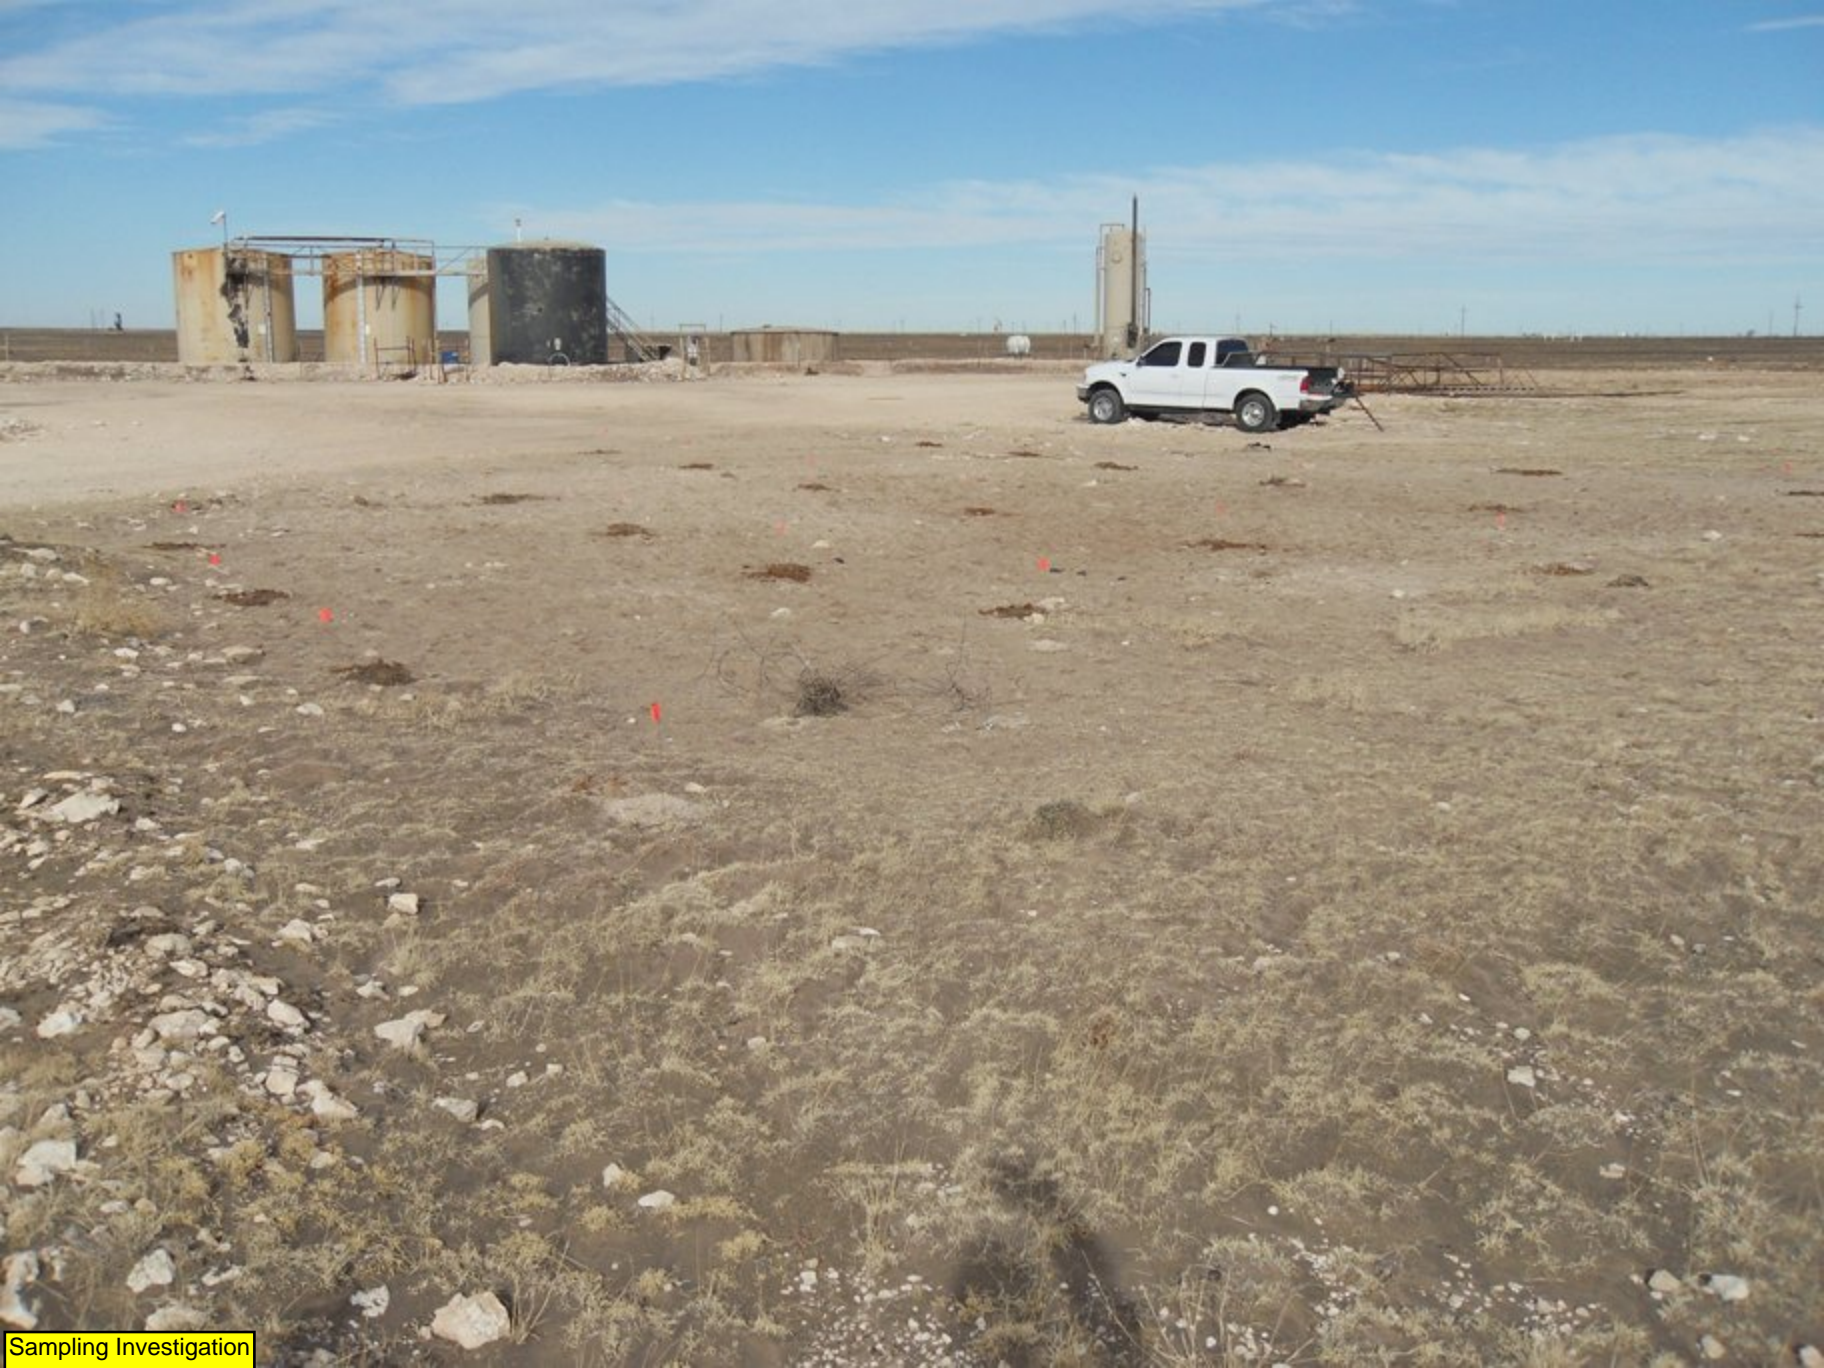
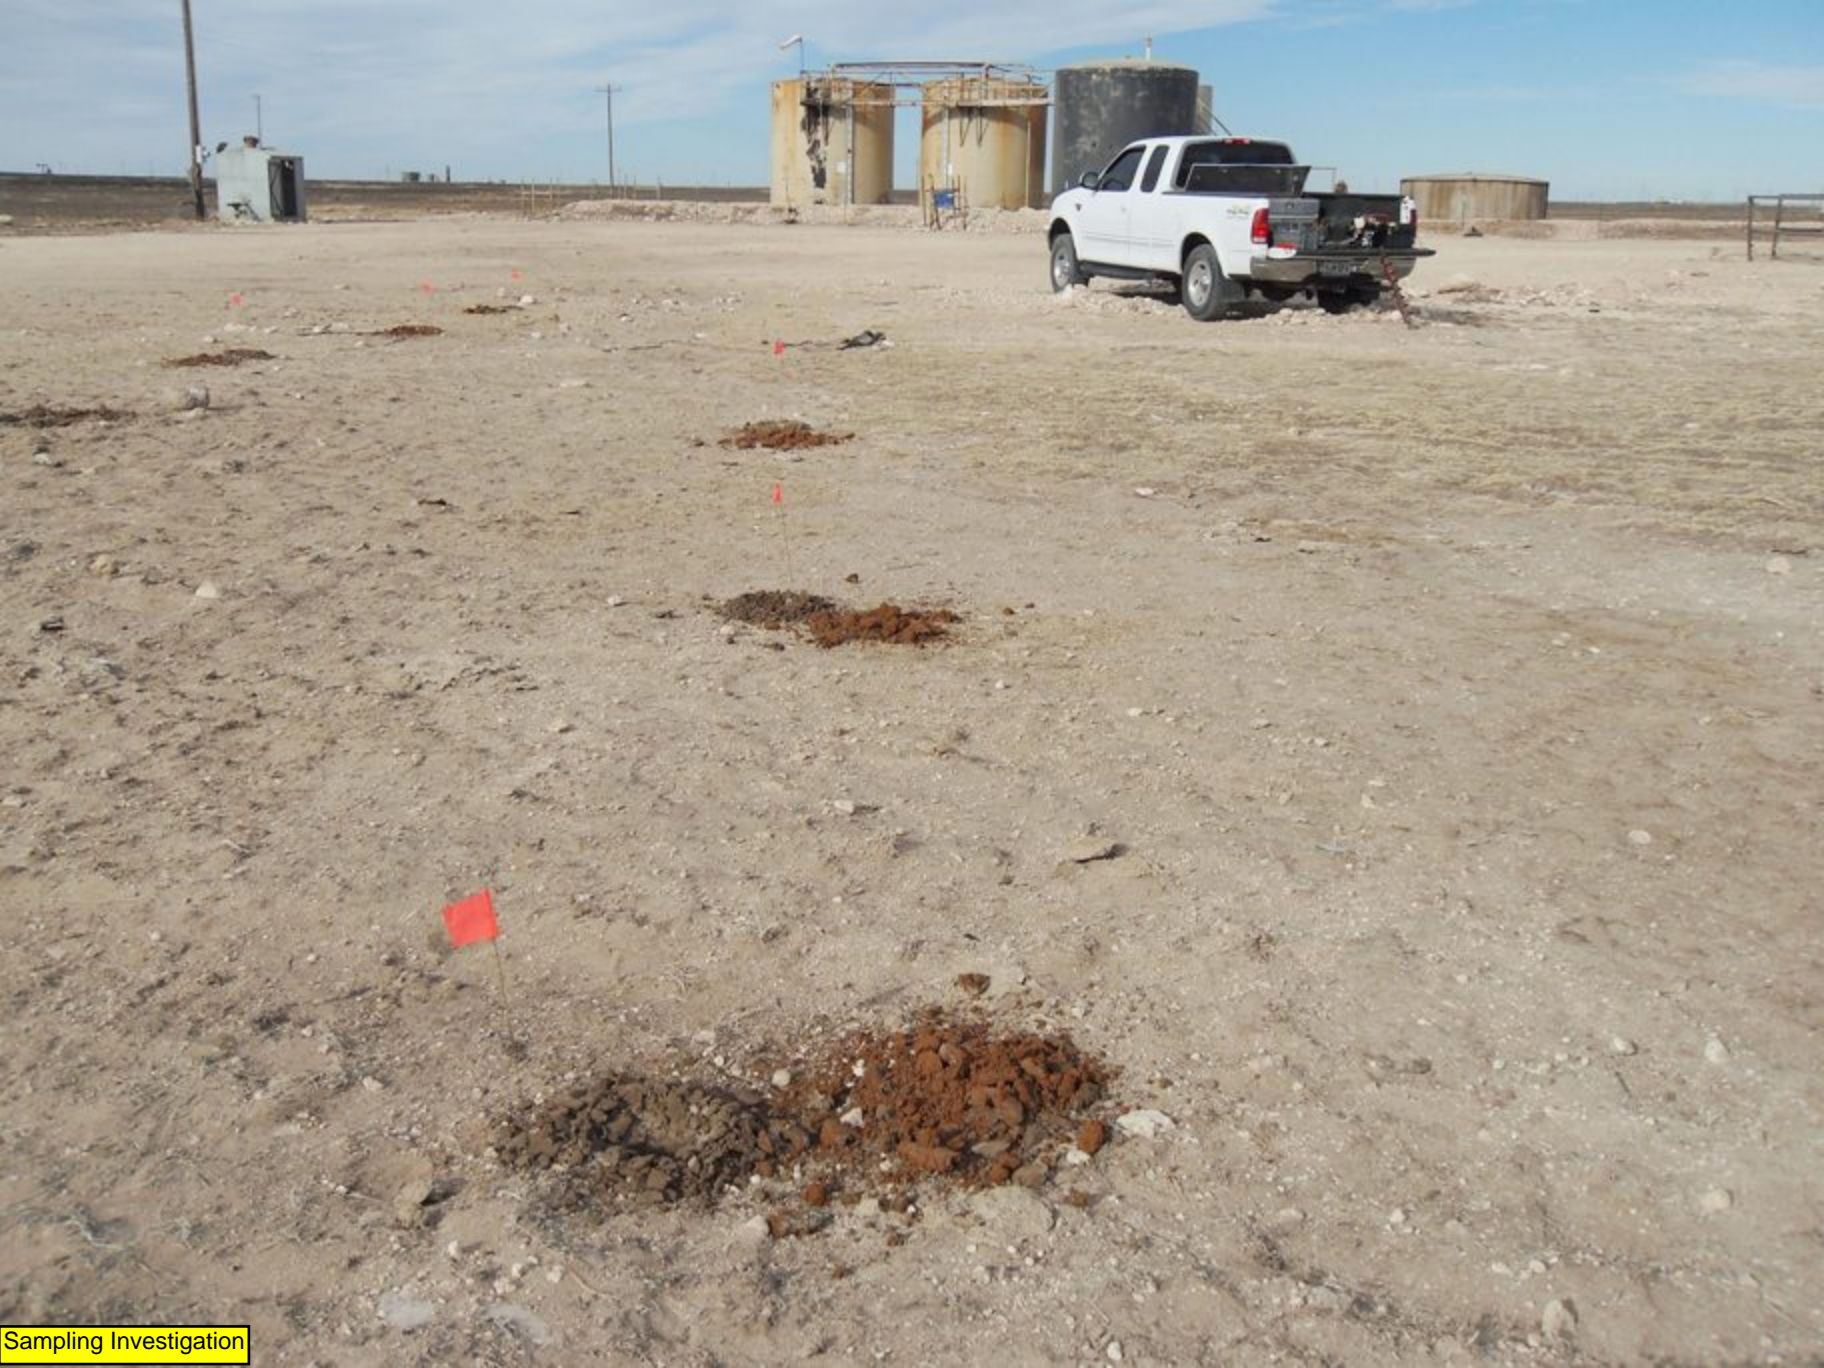
Sampling Investigation

Dike gave loose

Origin of spill - separator developed a leak. The dike and separator were repaired immediately.
