# PANTHER ENERGY SERVICES, LLC

Lease Name: South Langlie Jal Unit Injection Station

RP # 3831

## Work Plan

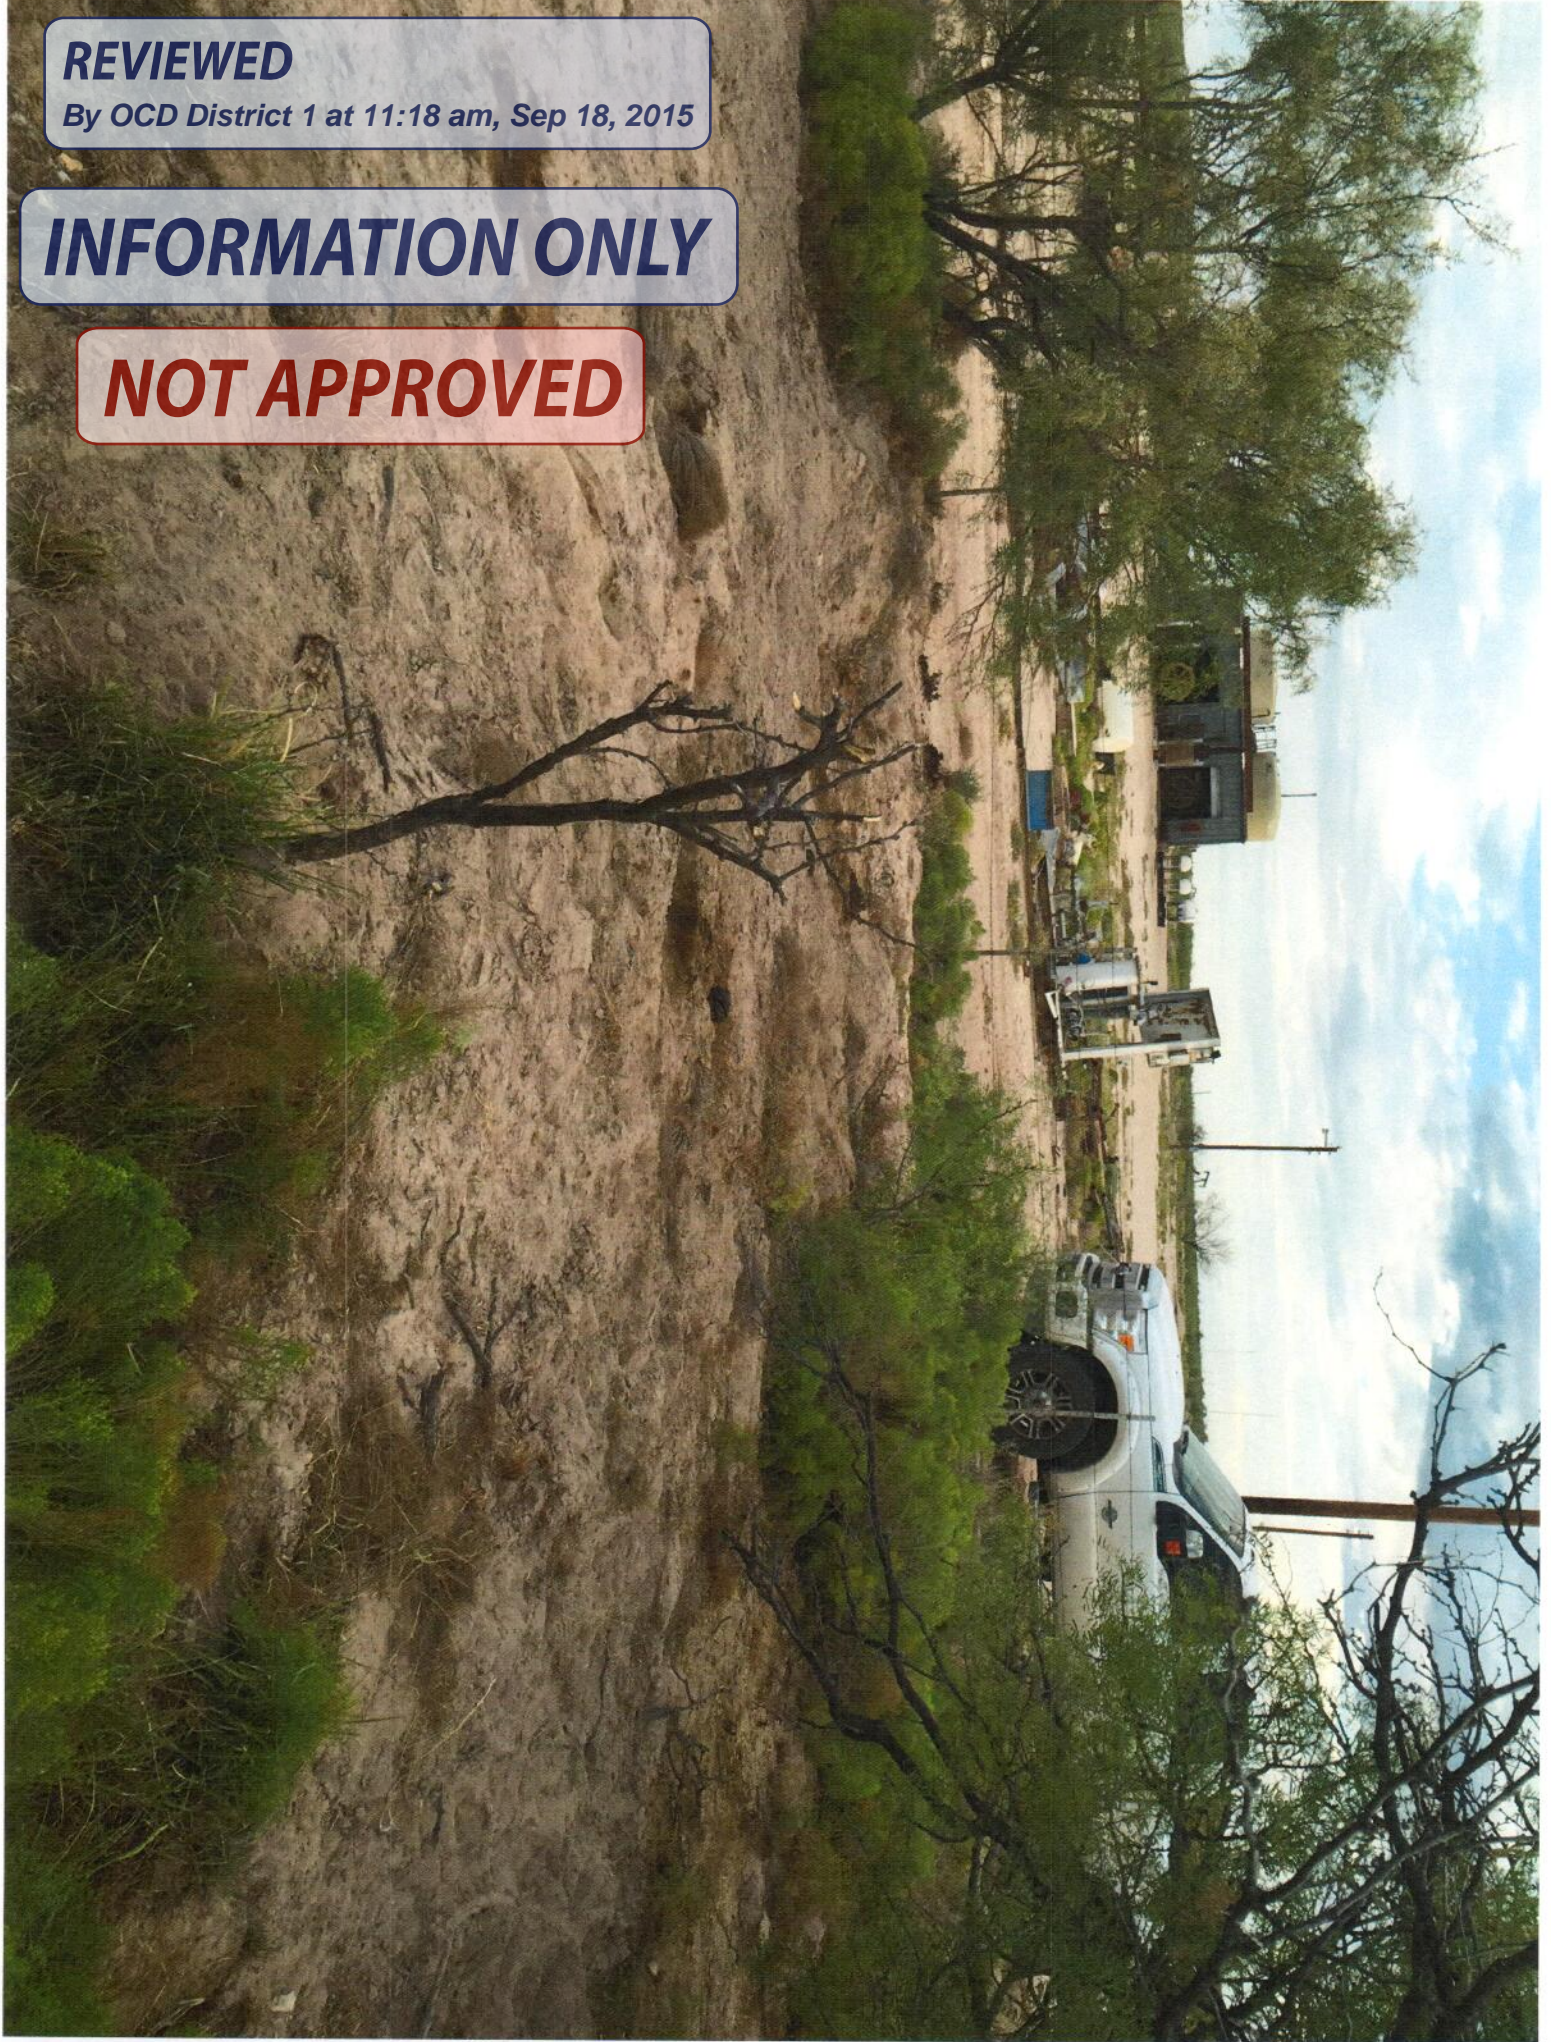
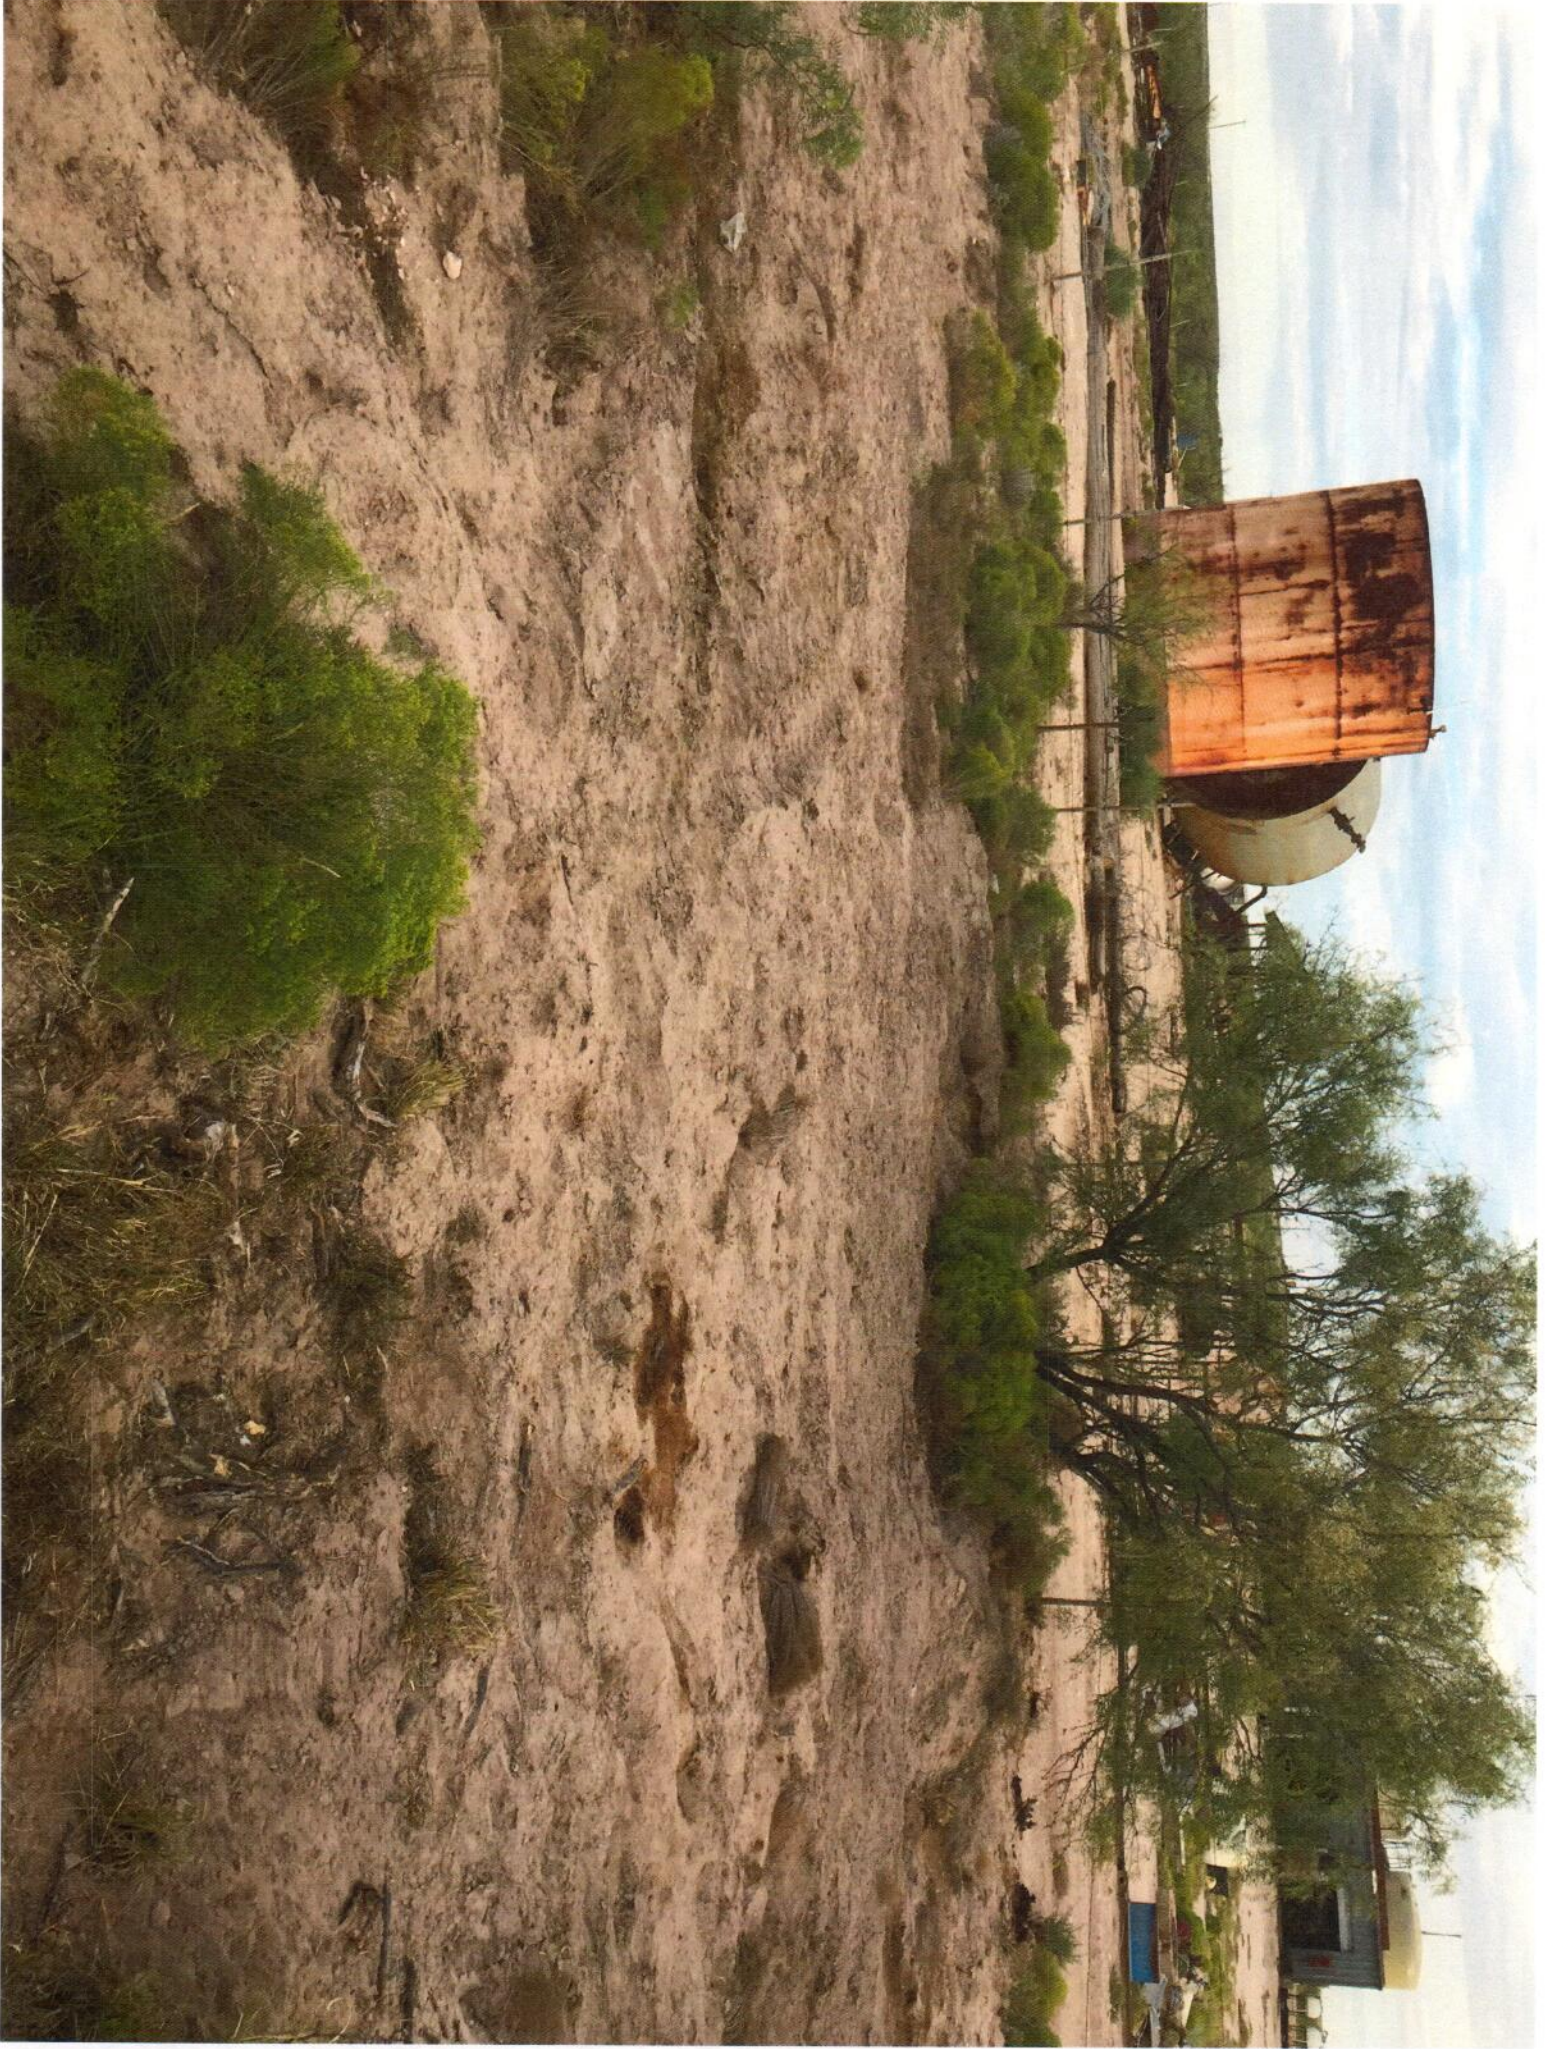
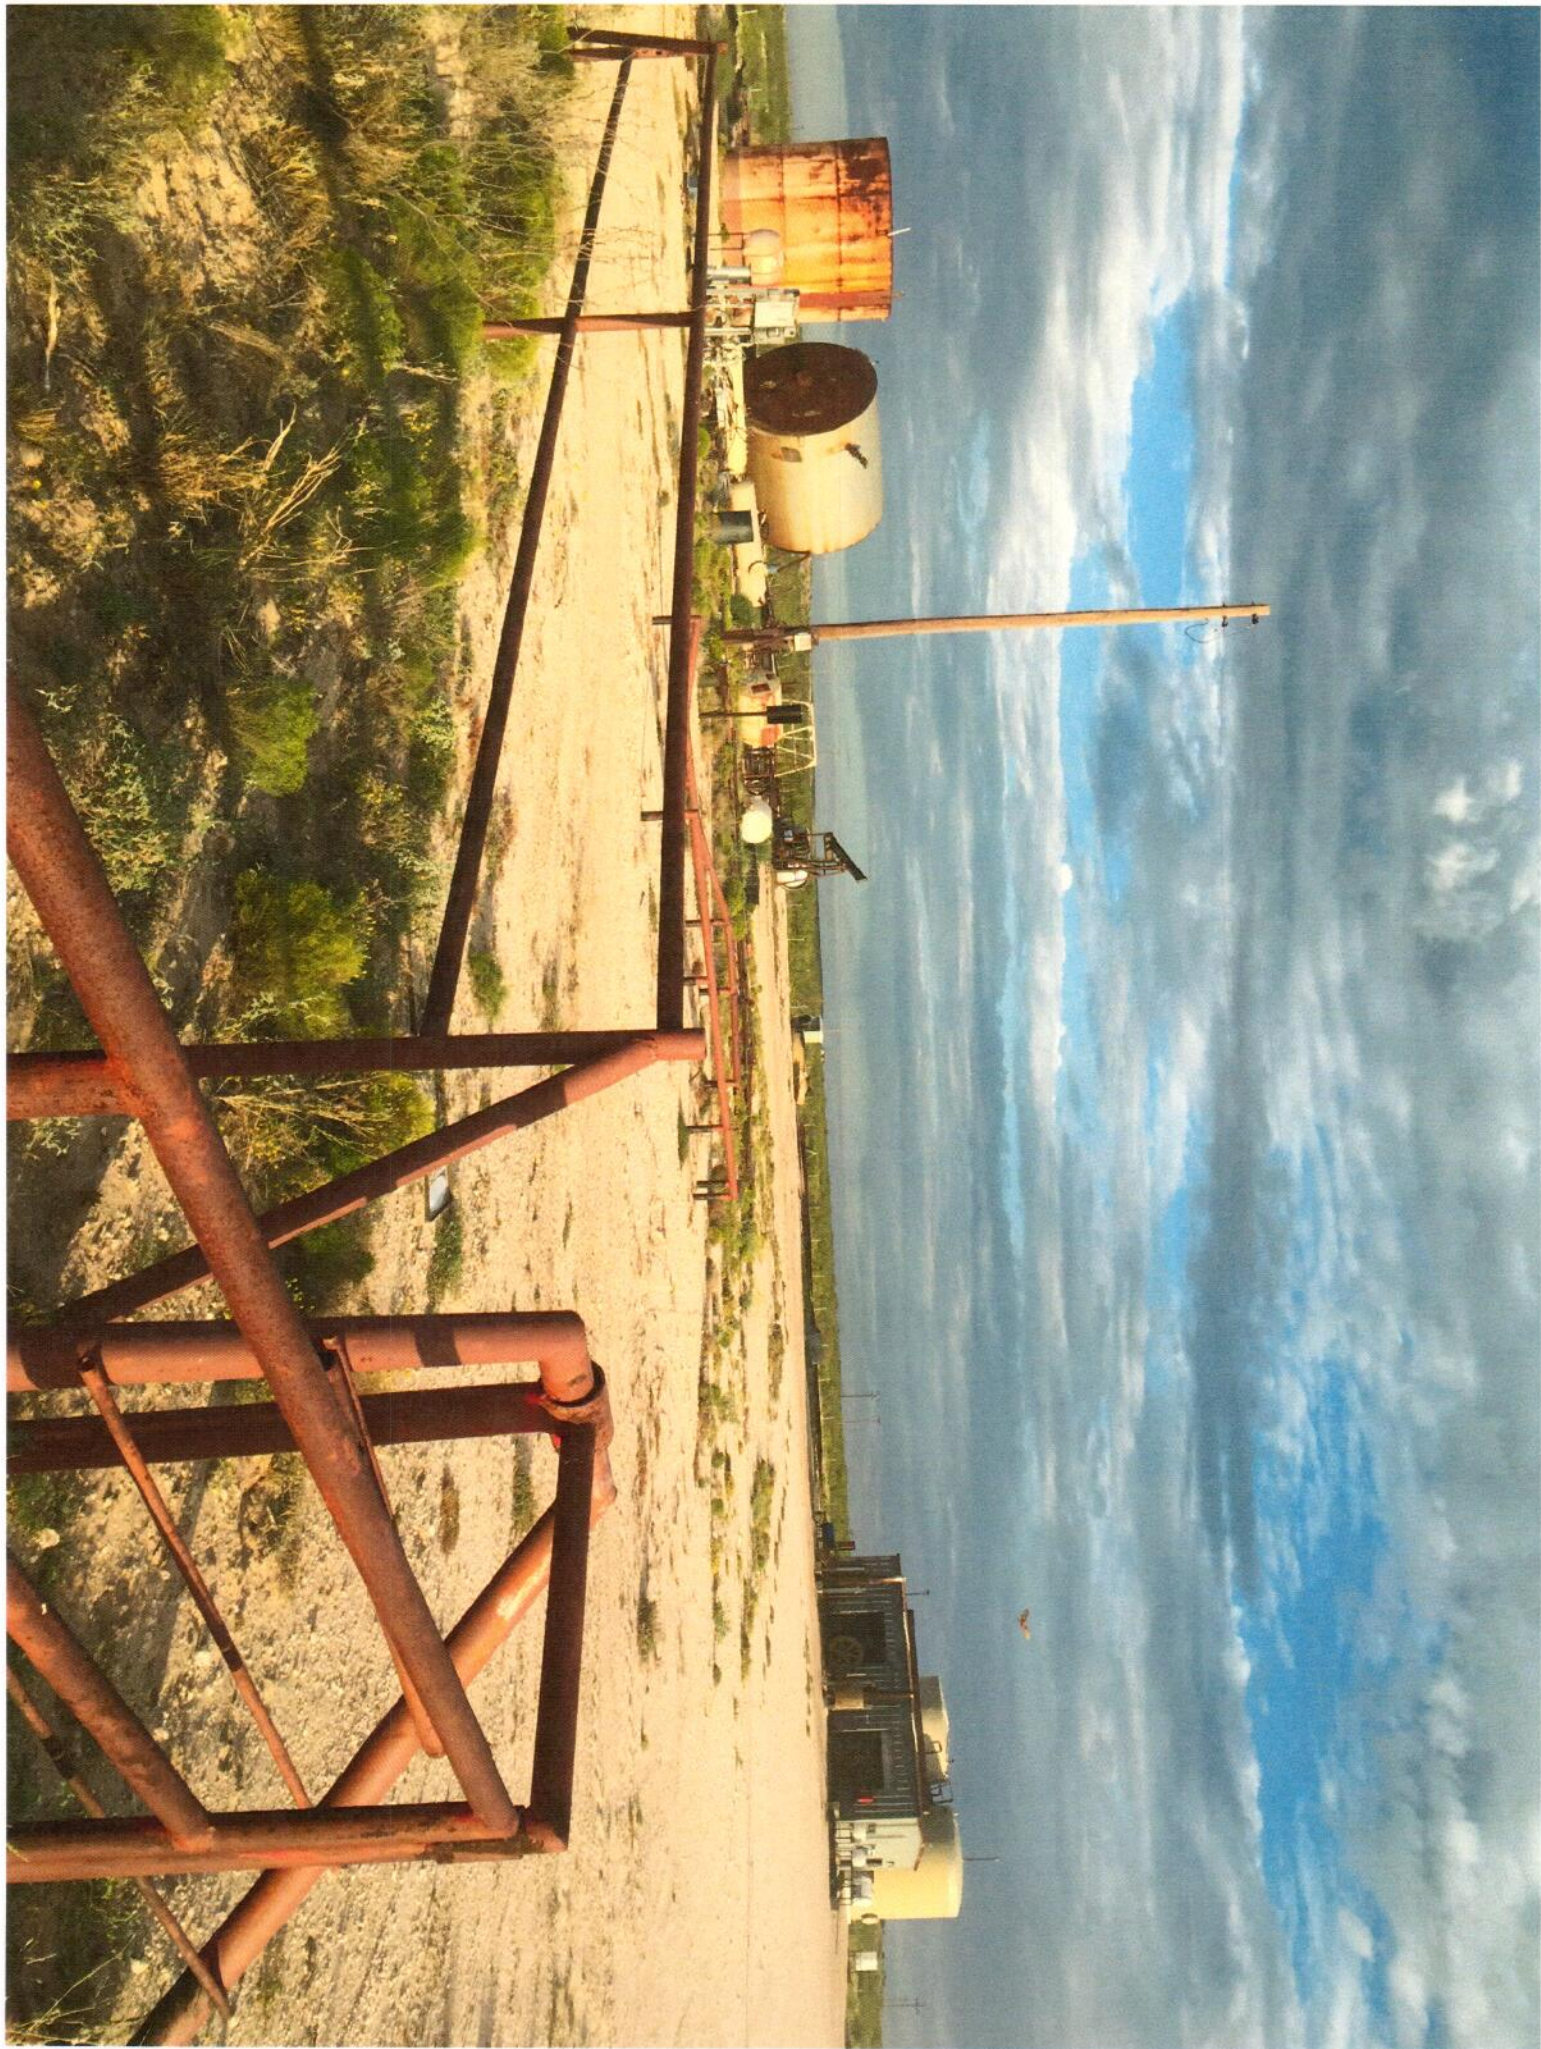
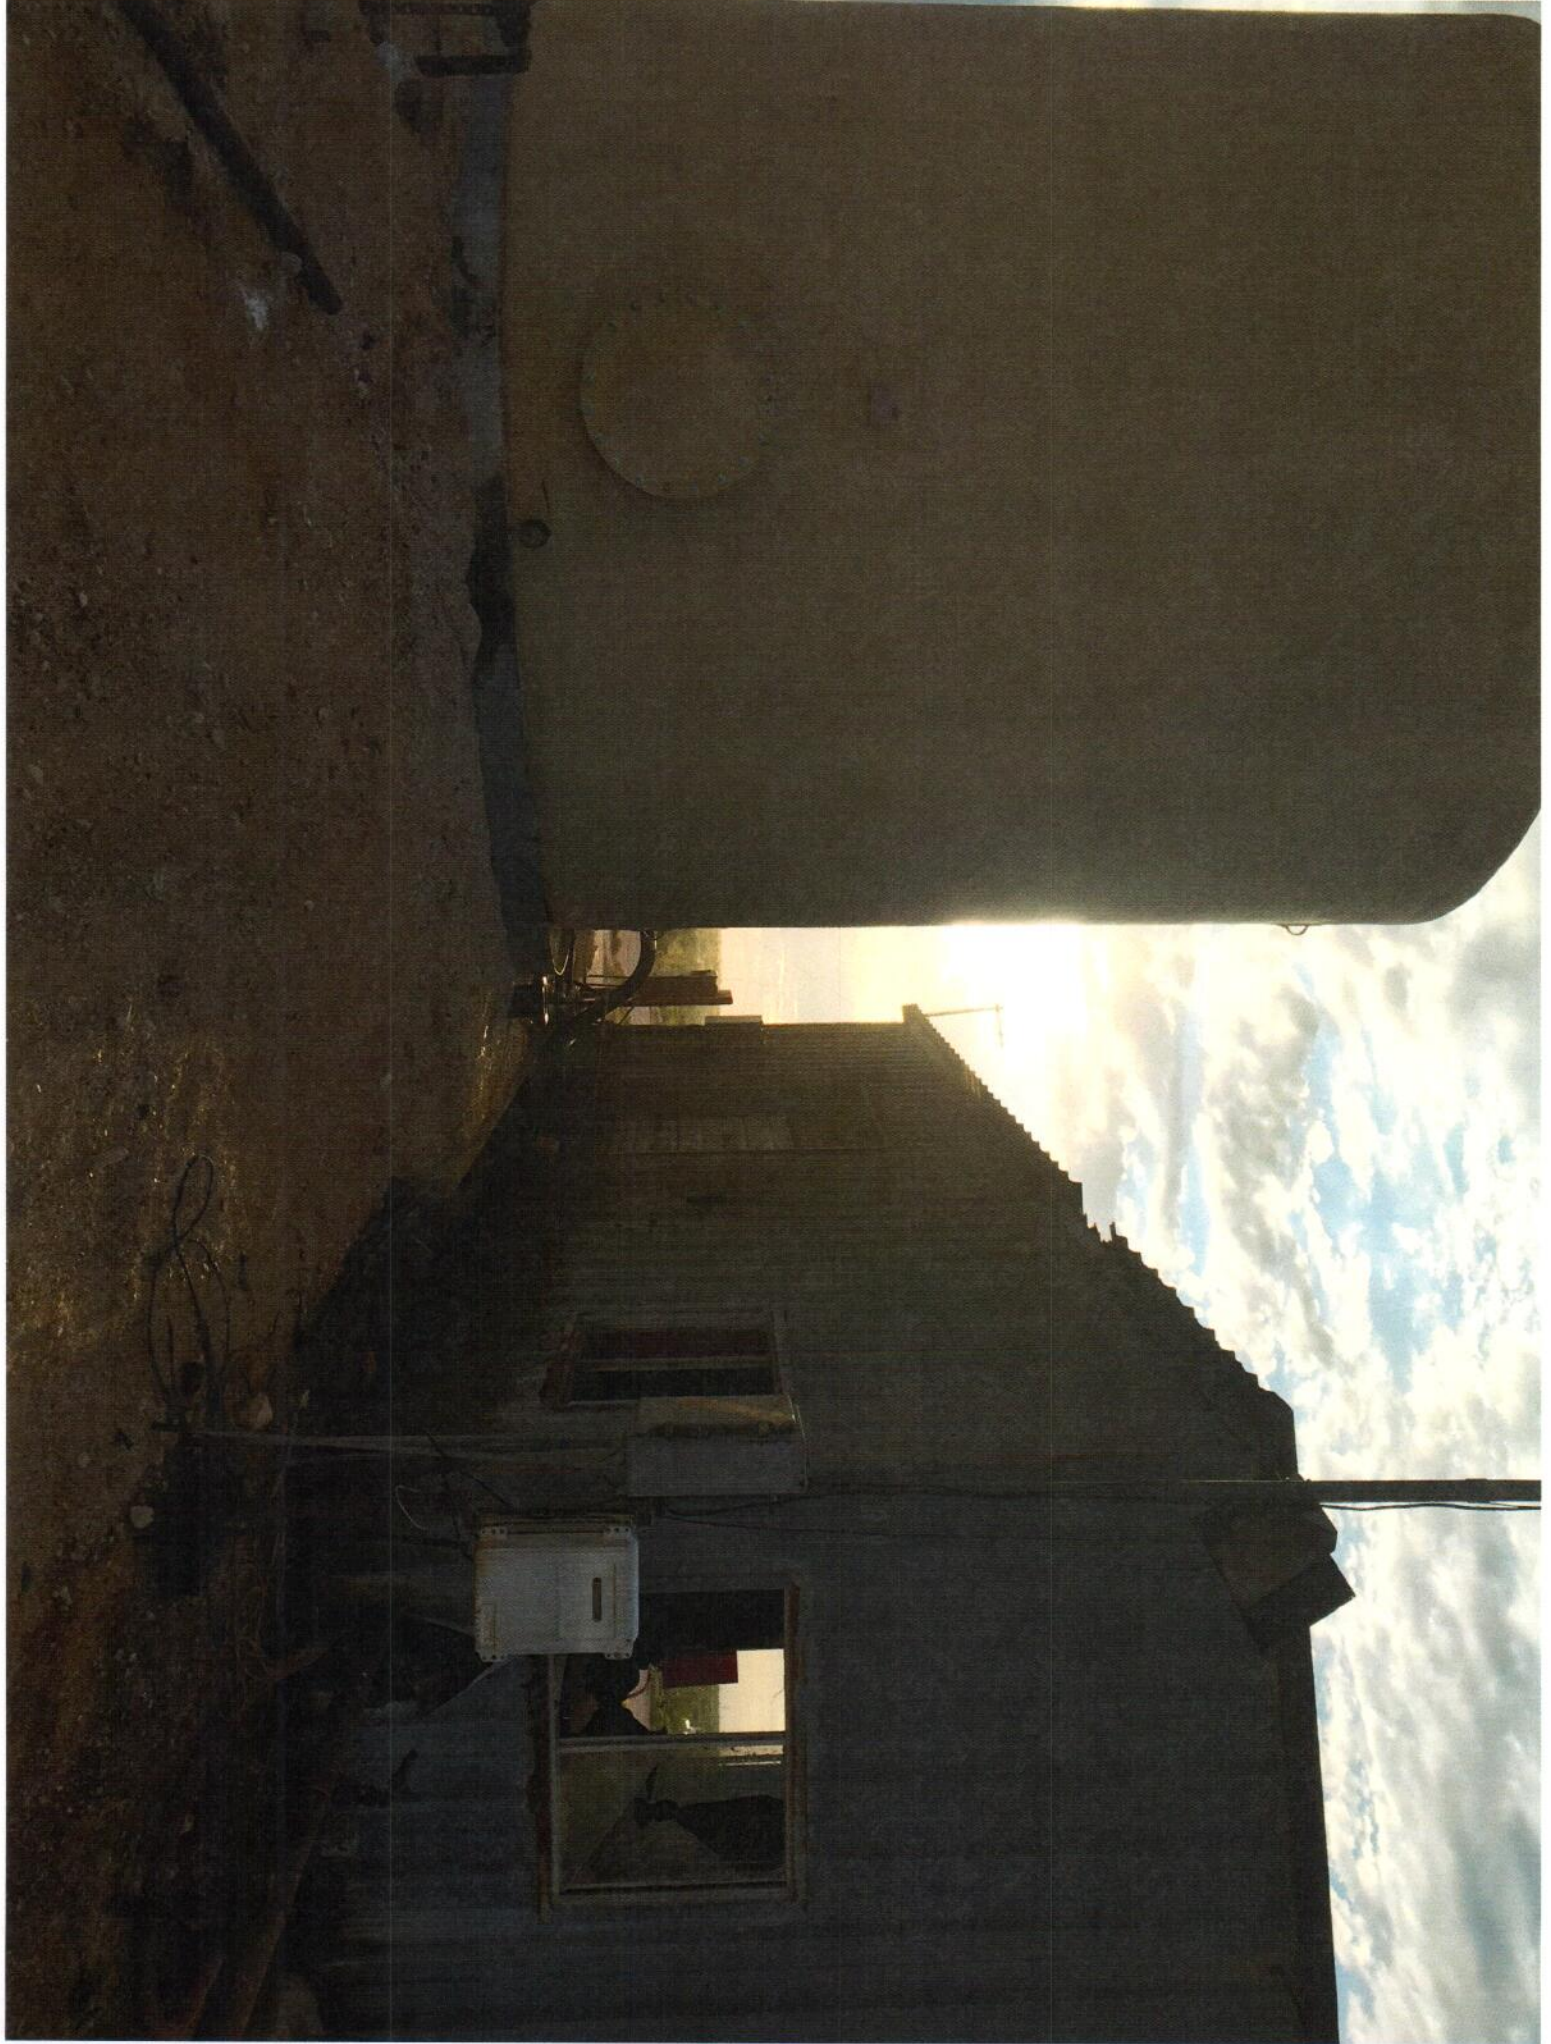
Tank that was  
hit by lightning

Spill Path

where spill stopped  
in pasture.

Sample spots

500 bbl fiberglass tank was struck by lightning causing the spill. The affected area is approximately 50' x 50' outside battery. No remedial activities have taken place. One call has been submitted. We will push up top soil of affected area. Then we will take PIS samples of area to find and clean up any hot spots left. Finally, we will take a composite sample of the area to see if clean. Sample will be taken to lab for verification. If clean we will backfill area.
