February 18, 2020

Vertex Project #: 20E-00141-001

**Spill Closure Report:** Malachite 22 CTB  
Unit D, Section 22, Township 19 South, Range 33 East  
County: Lea  
API: 30-025-40318  
Tracking Number: nOY1722030579

2020 Spill Assessment and Closure  
February 2020

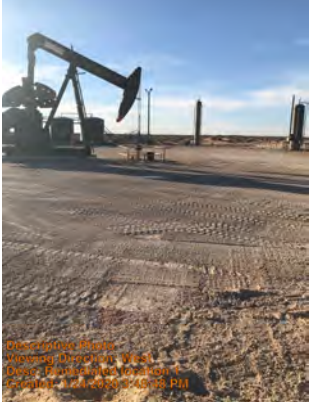
<p><b>Viewing Direction: West</b></p>

<p>Descriptive Photo Viewing Direction: West Date: Remediated location 1 Created: 1/24/2020 3:45:33 PM</p>	<p><b>Viewing Direction: Southeast</b></p>

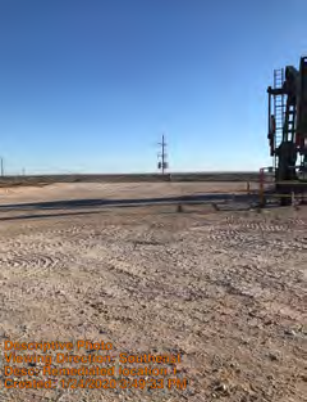
<p>Descriptive Photo Viewing Direction: Southeast Date: Remediated location 1 Created: 1/24/2020 3:45:33 PM</p>
Remediated location 1	Remediated location 1
<p><b>Viewing Direction: East</b></p>

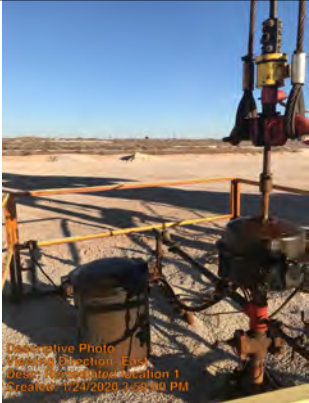
<p>Descriptive Photo Viewing Direction: East Date: Remediated location 1 Created: 1/24/2020 3:45:33 PM</p>	<p><b>Viewing Direction: Northwest</b></p>

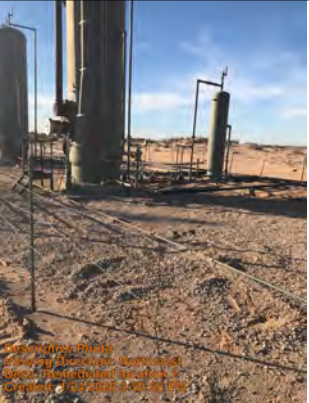
<p>Descriptive Photo Viewing Direction: Northwest Date: Remediated location 2 Created: 1/24/2020 3:45:33 PM</p>
Remediated location 1	Remediated location 2

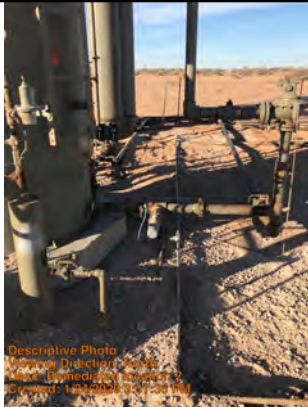
Viewing Direction: North

Remediated location 2

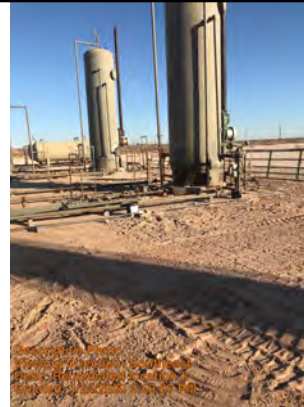
Viewing Direction: Southeast

Remediated location 2

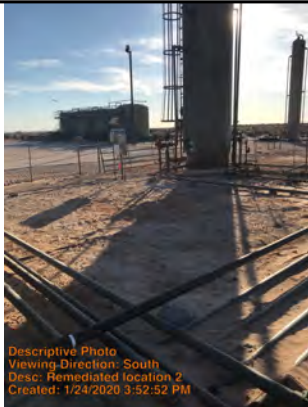
Viewing Direction: South

Remediated location 2

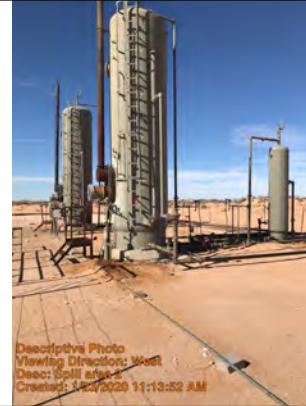
Viewing Direction: West

Spill area 1
