Release Notification

Site Name Seymour 6	Site Type Well
Date Release Discovered: 8/18/2022 @ 08:30am (MT)	API# 30-045-10684

Re: Remediation Work Plan and Variance Request

Seymour 6
San Juan County, New Mexico
Hilcorp Energy Company
NMOCD Incident No: nAPP2224144740

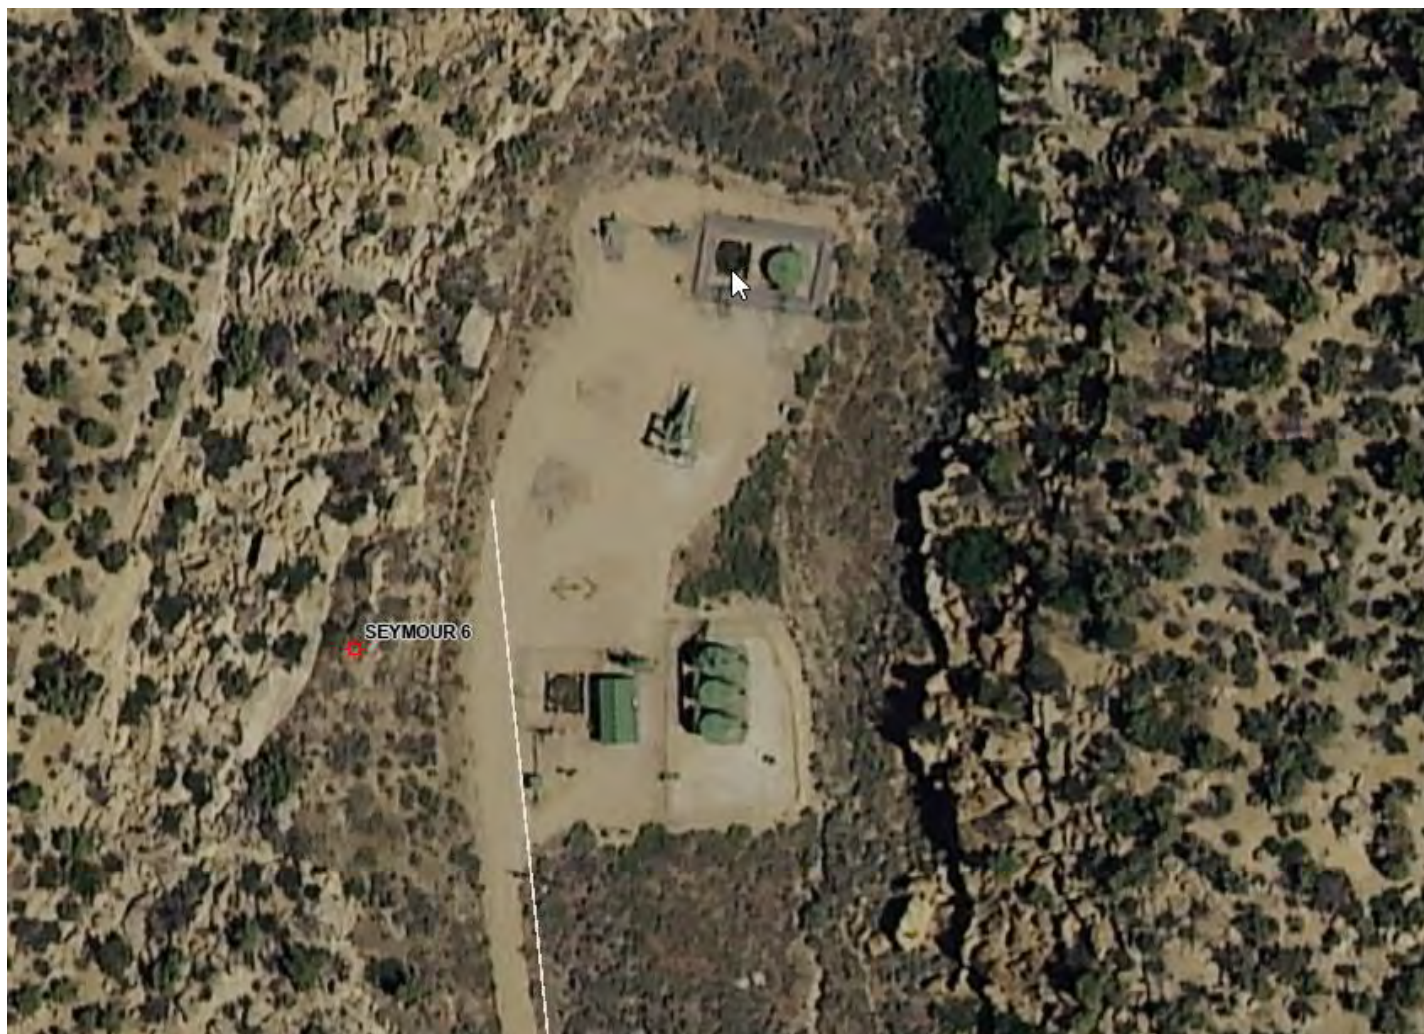
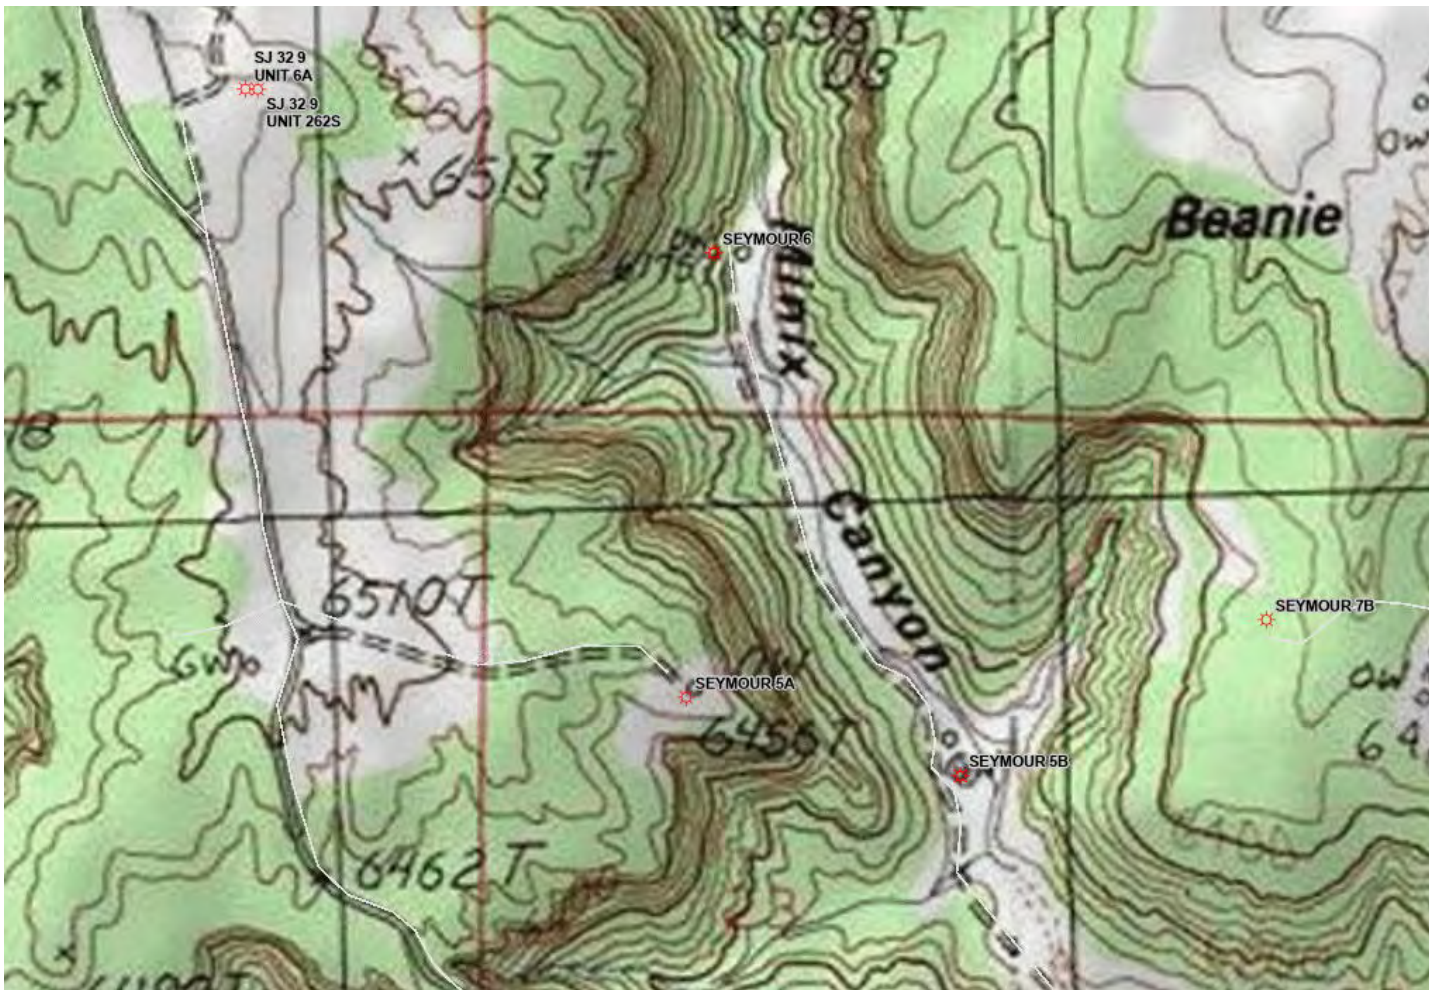
Based on initial assessments conducted by Hilcorp personnel, visual impacts to the unnamed watercourse were observed along approximately 950 linear ft with a width of 4 ft. These impacts are characterized as visual soil staining and discoloration on vegetation along the water feature. This is still being assessed at the moment.
