LINER INSPECTION AND CLOSURE REPORT **REPORTABLE RELEASE**

Spur Energy Partners
Hearse 36 State Com Battery
Incident ID: NAPP2113945611
Eddy County, NM

This report was prepared by Paragon Environmental LLC (Paragon) in response to the release for Spur Energy Partners (Spur) at the **Hearse 36 St Com Battery (Hearse)**.

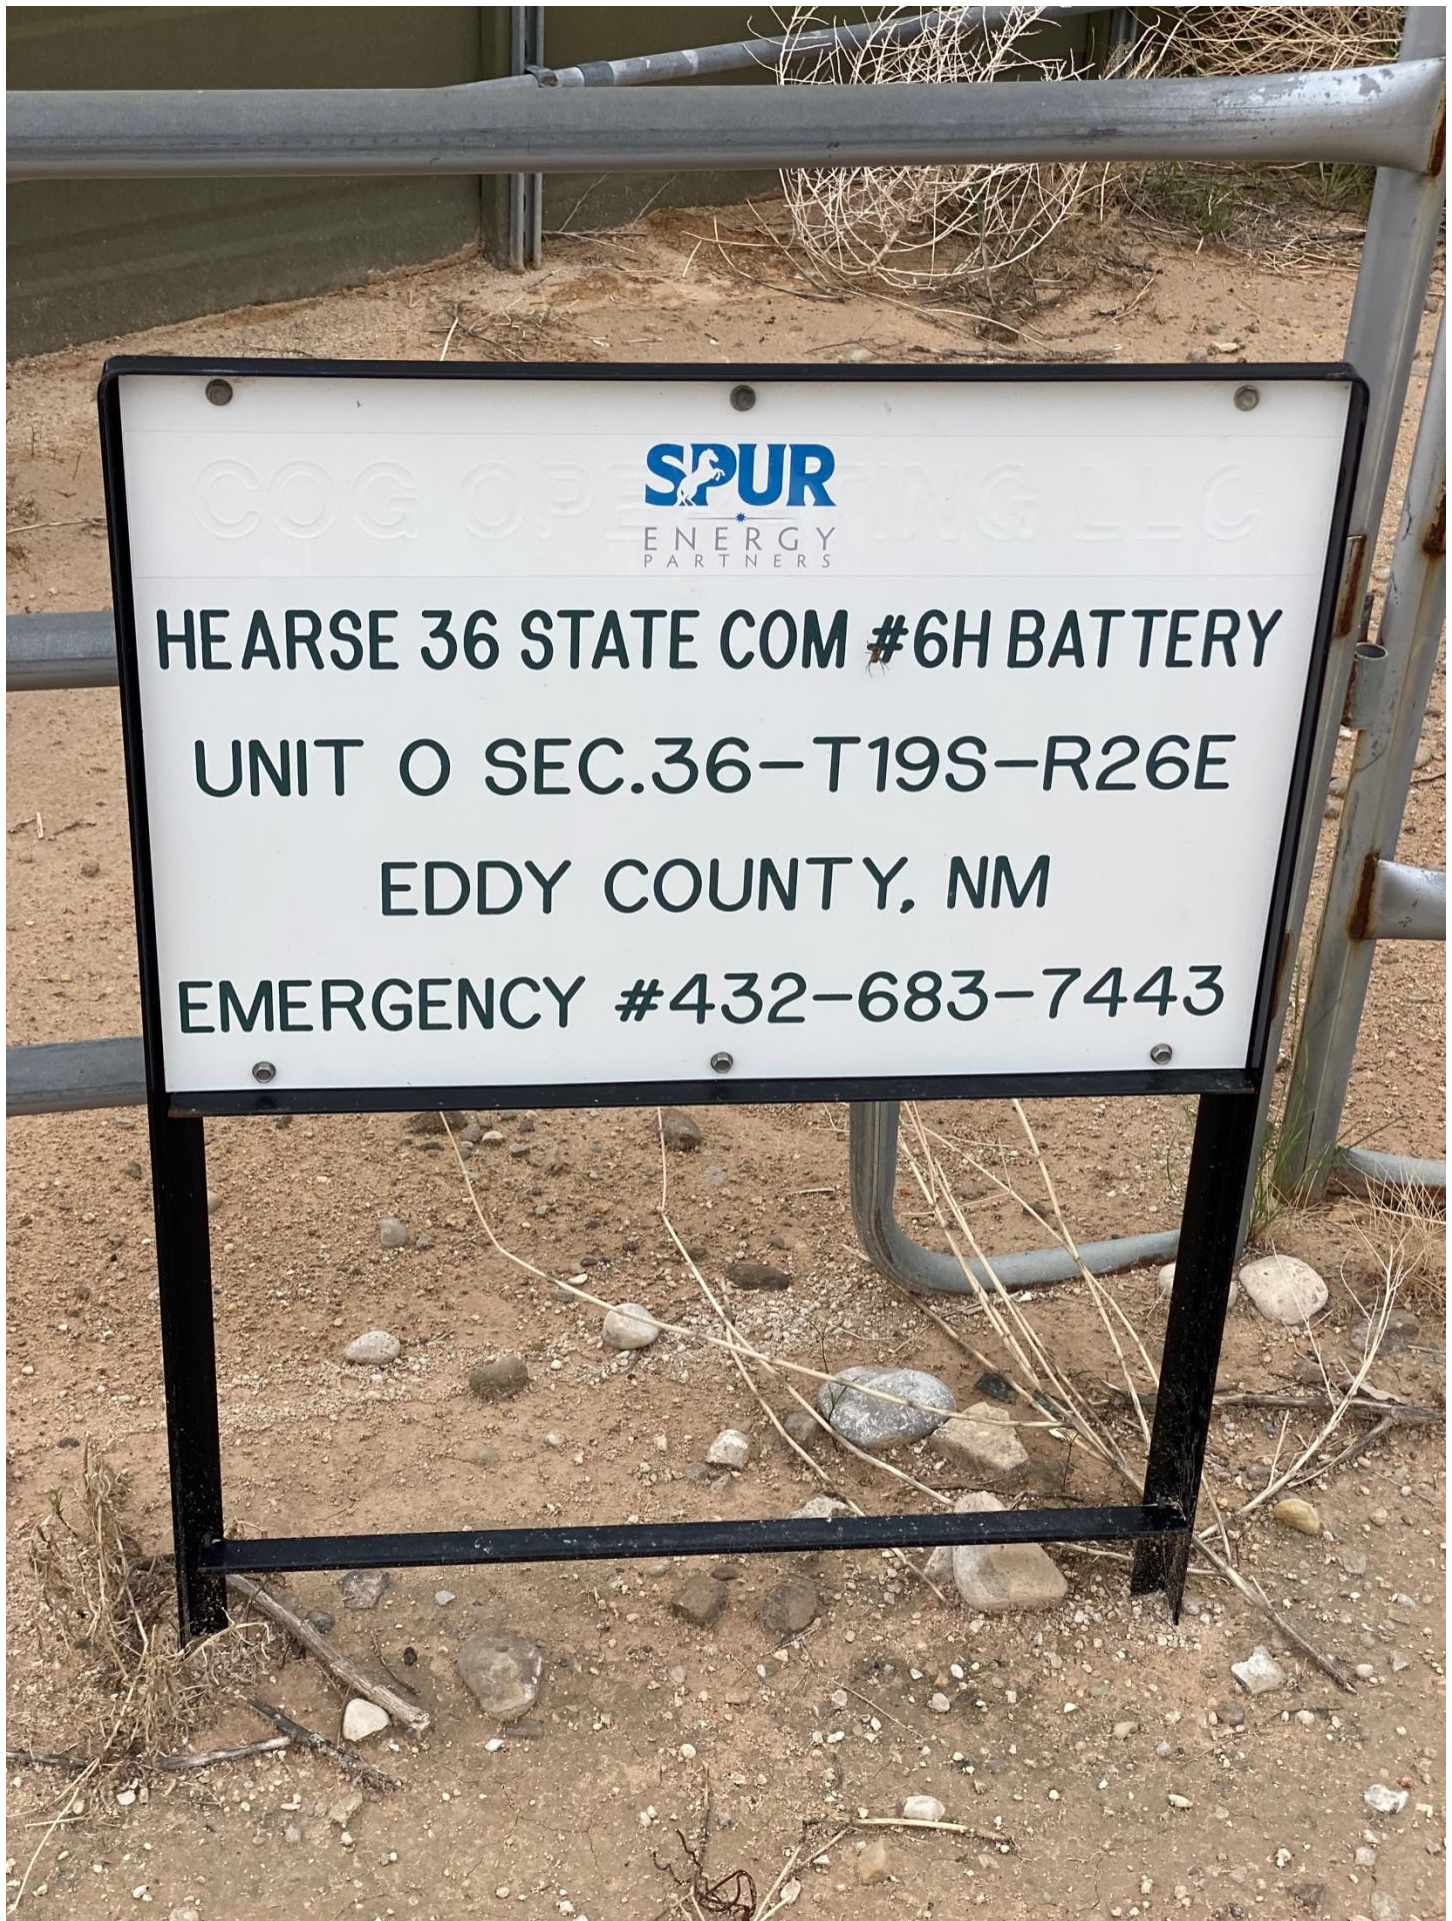
Liner Inspection

On July 20, 2022, Paragon returned to the site to conduct a liner inspection. A 48-hour notification was sent out to the NMOCD on July 18, 2022. The liner inspection concluded that the liner was all intact and in good condition. The integrity of the liner appears to have the ability to contain spills. See Appendix D for the email notification and liner report.

Visualization	Yes	No	Comments
Is there a tear in the liner?		x	
Are there holes in the liner?		x	
Is the liner retaining any fluids?		x	
Does the liner have integrity to contain a leak?	x
