Closure Report

Salado Draw 23 Central Tank Battery (05.29.2025)

Incident #: NAPP2515528266

Motor Oil Release

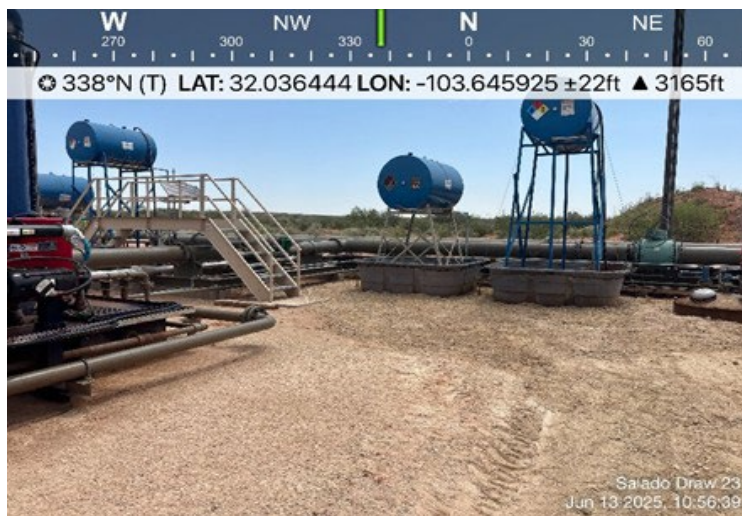
Photograph No. 3

Description:
View North, area of CS-3 & CS-4.

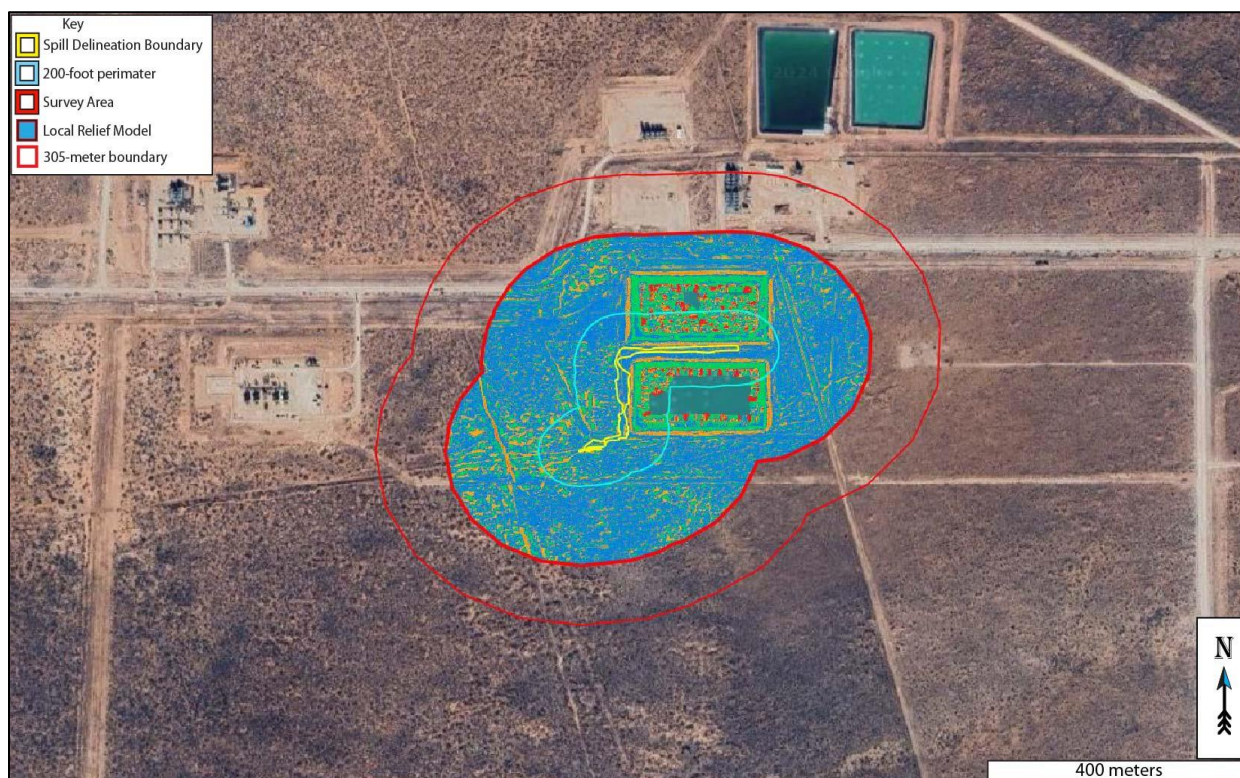
Figure 4: Survey overview. Background image credit: Google Earth. Image date: December 20, 2023. Datum: WGS-84.

No features identified as surface karst features are located in the survey area (Figure 4).

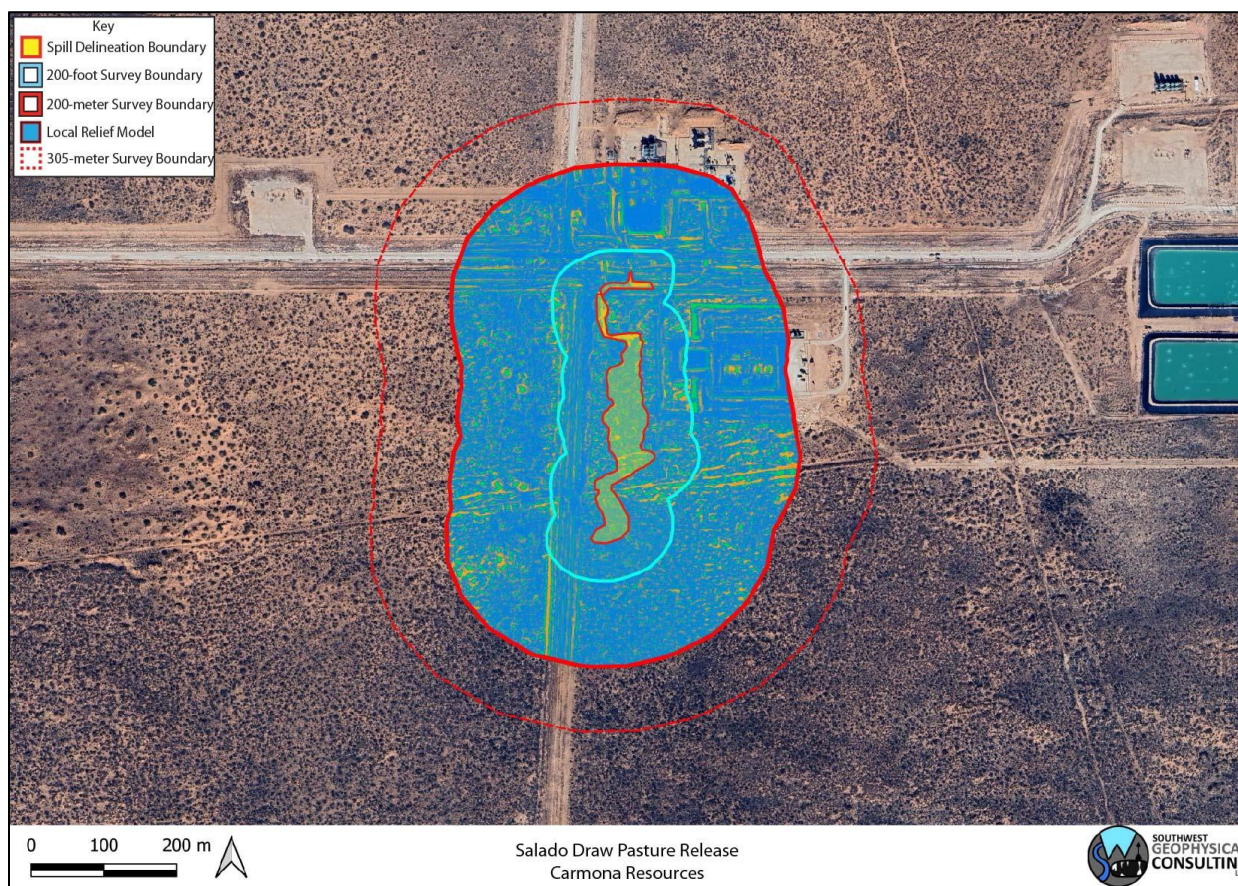
Figure 4: Survey overview. Background image credit: Google Earth. Image date: December 20, 2023. Datum: WGS-84.

No features identified as surface karst features are located within the survey area (Figure 4).
