**Re: Closure Request
Burton Flat Deep Unit 35 Facility 1
Incident Number nAPP2512565999
Eddy County, New Mexico**

Burton Flat Deep Unit 35 Facility 1

Devon Energy Production Company, LP
Burton Flat Deep Unit 35 Facility 1
Incident Number: nAPP2512565999
Unit C, Section 35, T 20S, R 28E
Eddy County, New Mexico

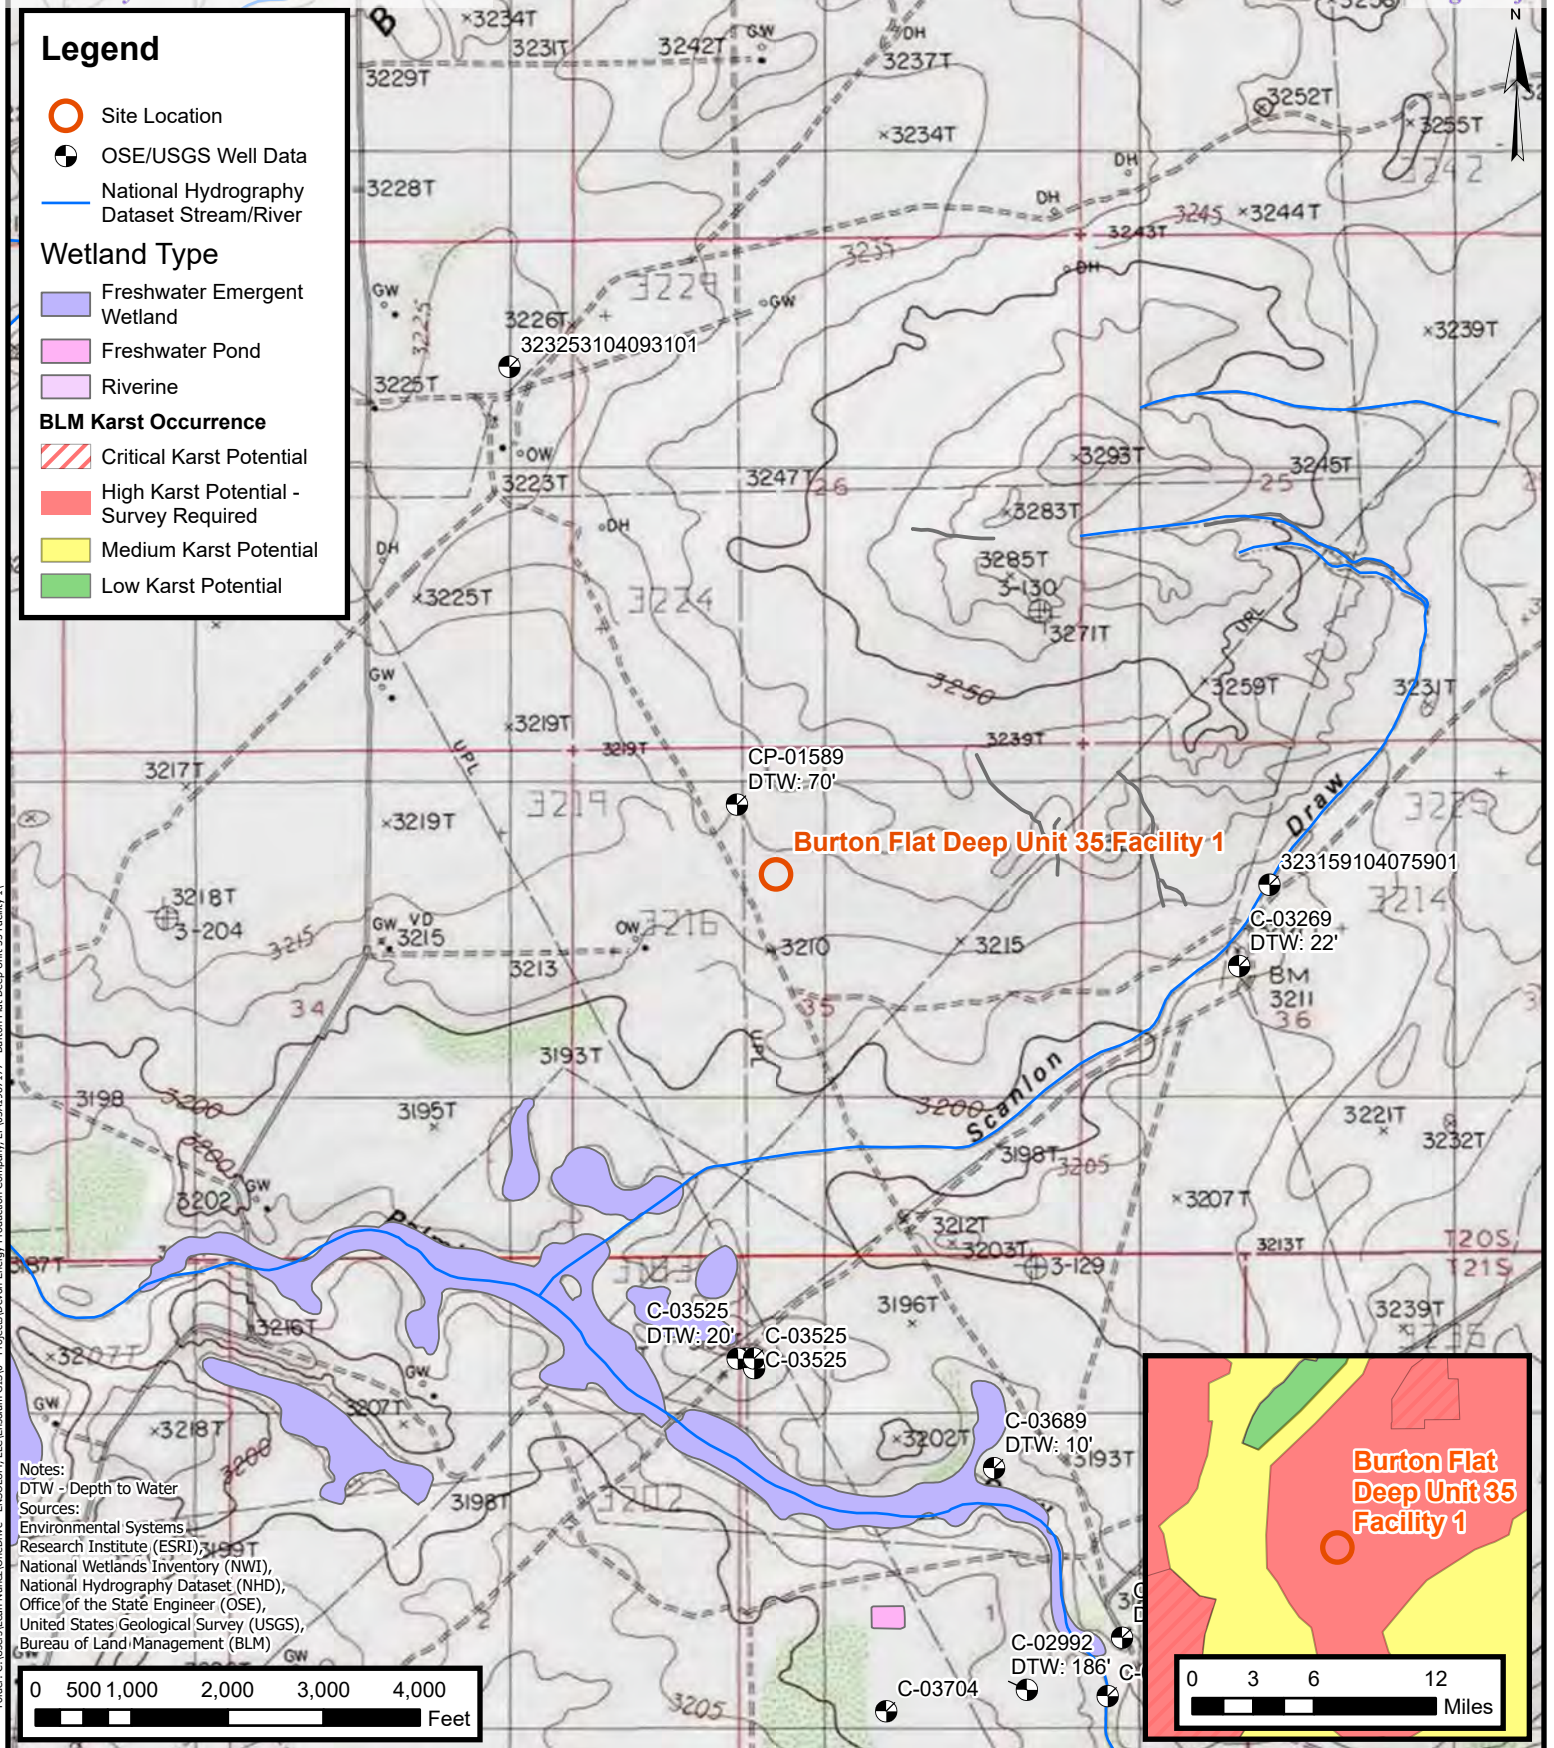
The Site was characterized to assess applicability of Table I, Closure Criteria for Soils Impacted by a Release, of Title 19, Chapter 15, Part 29 (19.15.29) of the New Mexico Administrative Code (NMAC). Results from the characterization desktop review are presented on page 3 of the Form C-141, Site Assessment/Characterization. Potential Site receptors are identified on Figure 1.

According to the New Mexico Office of the State Engineer (NMOSE), the closest permitted groundwater well with depth to groundwater data is CP 01589 POD1, located approximately 849 feet northwest of the Site. The well had a reported depth to groundwater of 70 feet below ground surface (bgs) and a total depth of 109 feet bgs. There are no regional or Site-specific hydrogeological conditions, such as shallow surface water, known surficial karst features, wetlands, or vegetation to suggest the Site is conducive to shallow groundwater. All wells used for depth to groundwater determination are presented on Figure 1. The referenced well record is included in Appendix A.

The closest continuously flowing or significant watercourse to the Site is an intermittent dry wash, located approximately 2,470 feet northwest of the Site. The Site is greater than 200 feet from a lakebed, sinkhole, or playa lake and greater than 300 feet from an occupied residence, school, hospital, institution, church, or wetland. The Site is greater than 1,000 feet to a freshwater well or spring and is not within a 100-year floodplain or overlying a subsurface mine. The Site is underlain by unstable geology (high potential karst designation area). Site receptors are identified on Figure 1.

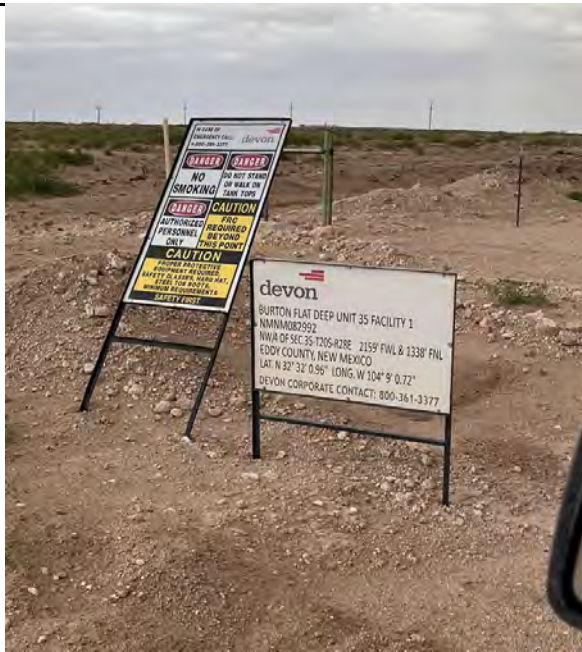
Photograph 1
Description: Site sign
View: NA
Date: 5/4/2025
