Red Skies 10 Fed Com TB

Incident ID nAPP2524531404

## Liner Inspection and Closure Report

October 14, 2025

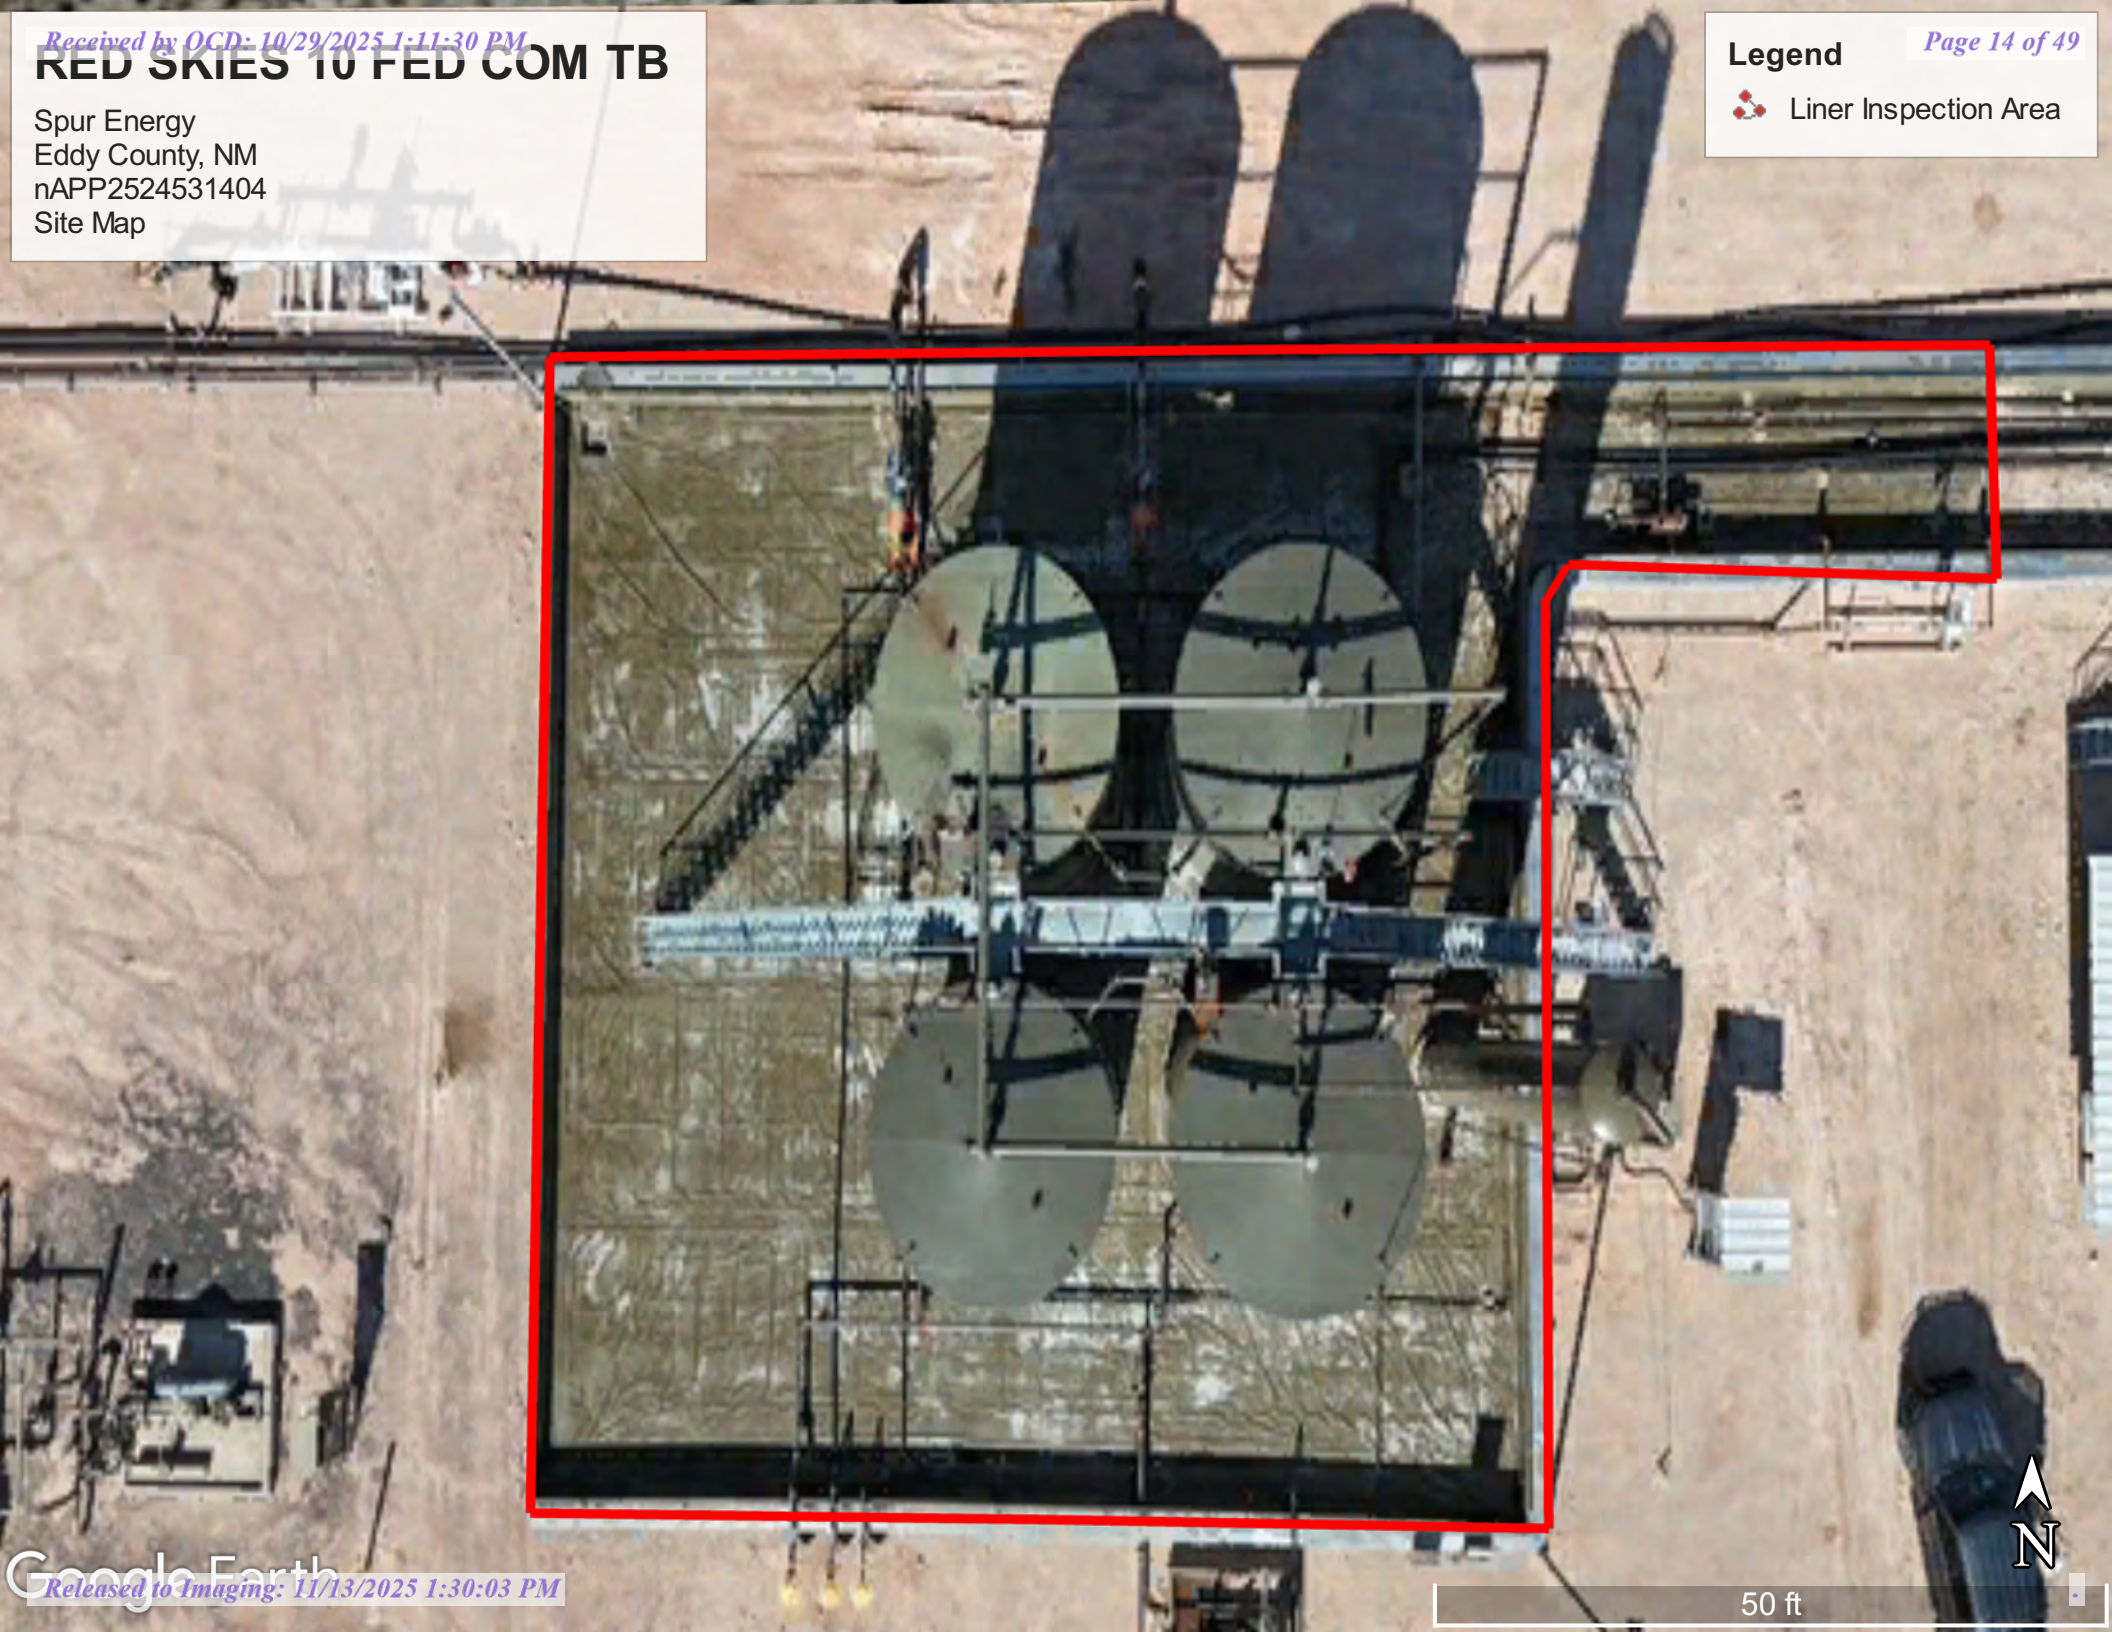
Spur Energy  
Eddy County, NM  
nAPP2524531404  
Site Map

**nAPP2524531404:** On August 30, 2025, debris on a check valve gasket caused a backflow that led to an overflow from the tank, releasing approximately 385 barrels of produced water into the lined secondary containment. Spur personnel promptly mobilized a vacuum truck and successfully recovered the entire released volume. All produced water was contained within the engineered secondary containment, and no fluids migrated beyond the containment area. A site map is provided in Figure 4 for reference.
