Re: 2024 Annual Groundwater Monitoring Report

Florance M #047X
San Juan County, New Mexico
Harvest Four Corners, LLC
NMOCD Incident No: nAUTOfAB000185
Remediation Permit Number: 3RP-317-0

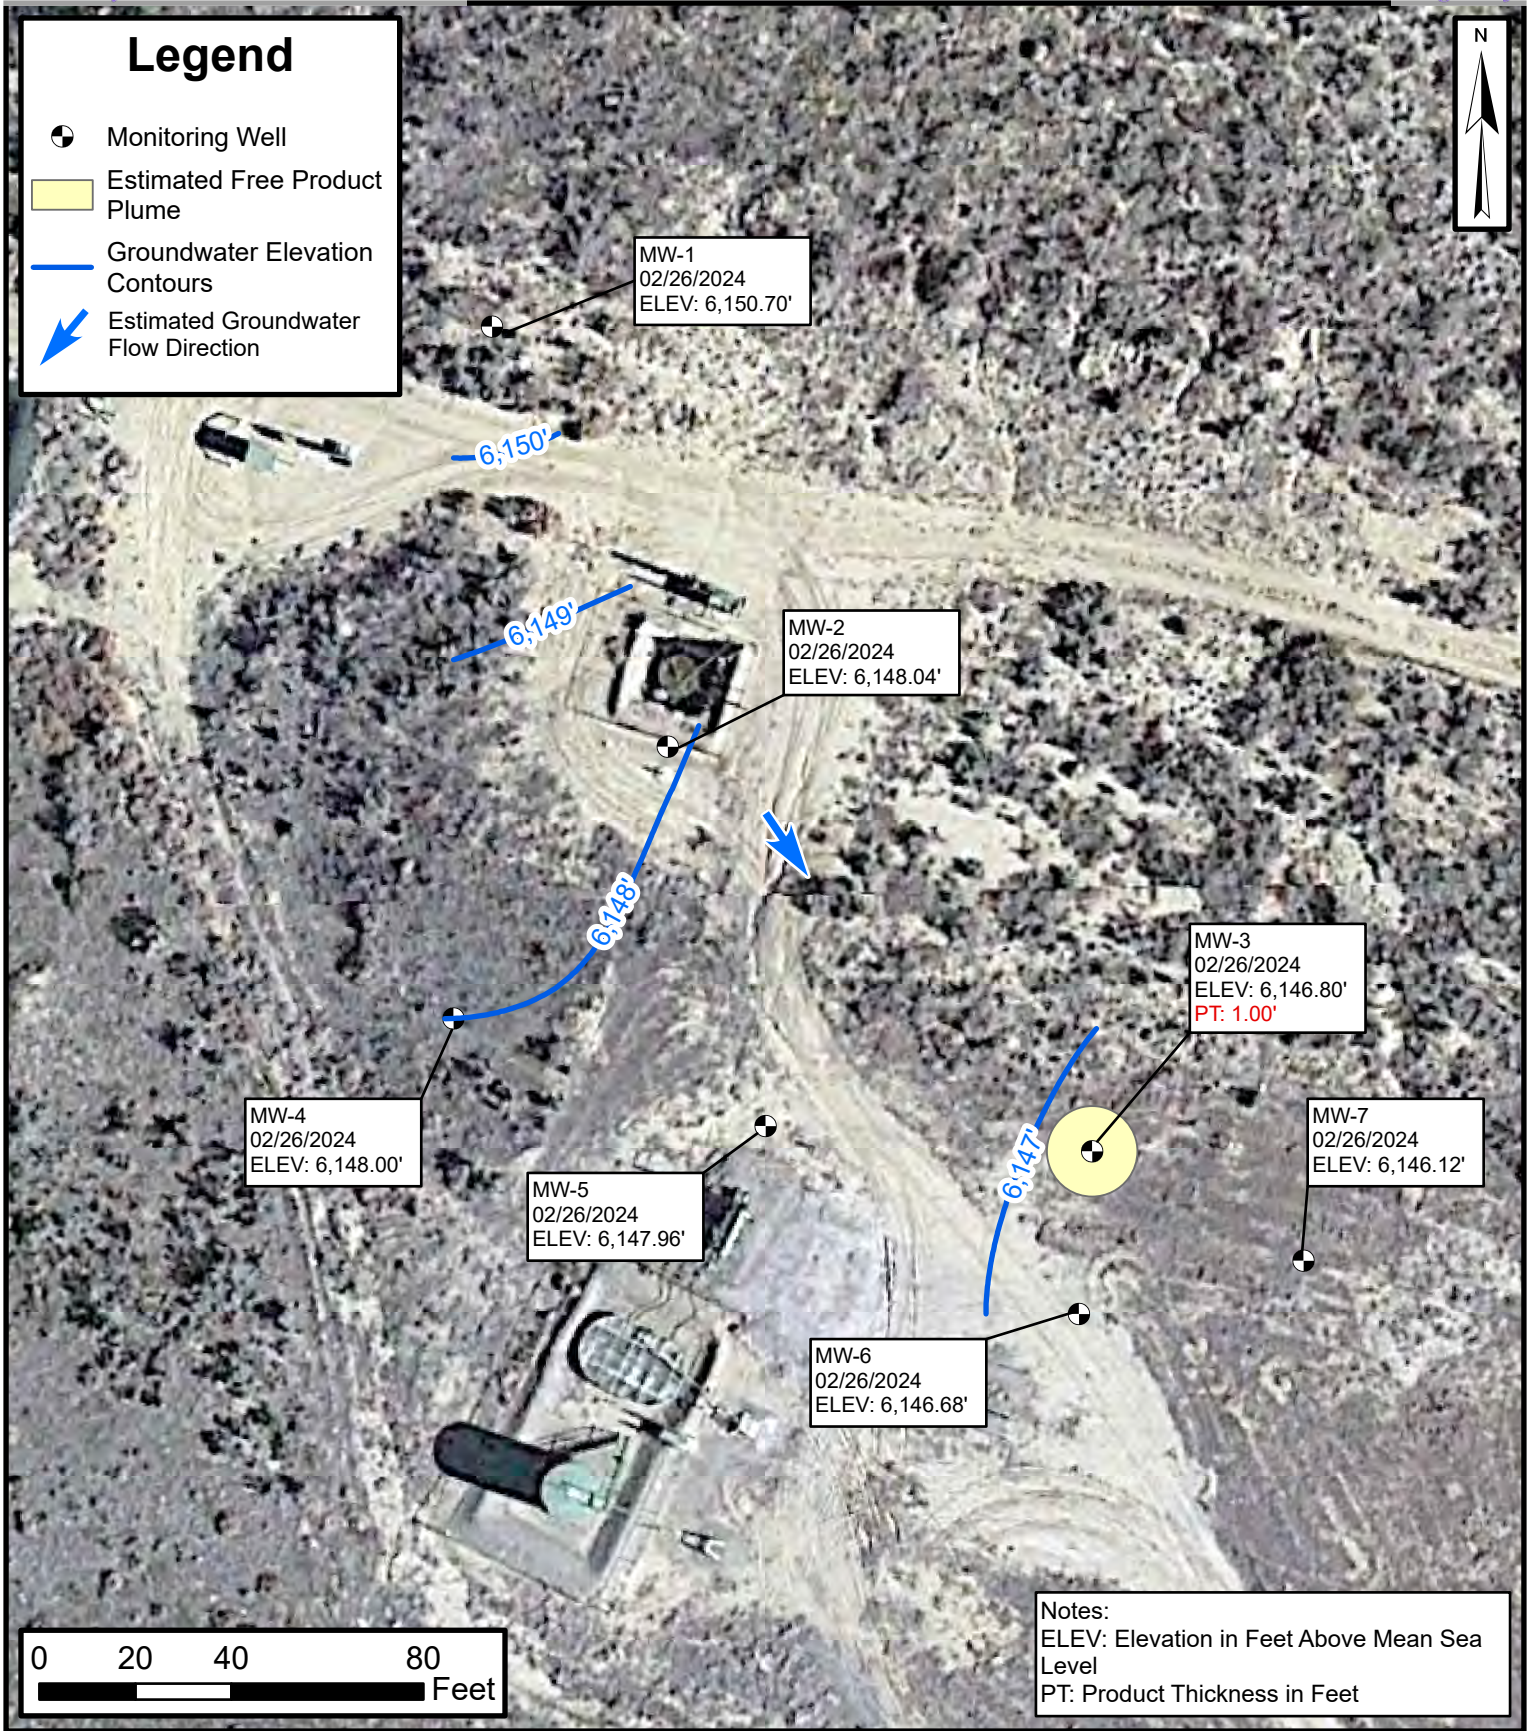
FIGURE
2

Depth to groundwater was collected in February 2024, June 2024, July 2024, and November 2024. Based on data collected during the four quarterly events, the interpreted groundwater-flow direction is to the southeast (contours shown on Figures 2 through 5). Contours were inferred based on groundwater elevations and physical characteristics at the Site (topography, proximity to irrigation ditches, etc.).

Groundwater Elevation (February 2024)
 Florance M #047X
 Harvest Four Corners, LLC
 36.8436, -107.8010
 SW/NE, Sec 5, T30N, R9W
 San Juan County, New Mexico

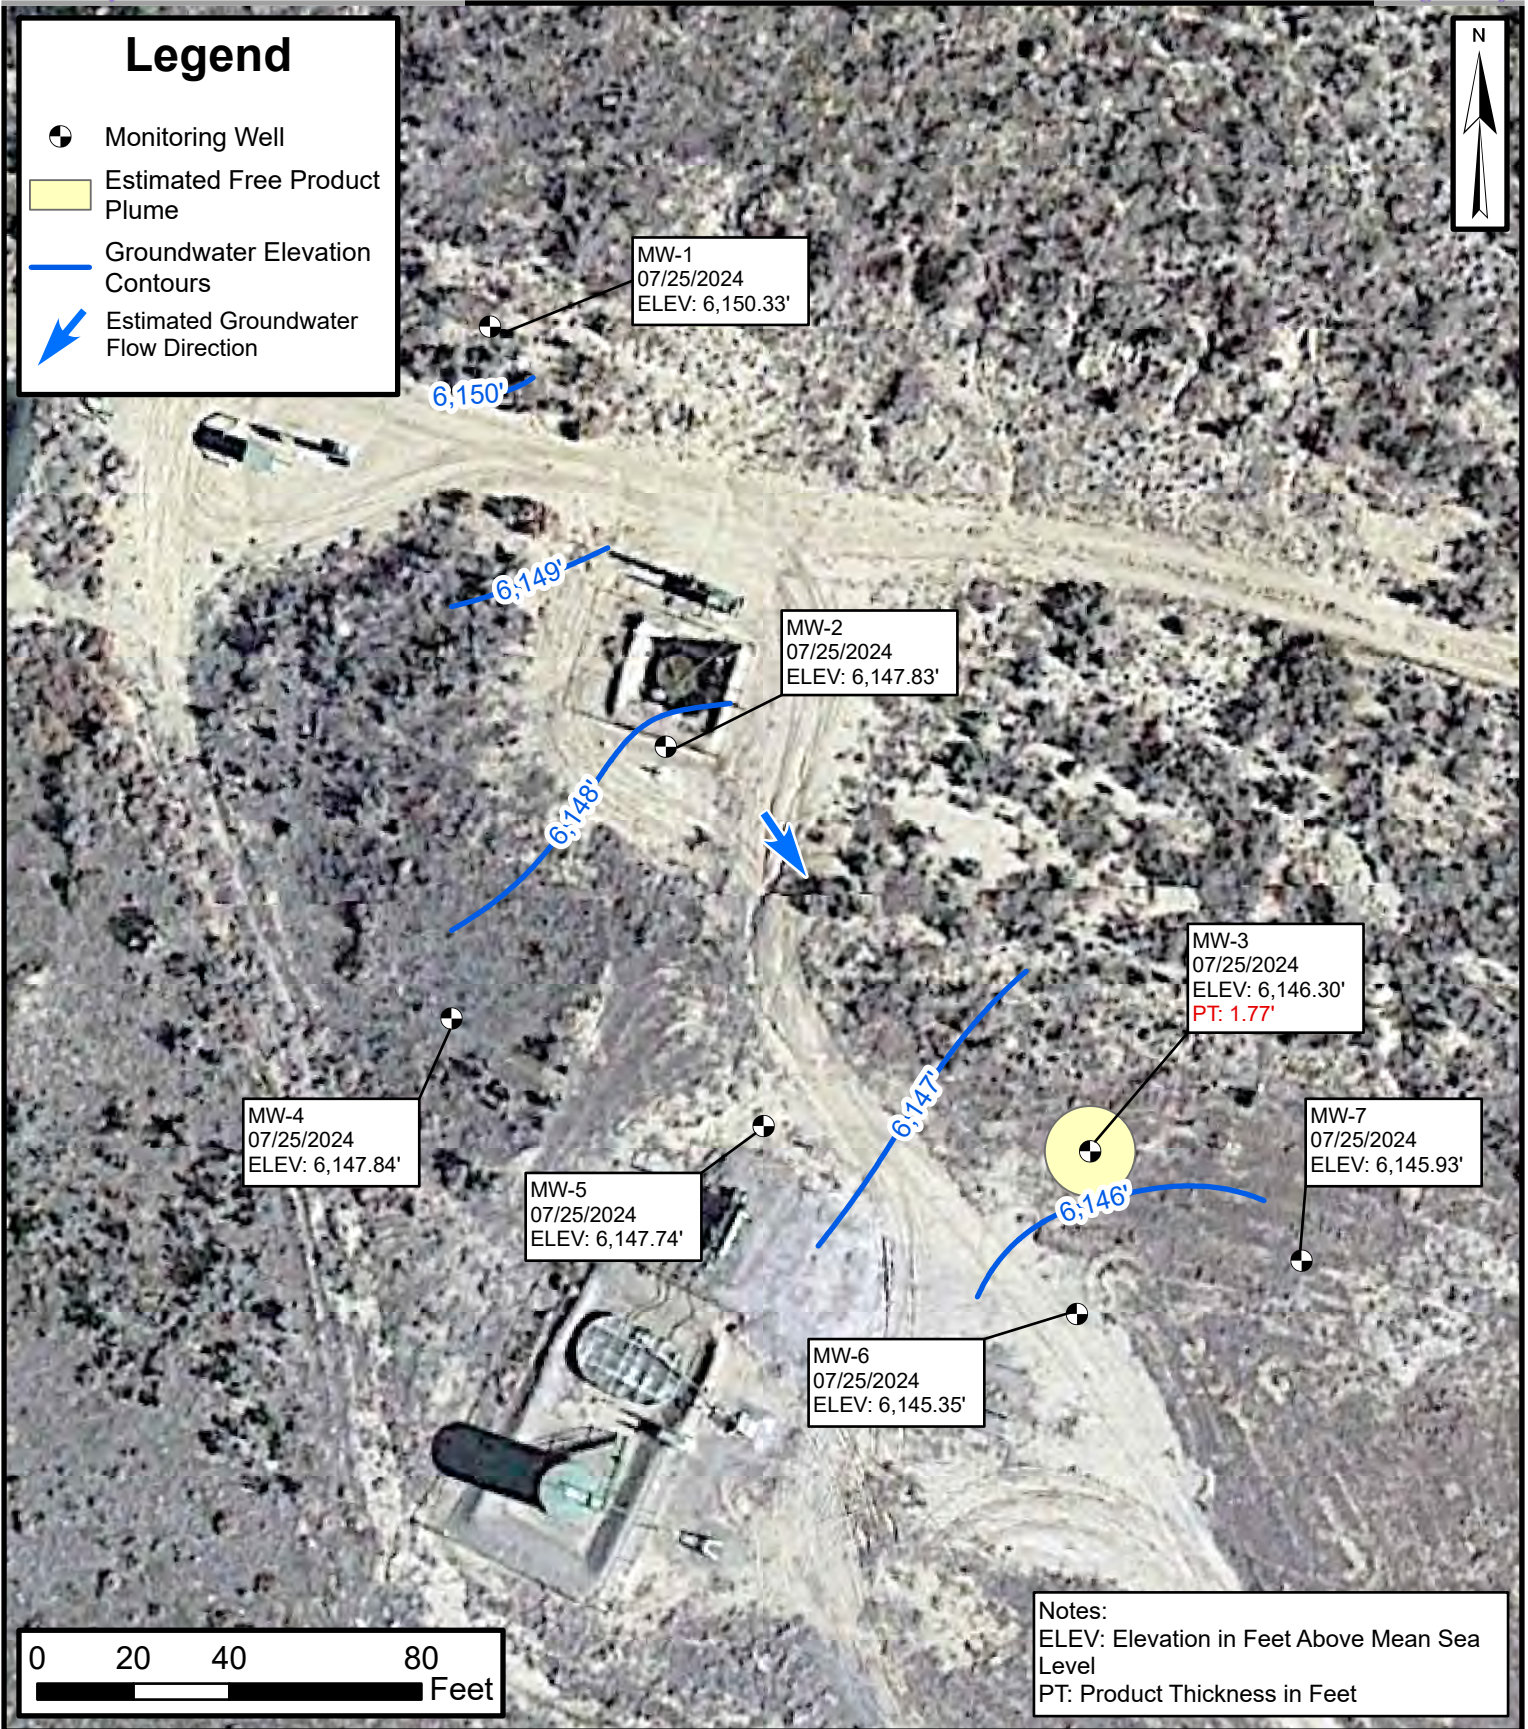
FIGURE
4

Groundwater Elevation (July 2024)
 Florance M #047X
 Harvest Four Corners, LLC
 36.8436, -107.8010
 SW/NE, Sec 5, T30N, R9W
 San Juan County, New Mexico
