Site Characterization-Delineation Report

Double L Queen Tank Battery

Incident # NAPM2303746352

February 16, 2023

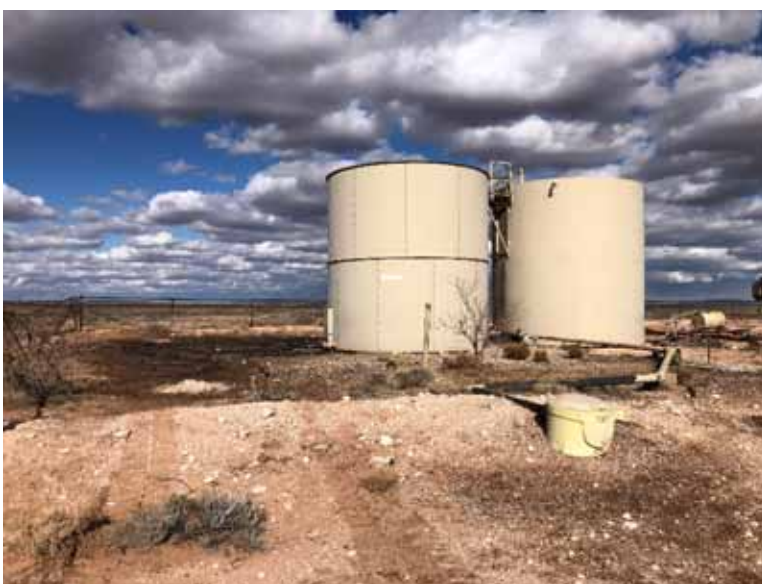
Photo 2: Tank Battery #1

Equipment debris including pipes, damaged fiberglass tanks, a metal vessel, and office furniture were observed along the perimeter of the yard and inside the building. Surface lines were observed from: tank battery #1 to the containment berm; from the separator to tank battery #2;

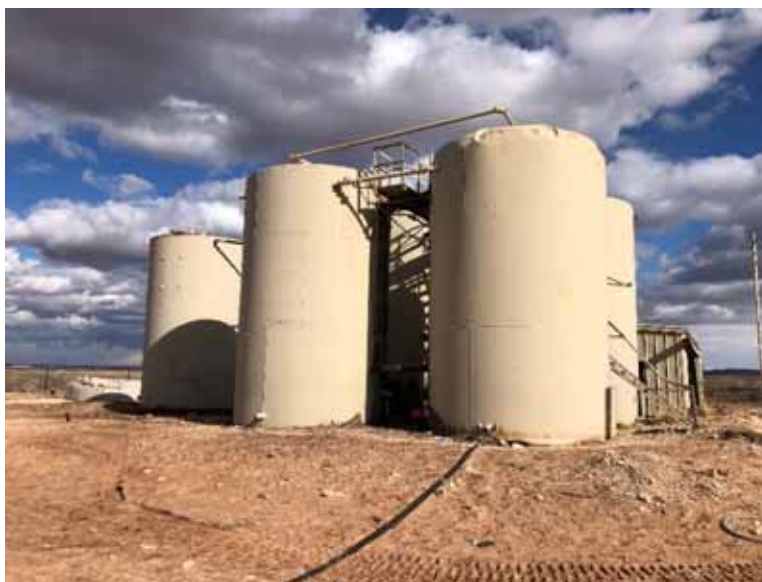
Photo 8: Tank Battery #2

All tanks, except for #4 and #7, had atmospheres measured utilizing a calibrated four-gas meter. All atmospheres measured 0 parts per million (ppm) for hydrogen sulfide, carbon monoxide, and methane. Oxygen level was reported as 20.9% for all the tanks assessed. Significant surface staining was observed in both tank batteries and evidence of overflow was observed from the tanks in battery #2; see **Appendix C**.

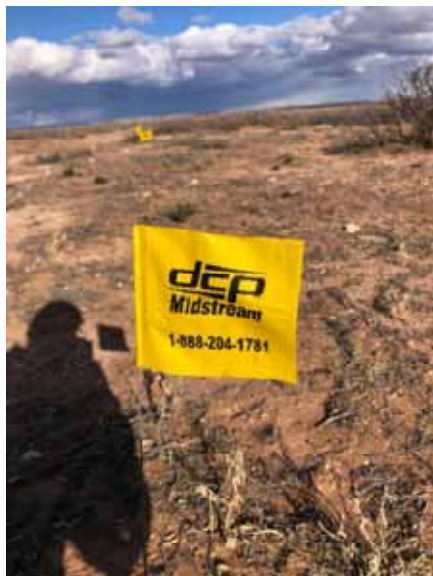
and from the building to the southern fence line where it becomes an underground line. Surface lines were also observed from tank battery #2 to the building. One the north side of the facility, outside the fence, a DCP Midstream pipeline was flagged and trended northeast.

Photo 21: DCP Midstream Line Locate Outside Facility

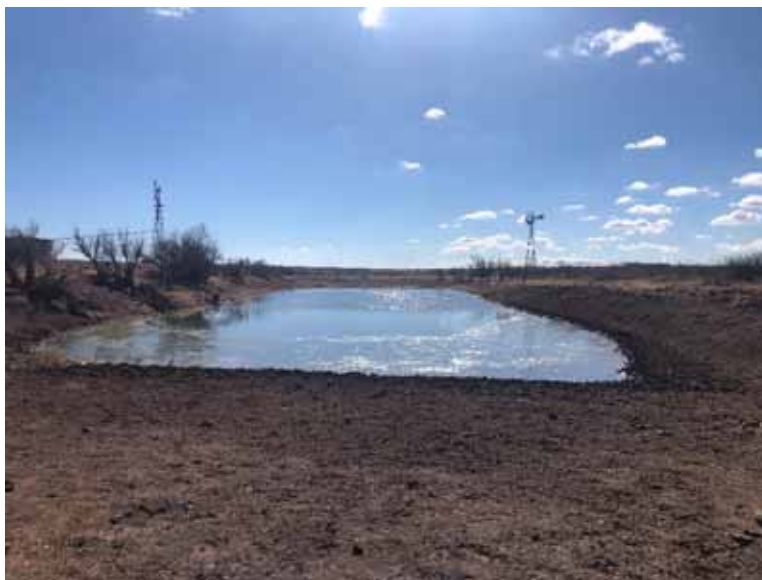
Depth to water records in proximity to the subject site were searched extensively for reasonably ascertainable data. The nearest water well with data from 1994 is located over 2 miles from the subject site. Depth to water ranged from 50 to 55 feet from 1986 to 1994 in USGS 3302211040031. Furthermore, windmills with a stock pond are located southeast, approximately 1,083 feet, from the facility; see **Figure 2, Site Map**. The windmills are estimated to be 15 feet in height, indicating relatively shallow depths to groundwater.

Photo 1: Stock Pond and Windmills South of Facility

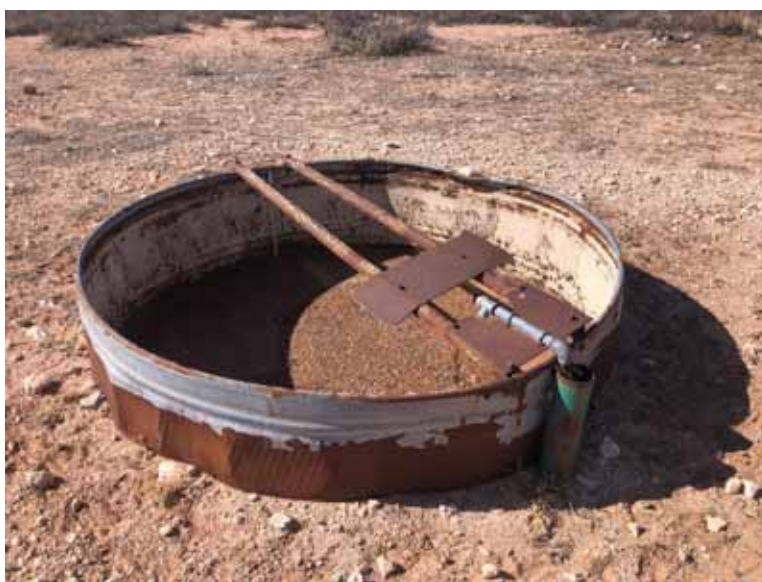
Photo 2: Water Line Can South of Facility

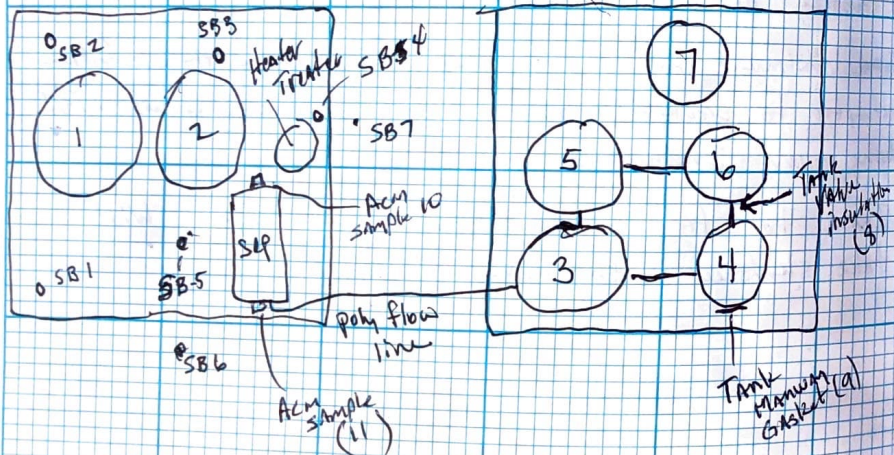
Tank #3 bulging

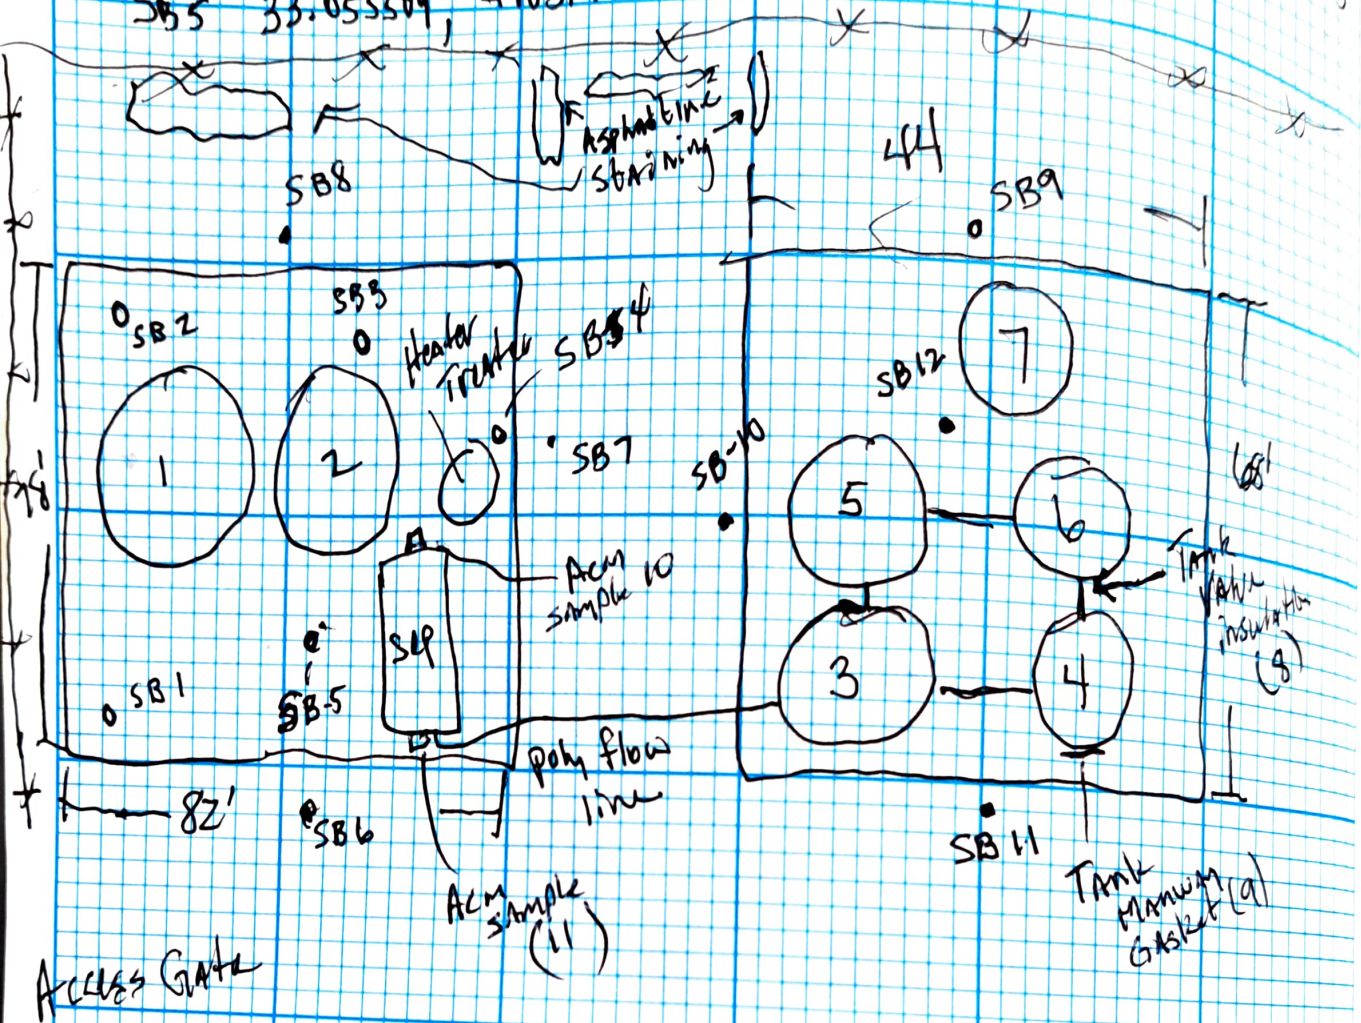
Tank #3 bulging
