SUBJECT: Liner Inspection and Closure Report for Purrito 18 CTB 1 – August 26, 2025 Site Visit

Incident ID: nAPP2520230747
Facility ID (Name): fAPP2408639251 (PURRITO 18 CTB 1)
Facility Location: Unit A of Section 18, Township 23 South, Range 32 East, New Mexico
Facility GPS Coordinates: 32.308038, -103.7206141
Lea County, New Mexico

Environmental Liner Inspection Field Notes & Photolog Report

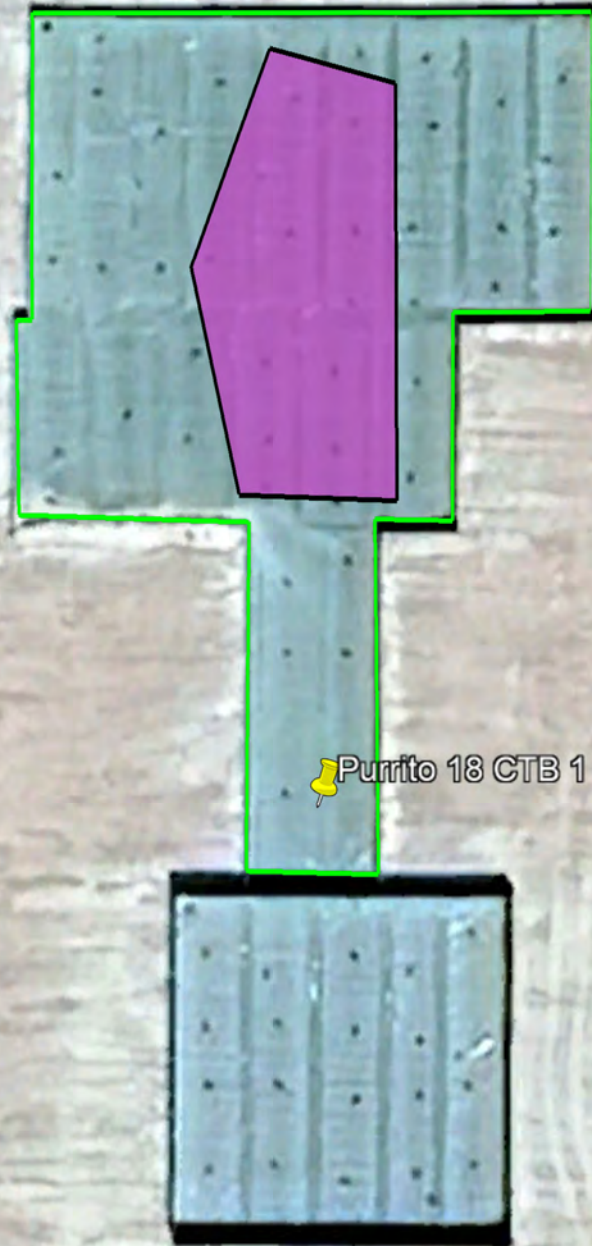
Release Area

On July 17, 2025, a Devon lease operator discovered a 6-inch ball valve that had developed a pinhole leak inside the secondary containment, resulting in the release of approximately 5 barrels (bbls) of produced water. Initial response actions were conducted by the operator and included source elimination, photographic documentation of the affected area, volume estimation, and an attempt to recover released fluids. Photographic documentation of the secondary containment, liner, tanks, and equipment where the release occurred is included in the Liner Inspection Field Notes & Photolog Report (**Appendix A**).
