**LAKWOOD SOUTH TB**

Incident ID nAPP2604948372

**Liner Inspection and Closure Report**

**RE: Liner Inspection and Closure Report**  
**LAKEWOOD SOUTH TB**  
**Facility ID: fAPP2122833205**  
**GPS: Latitude 32.60865 Longitude -104.47923**  
**UL- D, Section 3, Township 20S, Range 25E**  
**NMOCD Reference No. NAPP2604948372**

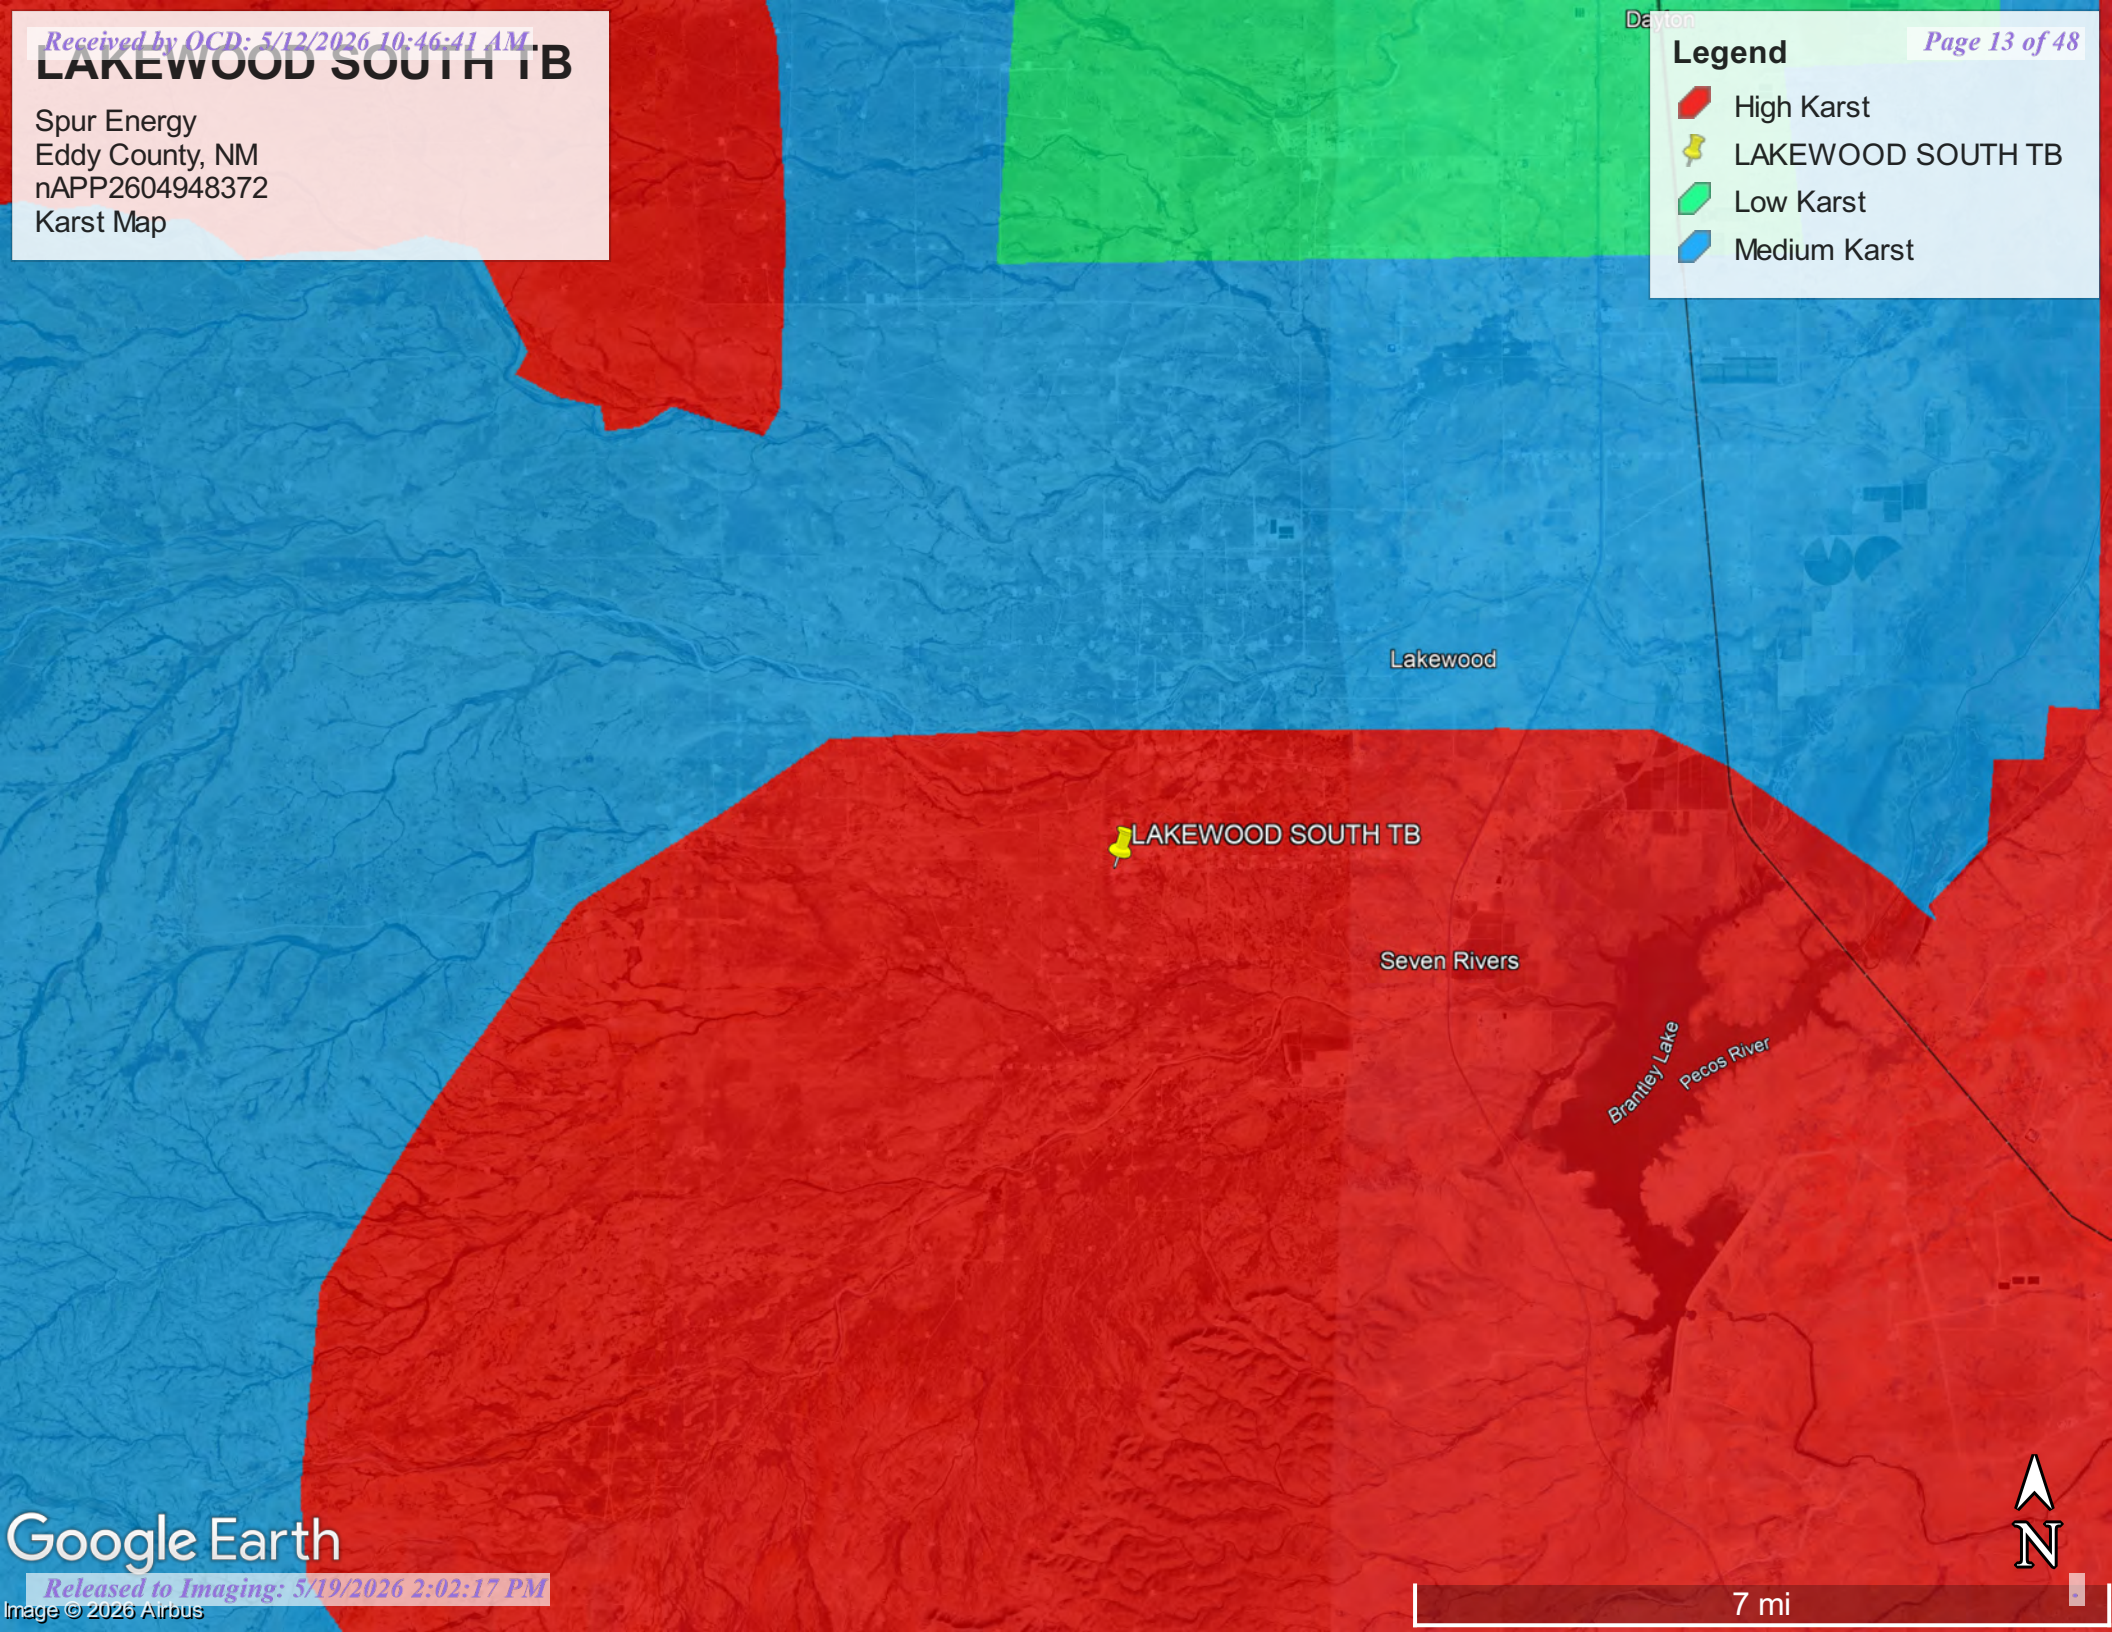
Spur Energy  
Eddy County, NM  
nAPP2604948372  
Site Map

**NAPP2604948372:** On February 18, 2026, a release of produced water and crude oil occurred due to corrosion of a nipple, resulting in the discharge of fluids into the lined containment. Approximately 42 barrels of produced water and 5 barrels of crude oil were released. Spur personnel immediately initiated response actions and successfully recovered all fluids using a vacuum truck. No impacts occurred outside of the lined containment. A site map is provided in Figure 4.
