GJ WEST COOP UNIT 92 TB

Incident ID nAPP2606927793

## Liner Inspection and Closure Report

April 27, 2026

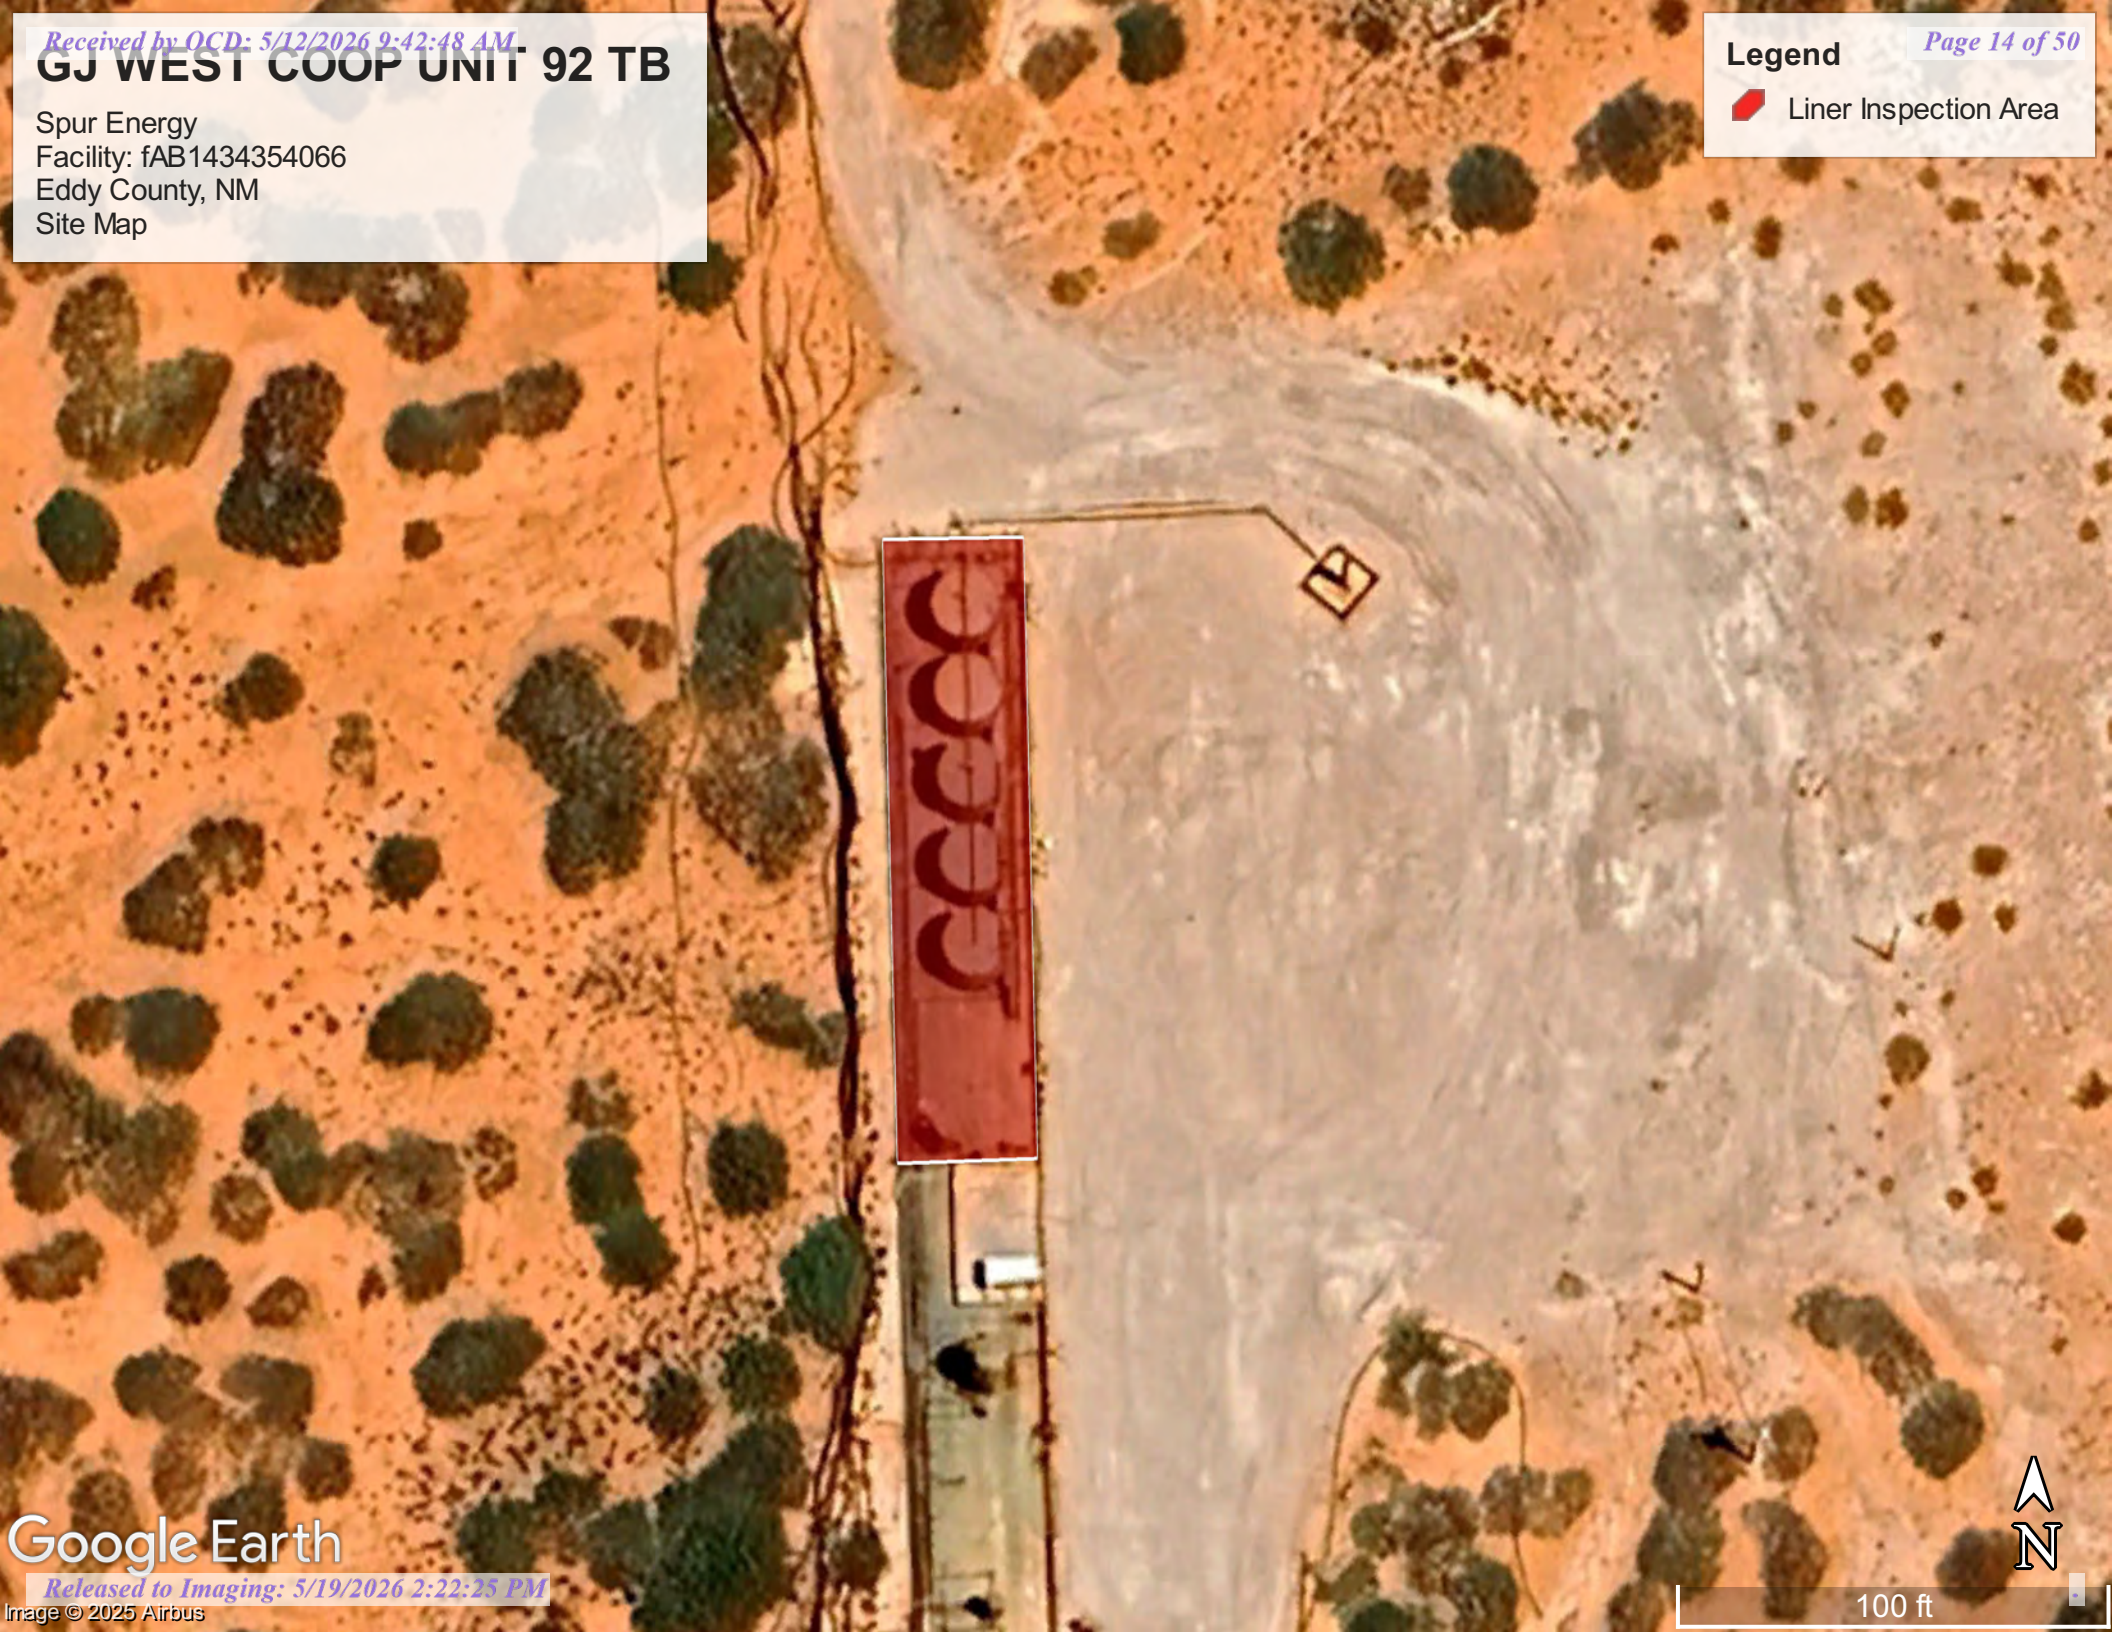
Liner Inspection Area

**nAPP2606927793:** On March 6, 2026, a water transfer pump seal failed, releasing produced water into the lined containment. Approximately 155 barrels of produced water were released. Spur personnel immediately initiated response actions and successfully recovered all fluids using a vacuum truck. No impacts occurred outside of the lined containment. A site map is provided in Figure 4.
