Closure Report
Ragin Cajun 12 CTB 2 (04.13.2026)
Incident ID: nAPP2610324829
Lea County, New Mexico
Unit D, S12, T26S, R34E
32.06154708°, -103.4296151°

Produced Water Release
Point of Release: Pinhole leak on Dump Line
Release Date: 04.13.2026
Volume Released: 12 Barrels of Produced Water
Volume Recovered: 12 Barrels of Produced Water

Re: **Closure Report**
Ragin Cajun 12 CTB 2 (04.13.2026)
Incident ID: nAPP2610324829
Devon Energy Production Company
Site Location: Unit D, S12, T26S, R34E
32.06154708°, -103.4296151°
Lea County, New Mexico

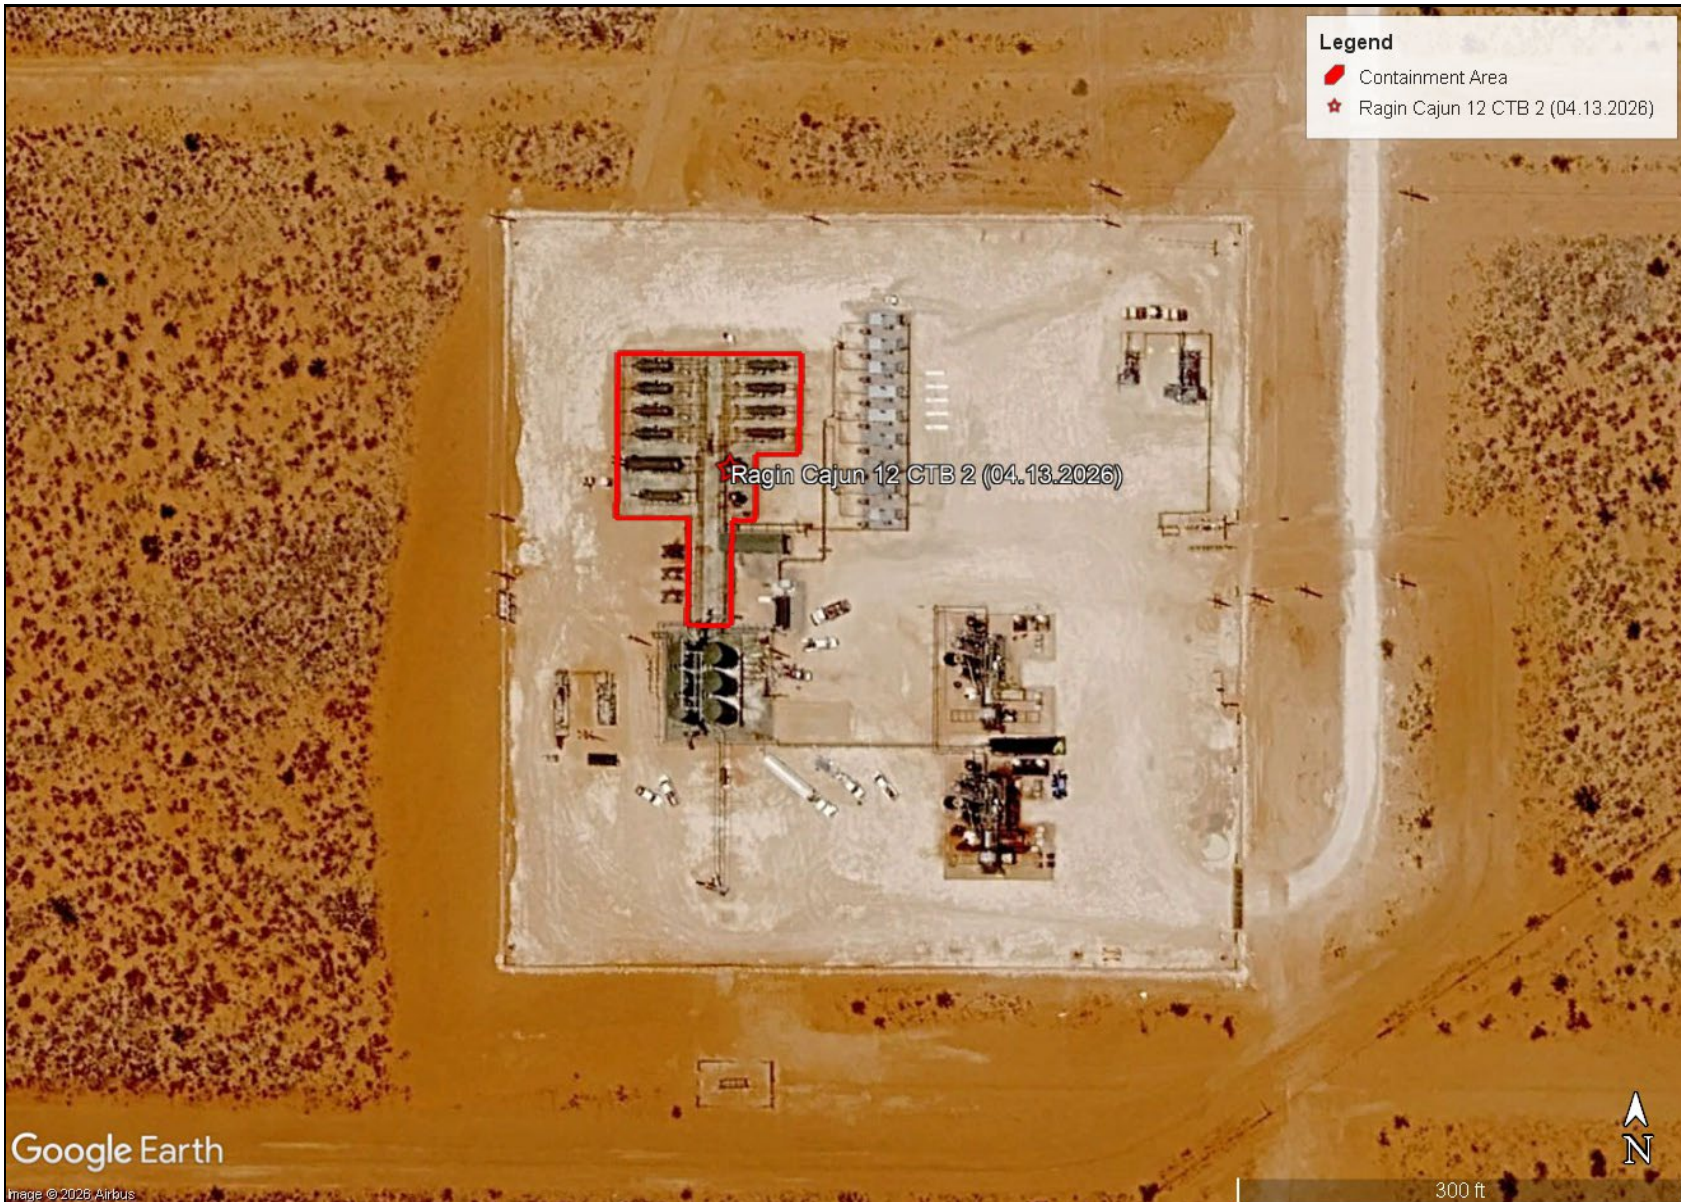
<p>LINED CONTAINMENT MAP DEVON ENERGY RAGIN CAJUN 12 CTB 2 (04.13.2026) LEA COUNTY, NEW MEXICO 32.06154708°, -103.4296151°</p>	<p>CARMONA RESOURCES  </p>	<p>FIGURE 3</p>
--	--	-----------------

Based on the initial C-141 obtained from the New Mexico Oil Conservation Division (NMOCD), the release was discovered on April 13, 2026, due to corrosion on the dump line causing the spill inside the containment. It resulted in approximately twelve (12) barrels of produced water being released inside the lined containment, with twelve (12) barrels of produced water being immediately recovered. The containment area is approximately 14,240 sq ft. The containment boundaries are shown in Figure 3. The initial C-141 form is attached in Appendix B.

Prior to Carmona Resources conducting a Liner Inspection, Devon contractors removed all fluid and washed the containment. The NMOCD division office was notified via NMOCD portal on May 14, 2026, per Subsection D of 19.15.29.12 NMAC. See Appendix B for the NMOCD correspondence prior to performing the liner inspection. On May 18, 2026, Carmona Resources, LLC conducted liner inspection activities to assess the tank batteries lined containment integrity and determined there were no integrity issues. Refer to the Photolog in Appendix A. Appendix B also contains a Liner Integrity Certification. Figure 3 shows the containment area outline.
