INITIAL C-141 AND SUPPORTING ITEMS

Release Notification and Corrective Action

Name of Company: Linn Energy	Contact: Joe Hernandez
Address: 2130 W Bender Blvd. - Hobbs, NM	Telephone No.: 575-942-8675
Facility Name: CMU Battery A	Facility Type: Oil and Produced Water Tank Battery

Project Name: CMU Battery A Release 09/05/11
Project No: 259-2970-000

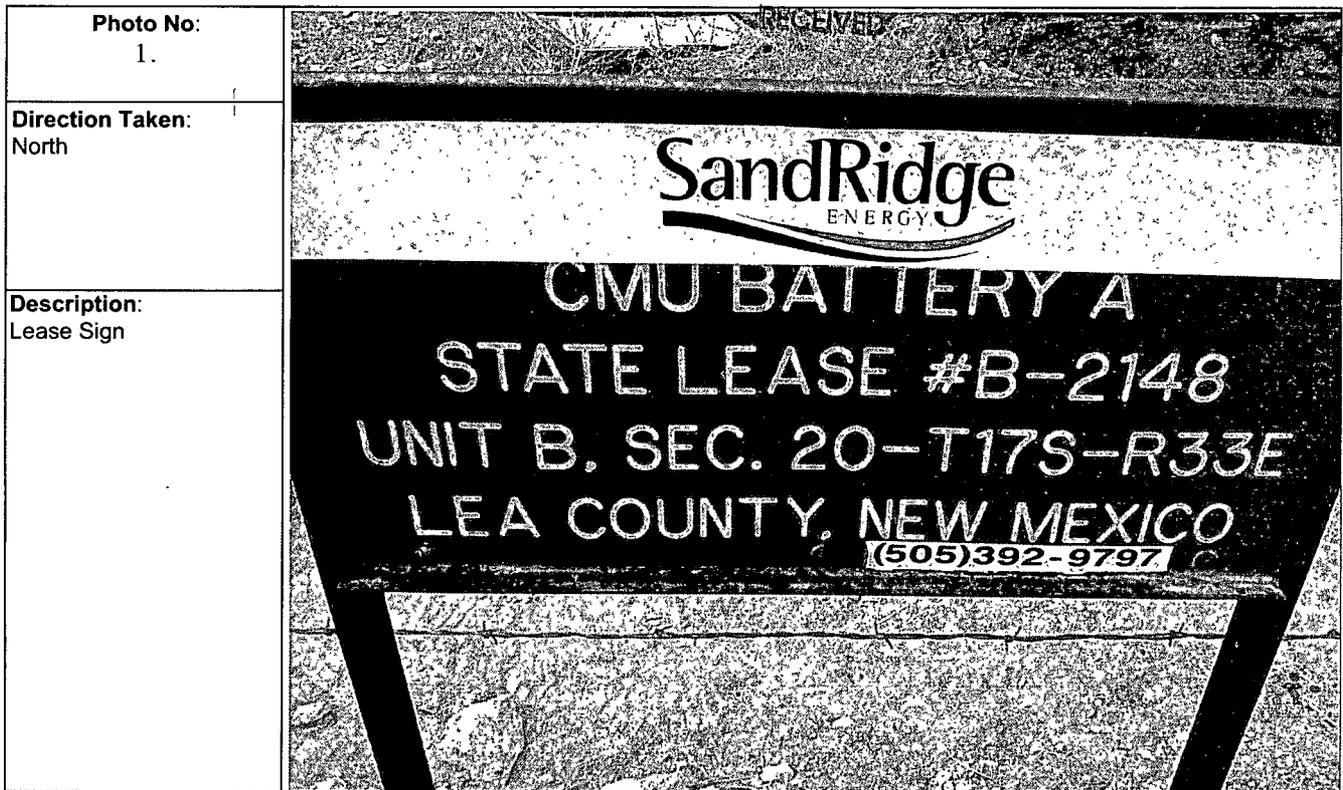
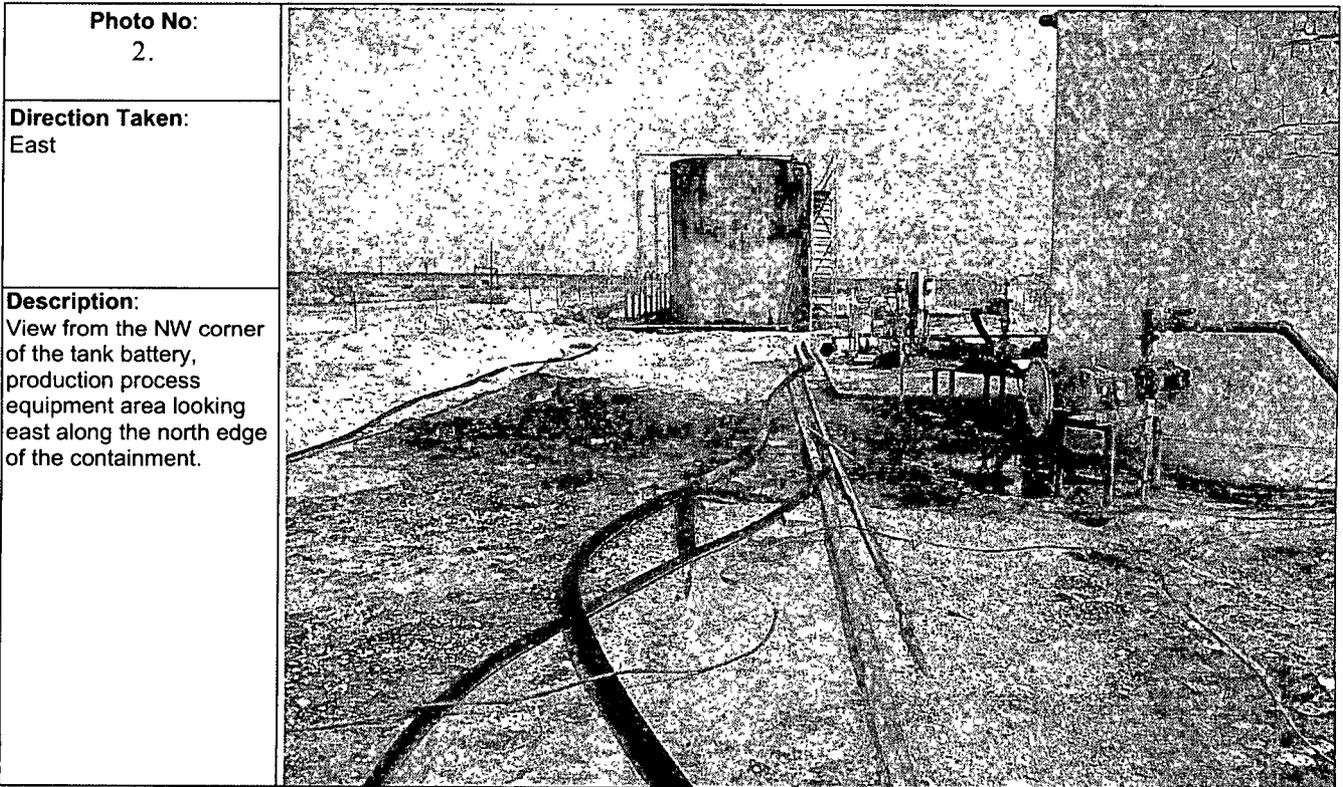
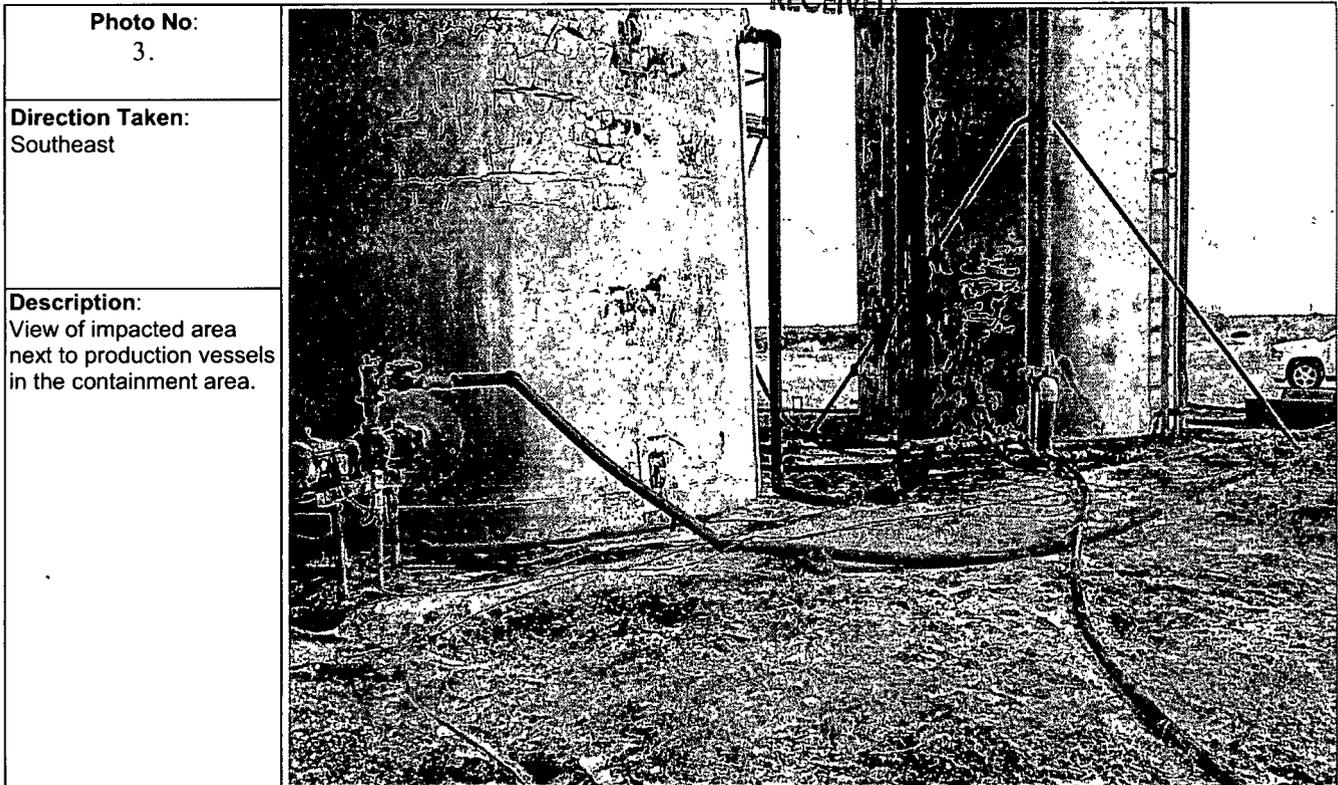
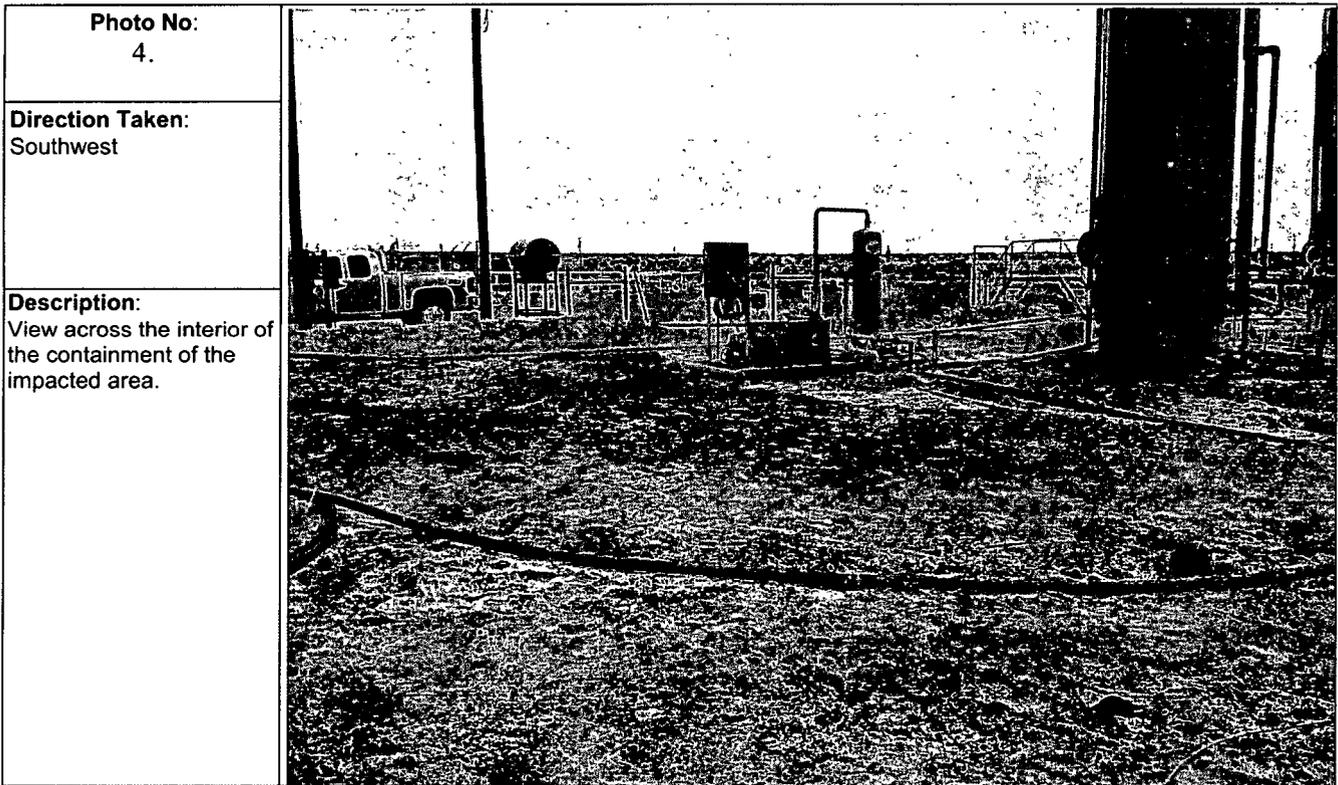
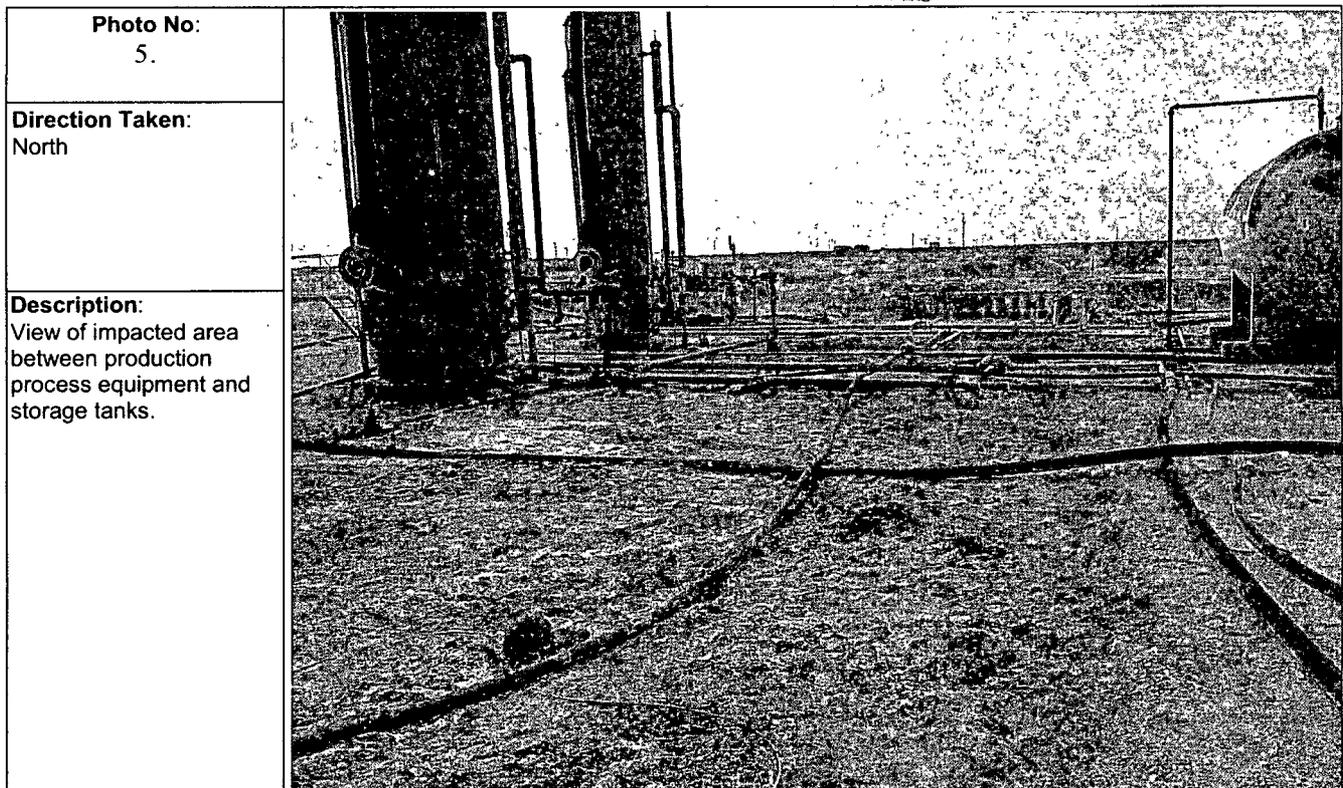
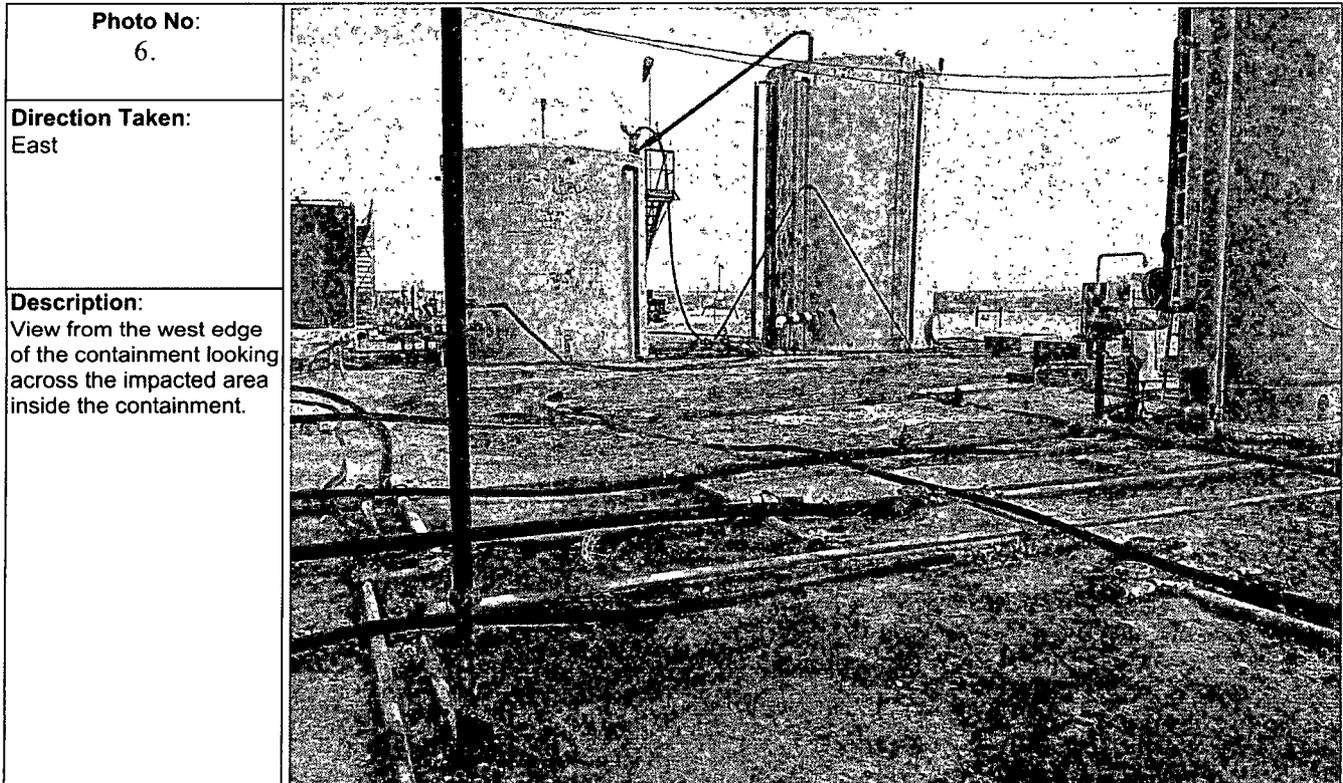
Photograph Log
Date Taken: 09/12/11

Cause of Release: Pipe nipple corroded on transfer pump allowing oil and produced water to be released.

The tank battery site is scheduled to be replaced. When the new tank battery is constructed, the equipment will be removed and the site remediated to OCD remedial action levels. Actual levels are pending depth to groundwater determination.
