December 14, 2012

**Re: Work Plan for the COG Operating LLC., Aid State SWD, Unit O,  
Section 14, Township 17 South, Range 28 East, Eddy County,  
New Mexico.**

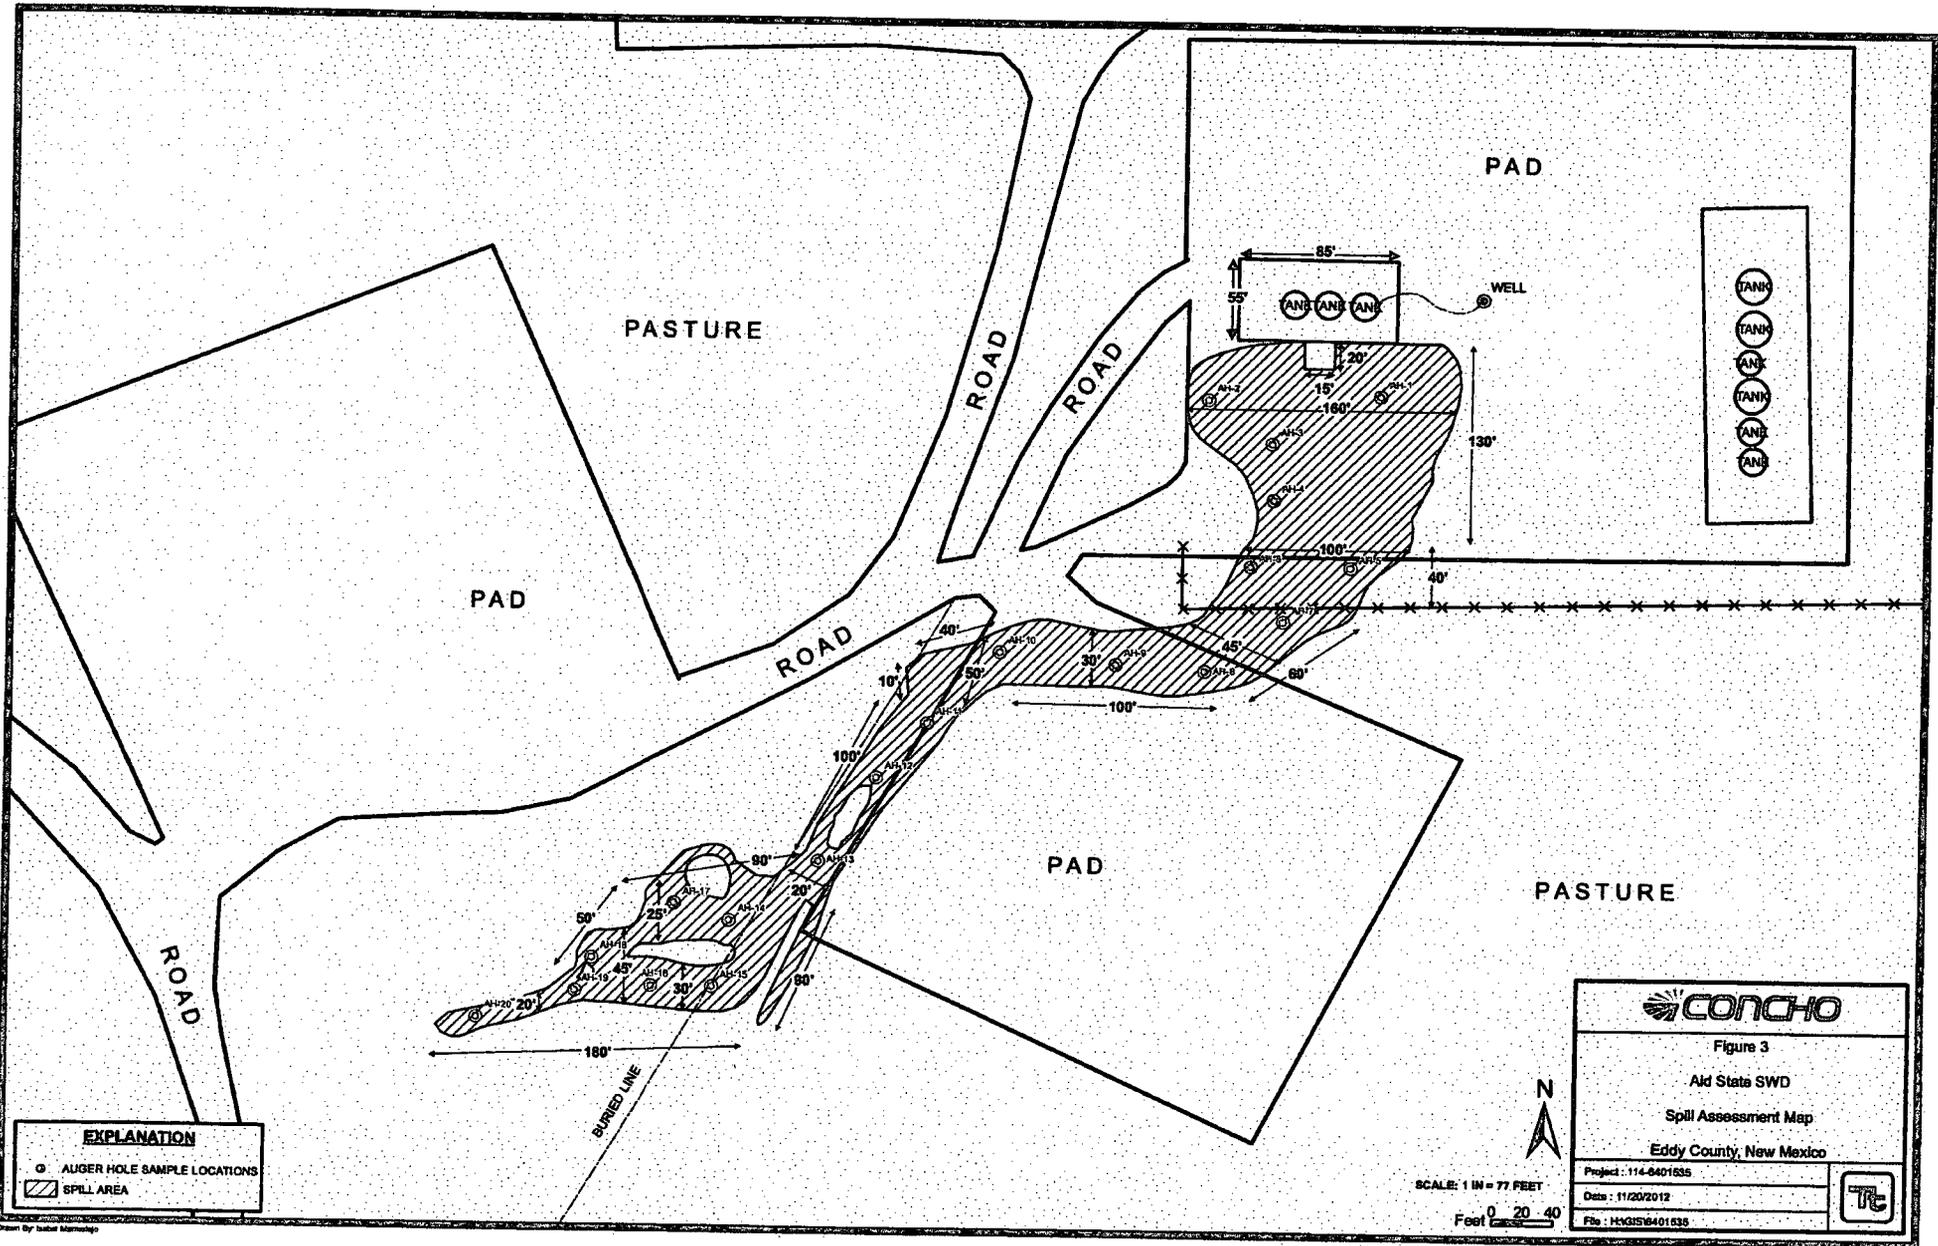
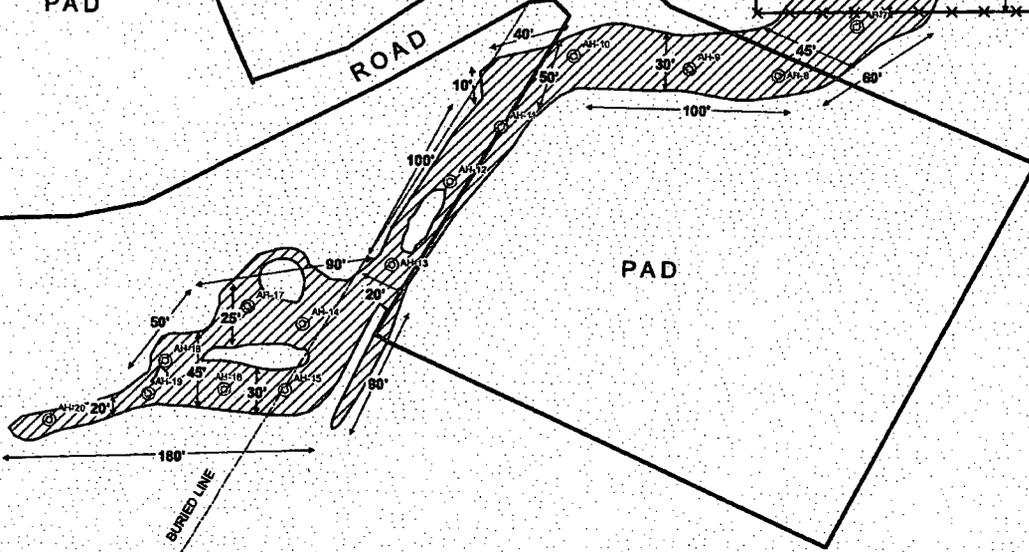
On October 2, 2012, Tetra Tech personnel inspected and sampled the spill area. Twenty (20) auger holes (AH-1 through AH-20) were installed using a stainless steel hand auger to assess the impacted soils. Selected samples were analyzed for TPH analysis by EPA method 8015 modified, BTEX by EPA Method 8021B and chloride by EPA method 300.0. Copies of laboratory analysis and chain-of-custody documentation are included in Appendix C. The sampling results are summarized in Table 1. The auger hole locations are shown on Figure 3.

Referring to Table 1, all of the auger hole samples were below the RRAL for TPH and BTEX. The chloride concentrations showed a shallow impact (0 to 2.0') to the soils at majority of the auger hole locations. Auger holes (AH-1, AH-2, AH-7, AH-8, AH-13, AH-19 and AH-20) were not vertically defined during the assessment.

The areas of AH-3 and AH-15 did not show a chloride impact to the soils. Auger holes (AH-9 and AH-10) detected chloride concentrations of 1,040 mg/kg (0-1') and 1,440 mg/kg (0-1'), respectively. The deeper samples (1-1.5') declined with depth to 293 mg/kg (AH-9) and 375 mg/kg (AH-10). Auger hole (AH-5) exhibited the highest chloride concentration of 10,600 mg/kg at 1-1.5', but declined to 571 mg/kg at 2-2.5' below surface. All chloride concentrations declined with depth, with the exception of AH-19 and AH-20. These two auger holes exhibited chloride concentrations of 2,080 and 604 mg/kg respectively at 1-1.5' below surface and increased to 5,950 and 3,320 mg/kg at 2-2.5' below surface.
