State G Com #1
(Located in UL-E of SEC 24, T19S, R27E of Eddy Co, NM)
(GPS Reading of 32°-38'-51.0"-N & 104°-14'-19.4"-W)
API # 30-015-22955

Spill Assessment Report

Basic Energy Services
PO Box 10460
Midland, Texas 79702

Phoenix Environmental, LLC.
P.O. Box 1856
Hobbs, New Mexico 88240

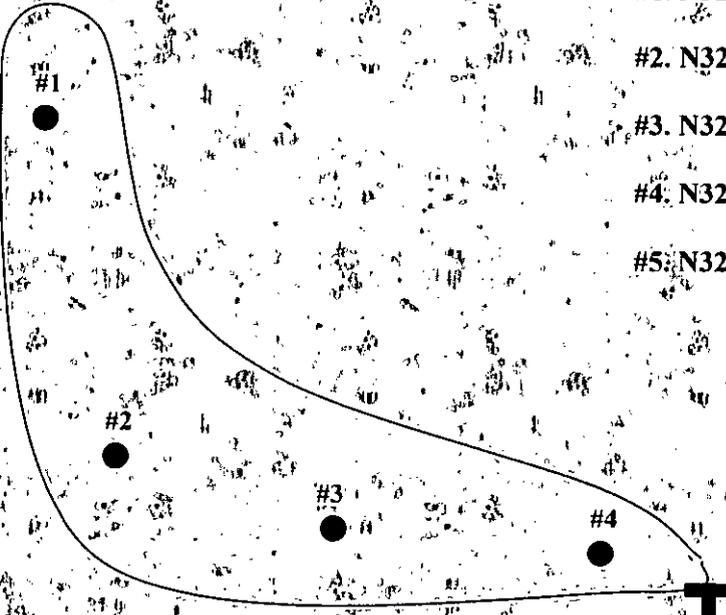
#1. N32° 38' 51.9" – W104° 14' 20.3"

#2. N32° 38' 51.0" – W104° 14' 20.9"

#4. N32° 38' 50.9" – W104° 14' 20.0"

#5. N32° 38' 50.5" – W104° 14' 19.2"
