### Report Type: Work Plan

<b>Site:</b>	Pronghorn SWD Facility		
<b>Company:</b>	COG Operating LLC		
<b>Section, Township and Range</b>	Unit B	Sec 24	T19S R32E
<b>Lease Number:</b>	API 30-025-32735		
<b>County:</b>	Lea County		
<b>GPS:</b>	32.65218° N	103.71698° W	
<b>Surface Owner:</b>	Federal		
<b>Mineral Owner:</b>			
<b>Directions:</b>	From the intersection of 529 and CR-126, travel south on 126 for 9.9 miles, turn left and travel 4.5 miles, turn right (at tin horn) and travel 0.6 miles to location

**Re: Work Plan and Assessment Report for the COG Operating LLC,  
Pronghorn SWD Facility Spills, Unit B, Section 24, Township 19 South,  
Range 32 East, Lea County, New Mexico.**

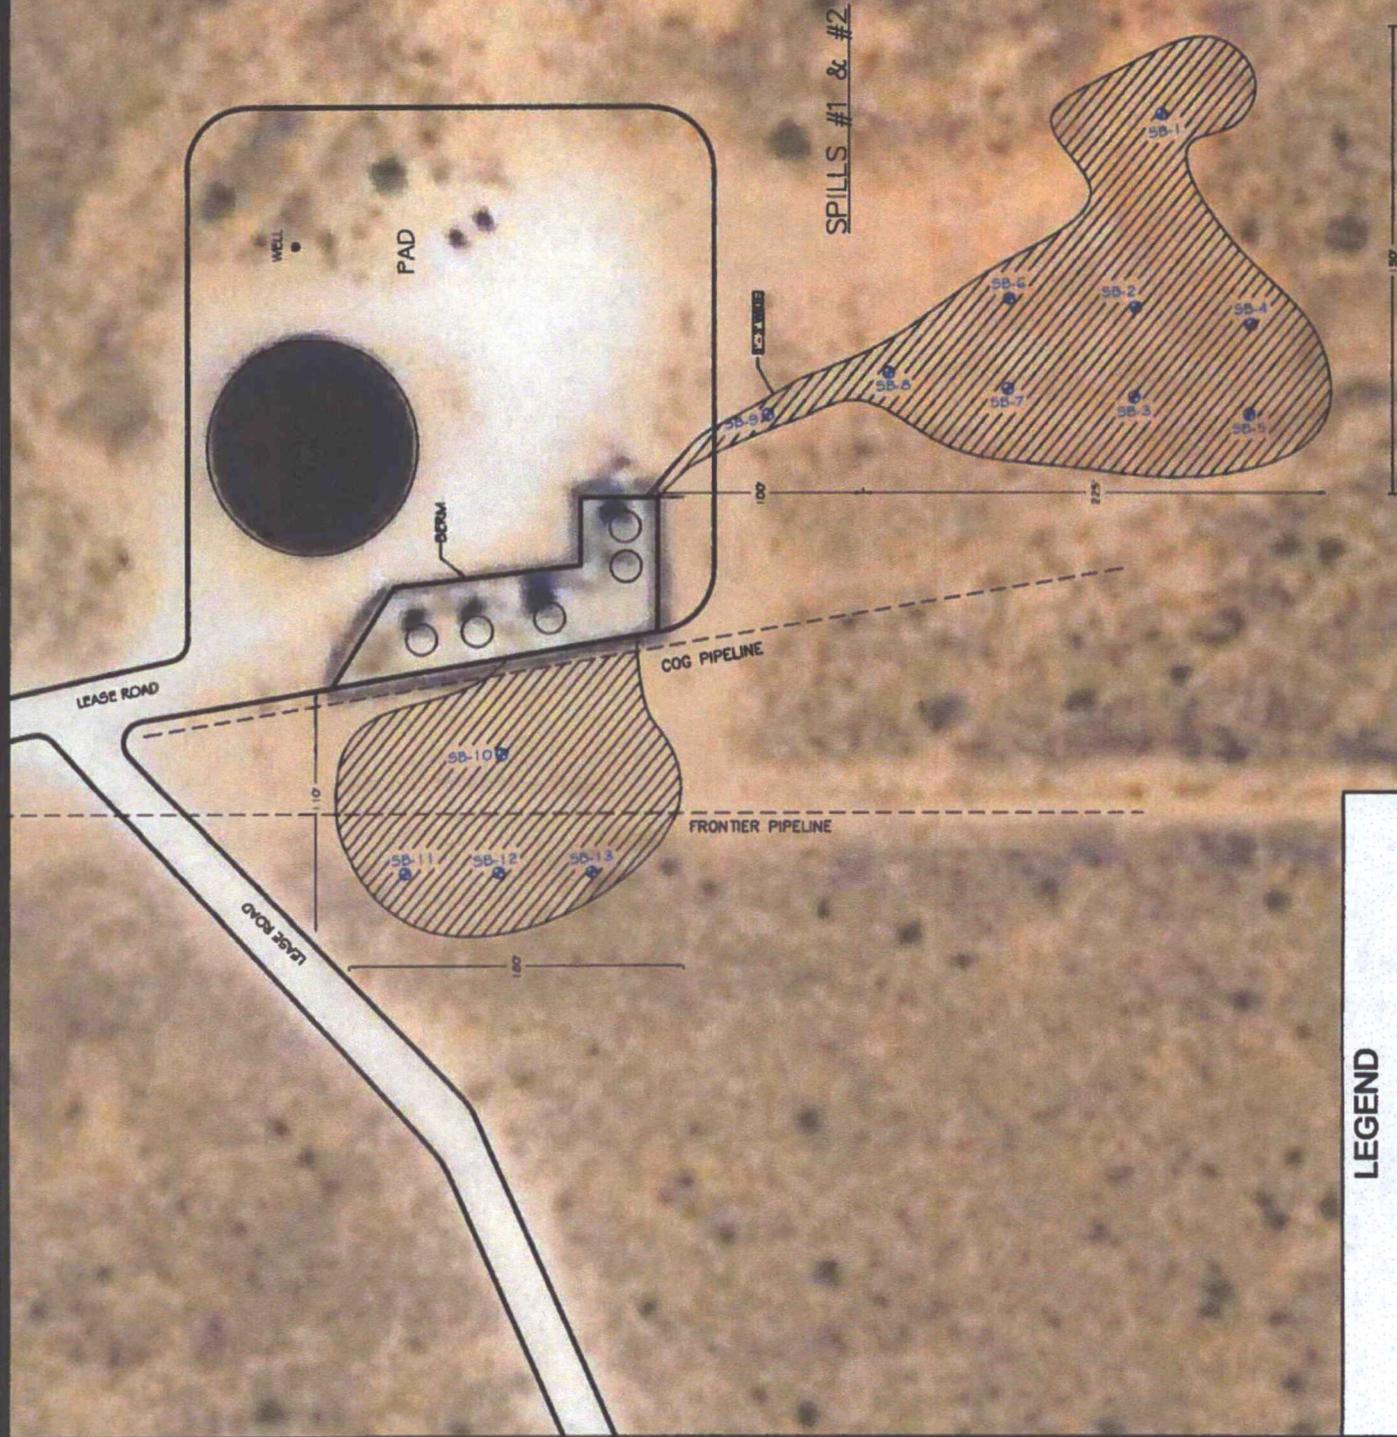
Figure 3a

According to the State of New Mexico C-141 Initial Report, the leak was discovered on November 20, 2009 and released approximately 1,500 barrels of produced water. A 1" x 4" swedge broke off the discharge of the pump going to the Pronghorn well. Vacuum trucks were used to pick up standing fluids and recovered 1,300 barrels. The spill area impacted the area top of the previous spill footprint. The spill area is shown on Figure 3. The initial C-141 is enclosed in Appendix A.

Spill #1 & #2 Assessment Map w/ Aerial

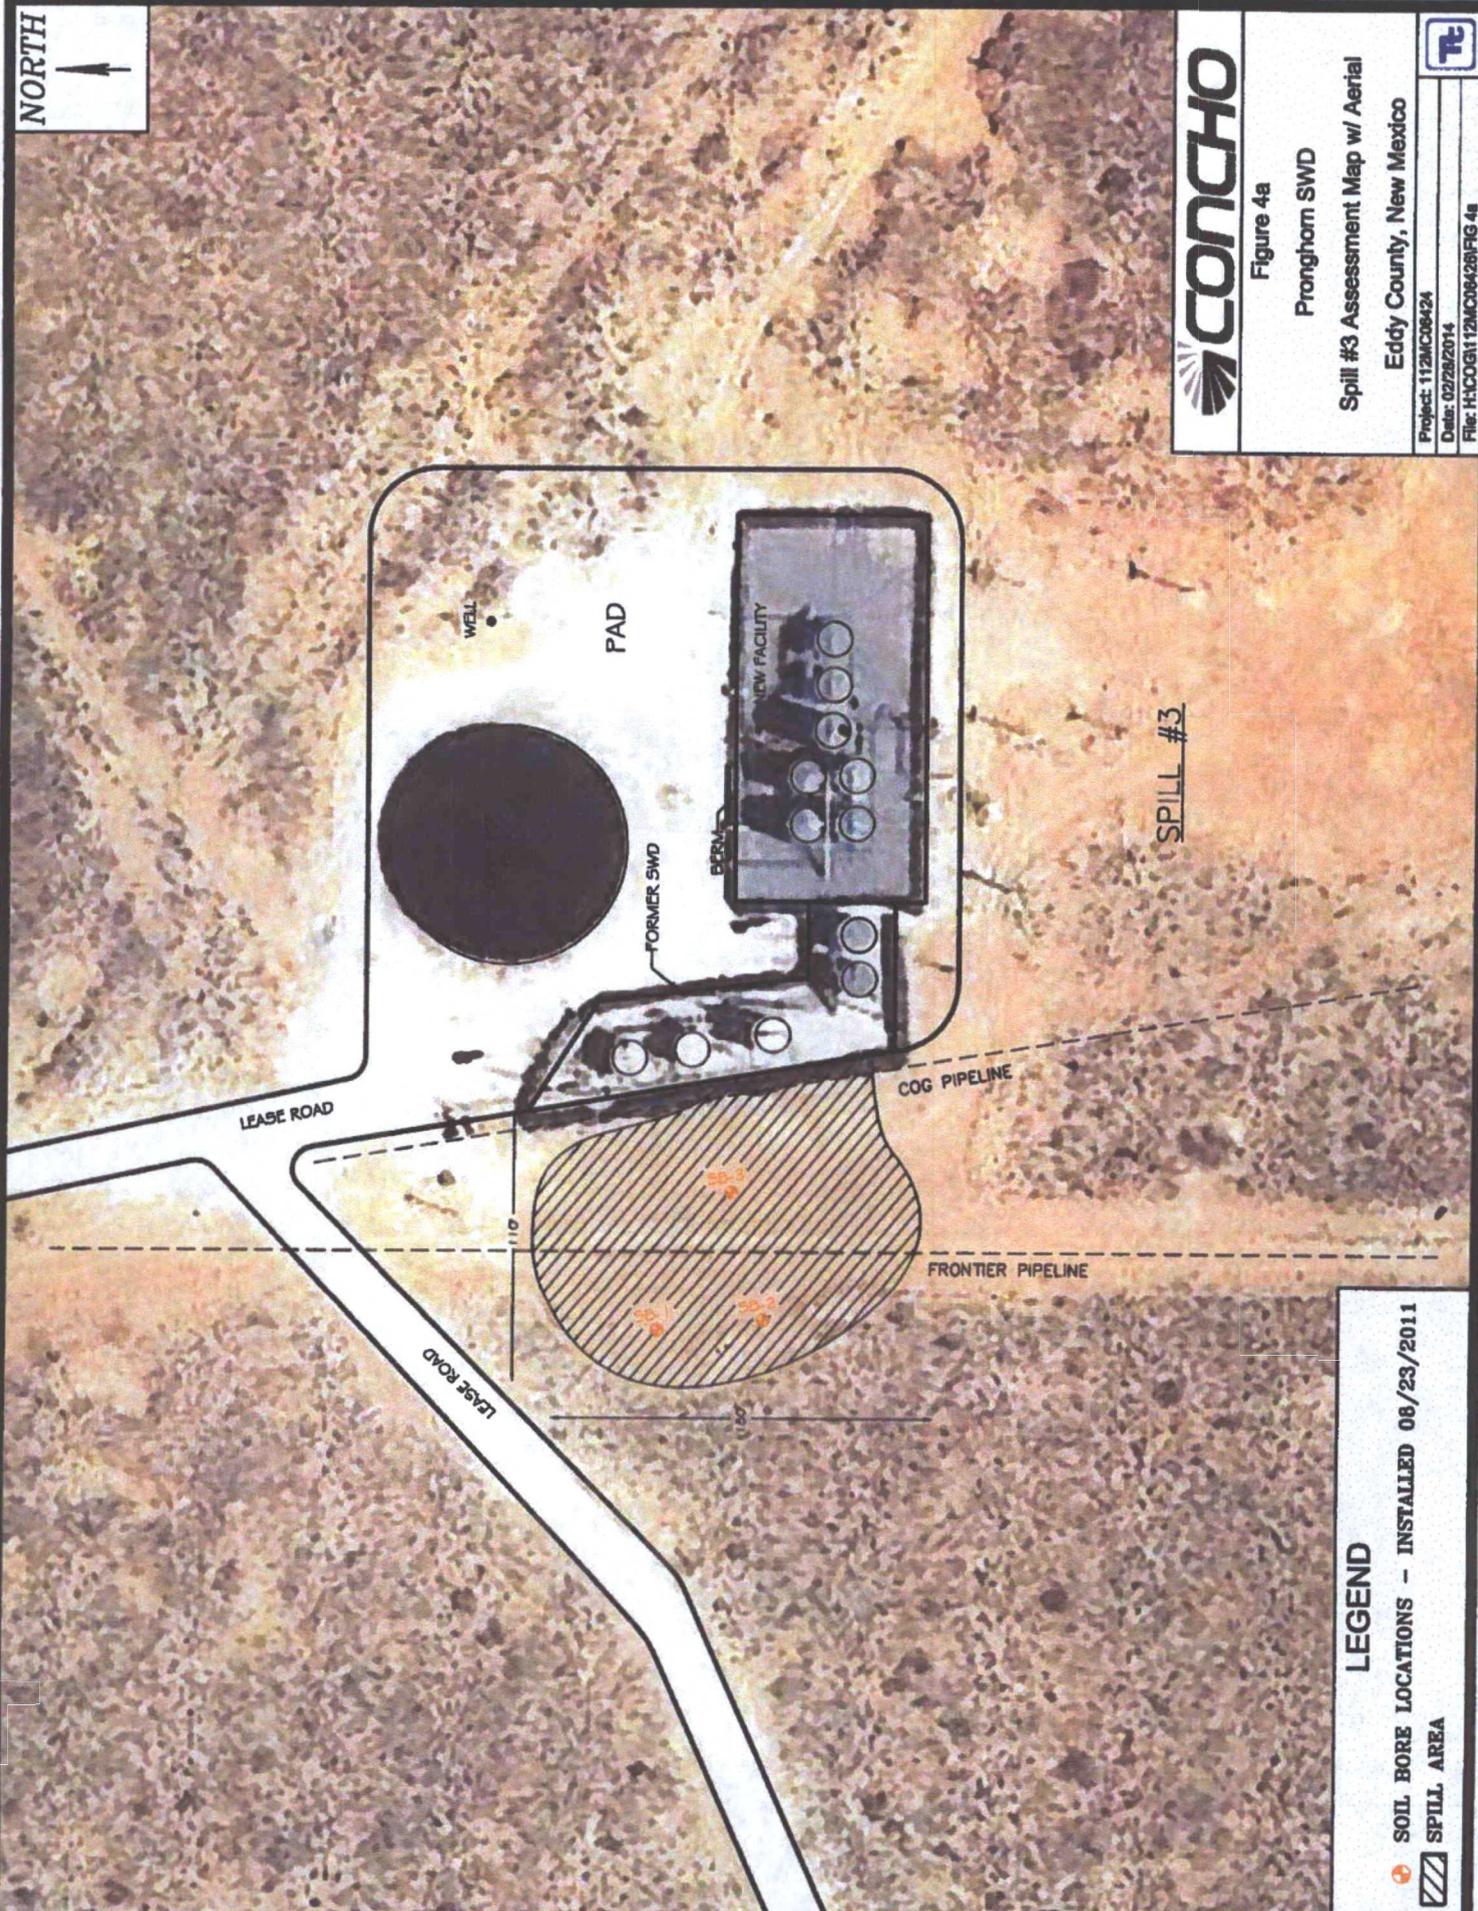
Figure 4a  
 Pronghorn SWD  
 Spill #3 Assessment Map w/ Aerial  
 Eddy County, New Mexico  
 Project: 112MCO6424  
 Date: 02/28/2014  
 File: H:\COG\112MCO6428\FIG 4a

According to the State of New Mexico C-141 Initial Report, the leak was discovered on July 20, 2011 and released approximately 100 barrels of produced water. The check valve on the transfer pump failed, the standing fluid has been removed and 95 bbls were recovered. The spill area released to the west of the facility and encompassed the area of the first and second spills. The initial C-141 is enclosed in Appendix A. The spill area is shown on Figure 4.

A total of three (3) soil borings (SB-1, SB-2 and SB-3) were installed to assess the third spill in the pasture. The soil boring locations are shown on Figure 4. The boring logs are shown in Appendix B. Selected samples were analyzed for TPH analysis by EPA method 8015 modified, BTEX by EPA Method 8021B and chloride by EPA method 300.0. Copies of laboratory analysis and chain-of-custody documentation are included in Appendix C. The results of the sampling are summarized in Table 2.

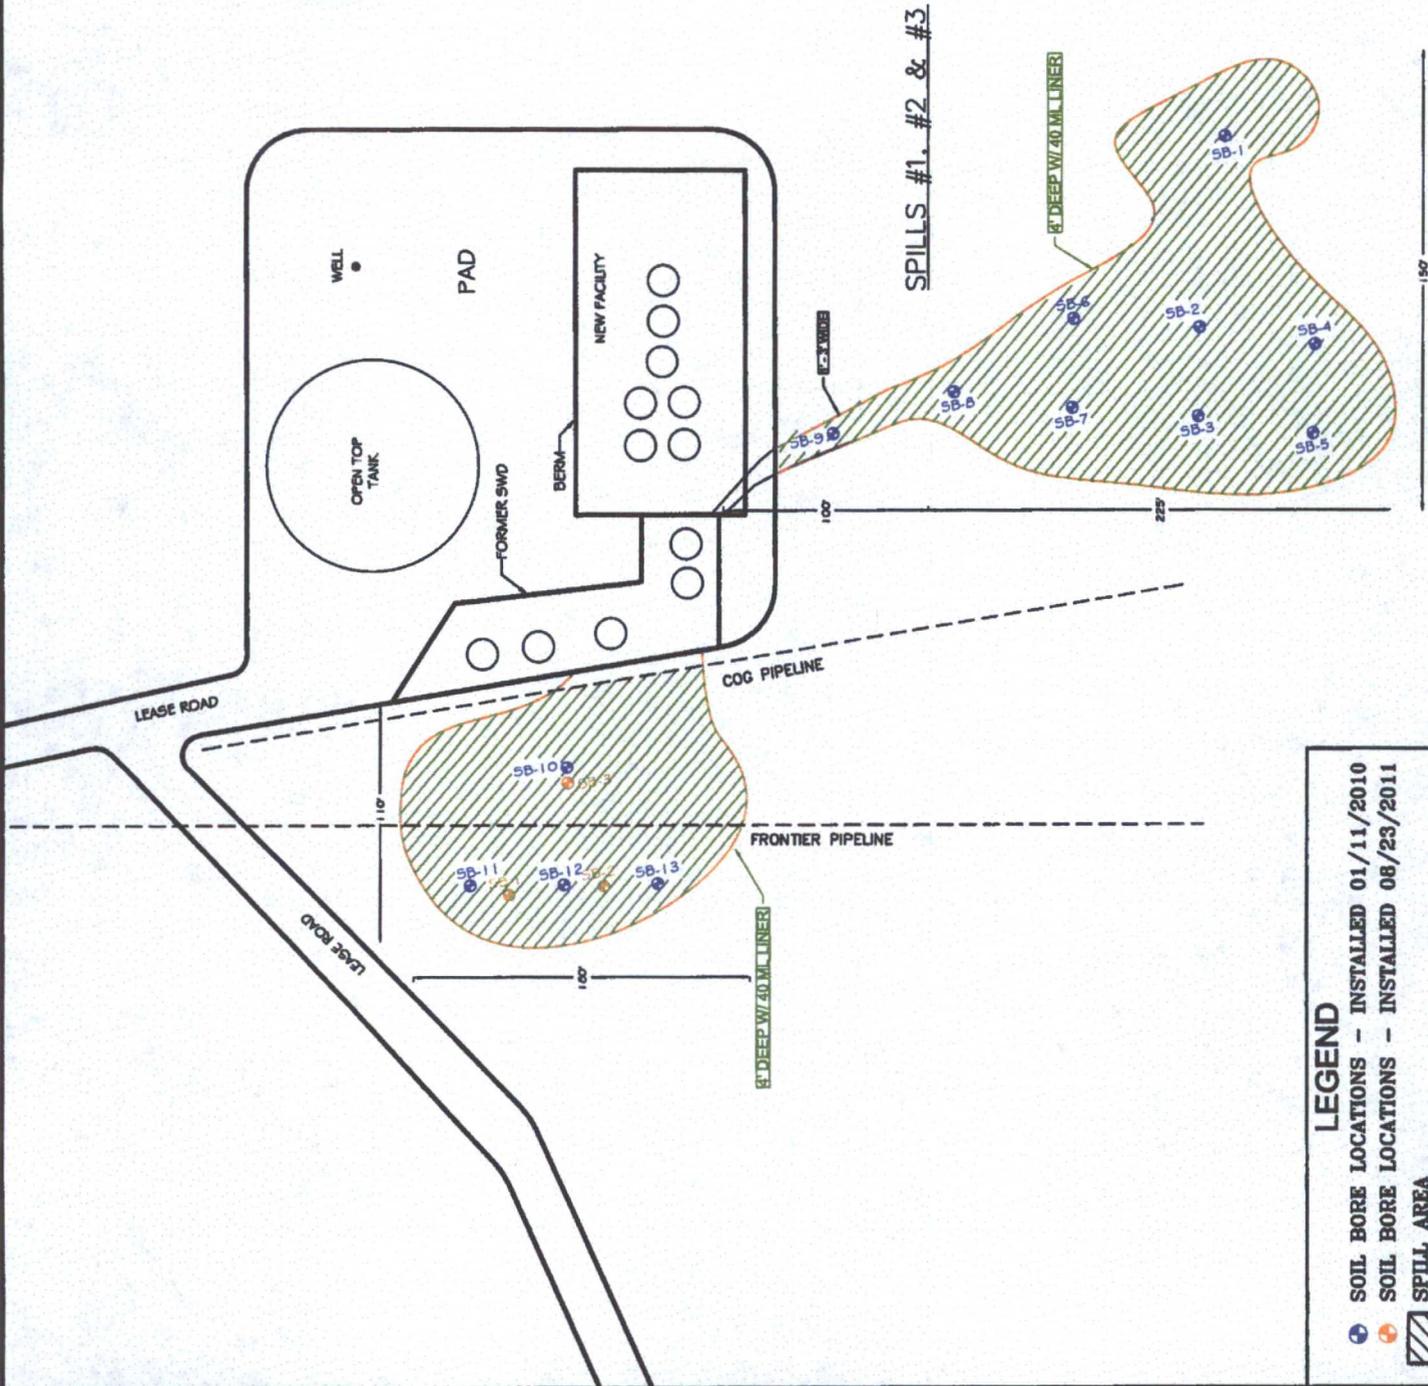
Figure 6

- SOIL BORE LOCATIONS - INSTALLED 01/11/2010
- SOIL BORE LOCATIONS - INSTALLED 08/23/2011
- SPILL AREA
- PROPOSED LINER/CLAY
