PURVIS OPERATING CO

R. T. HICKS CONSULTANTS, LTD.

February 16, 2010

RE: Gladiola SWD No. 2 Release Site T-12-S R-38-E Section 30 Unit Letter D
NMOCD # Not Assigned

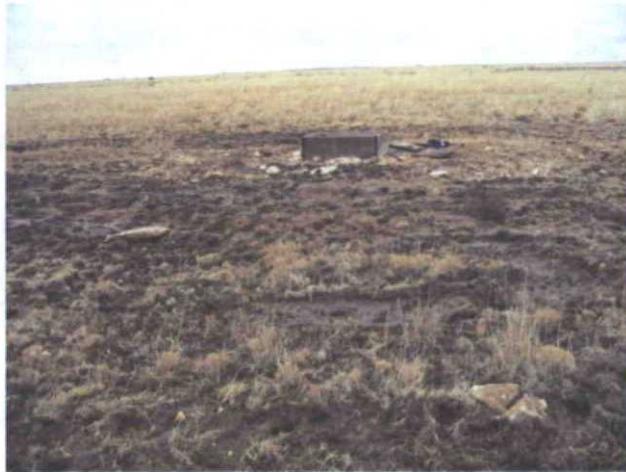
Figure 1 is a site overview map that indicates the locations of the release areas, soil sample laboratory results, proposed monitoring well and soil boring locations, and the proximity to the June 2007 Gladiola SWD spill site (1R-1739).

The horizontal extent of the spill (approximately 4,000 ft²) is not well defined due the saturated and highly disturbed condition of the shallow soil. Once the soil has completely dried the horizontal extent of the chloride impact should be more apparent.

Hicks Consultants proposes that one 4-inch monitoring well be installed to the shallow perched ground water zone within the spill footprint and at least four 20-foot soil borings installed adjacent to the footprint in order to delineate the vertical and horizontal extent of the chloride-impacted soil at the main spill. In addition, a 20-foot soil boring will be installed adjacent to the excavation at the secondary spill area.
