CML EXPLORATION, LLC

R. T. HICKS CONSULTANTS, LTD.

April 18, 2011

RE: CML Exploration, Paddy 19 State #3, Unit F, Section 19, T17S, R33E
API #:30-025-38591
Ground Water Monitoring Report and Request for Closure

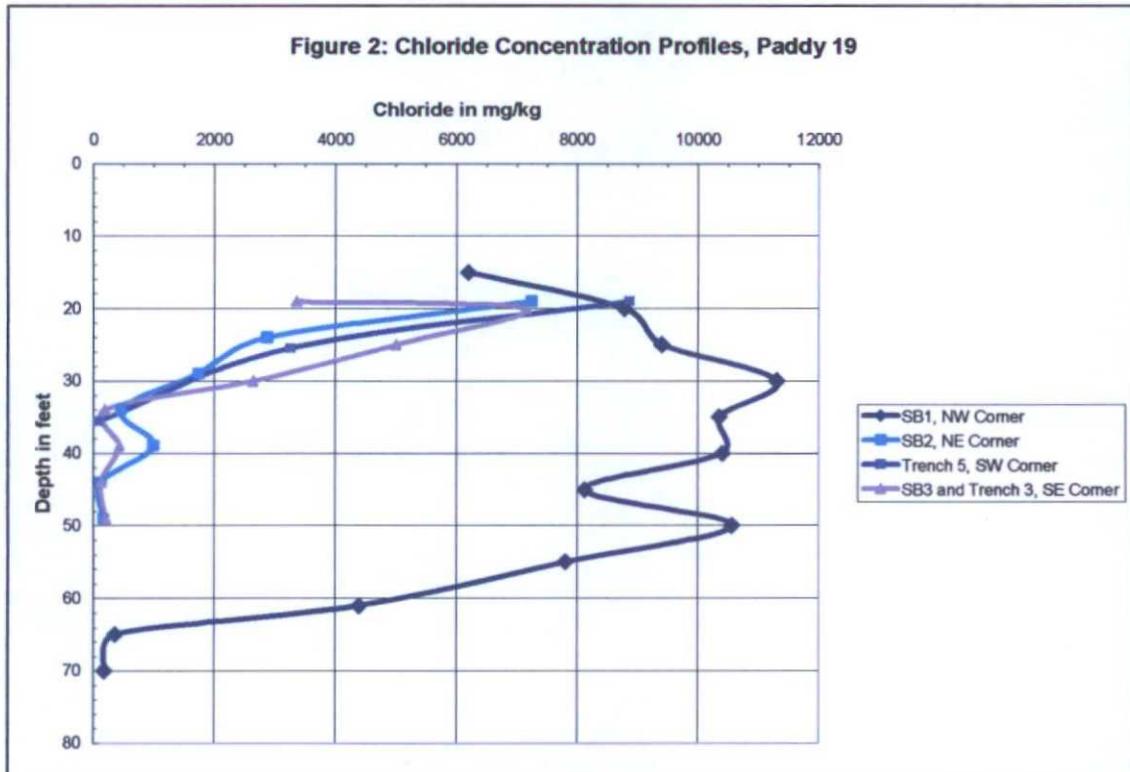
Figure 2 from the July 2009 Corrective Action Plan shows depth of the center of chloride mass beneath the former drilling pit is between 20 and 60 feet below grade. Samples from SB-1 show chloride concentrations from 170 to 352 mg/kg at 65-70 feet below grade. Chloride concentrations 5-10 feet above the water table obtained from the four monitoring wells range from 54 to 272 mg/kg.

Depth to water measured at MW-1 under non-pumping conditions is typically 75 feet below grade.

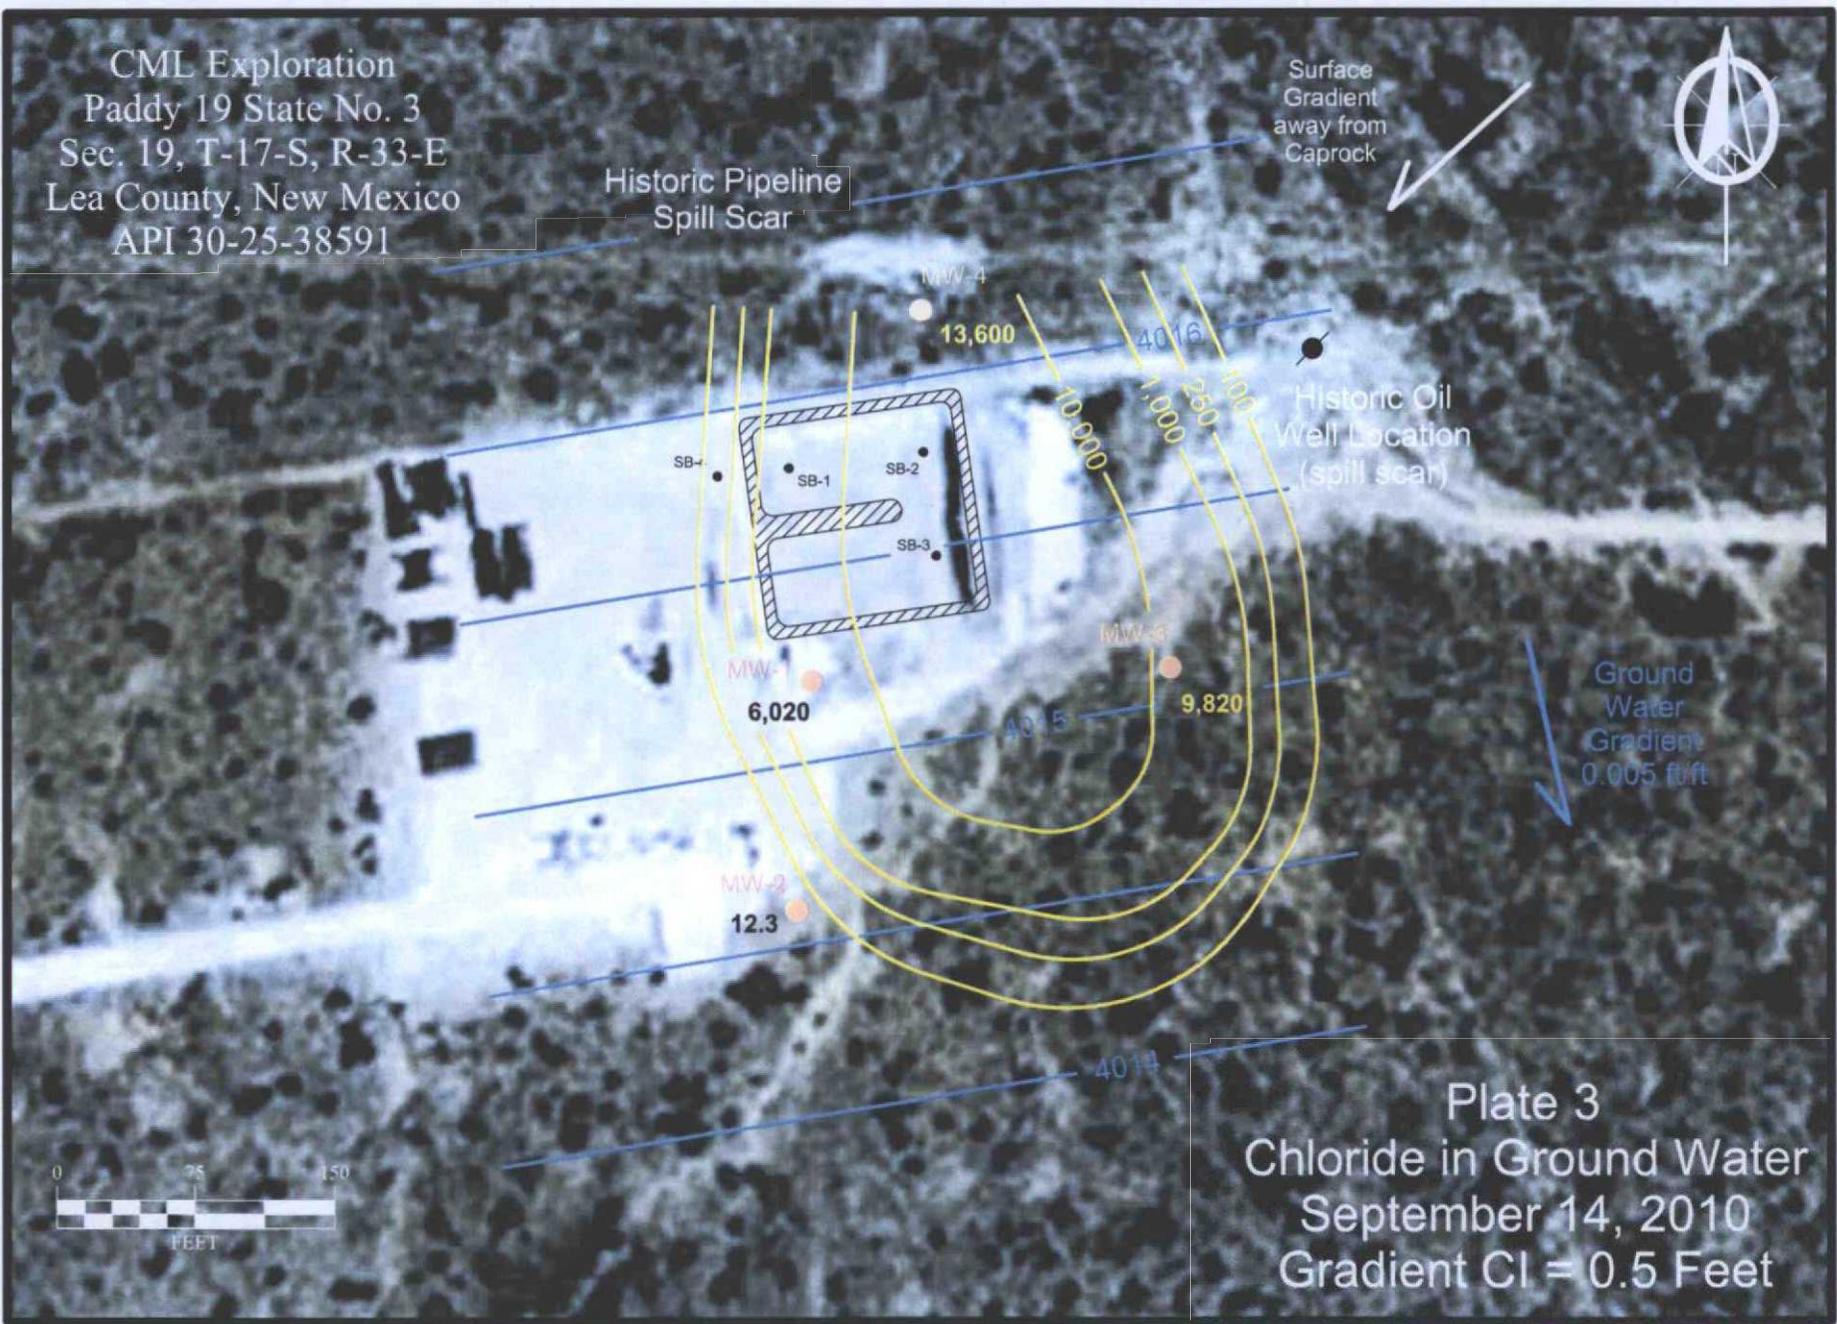
Plate 3
Chloride in Ground Water
September 14, 2010
Gradient Cl = 0.5 Feet

Plate 3 presents isoconcentration contours of chloride in ground water based upon the following interpretation of the data:

- A historic release from the pipeline north of the former Paddy 19 #3 reserve pit created saturated flow of produced water from the pipeline to ground water. This release caused chloride concentrations in ground water quality beneath the pipeline to exceed 10,000 mg/L.

- Over time, the area of ground water impairment caused by the release from the pipeline migrated south-southeast with ground water flow.
- Migration of chloride from the 1958 drilling pit associated with well 3002501484 may have caused impairment of ground water quality.

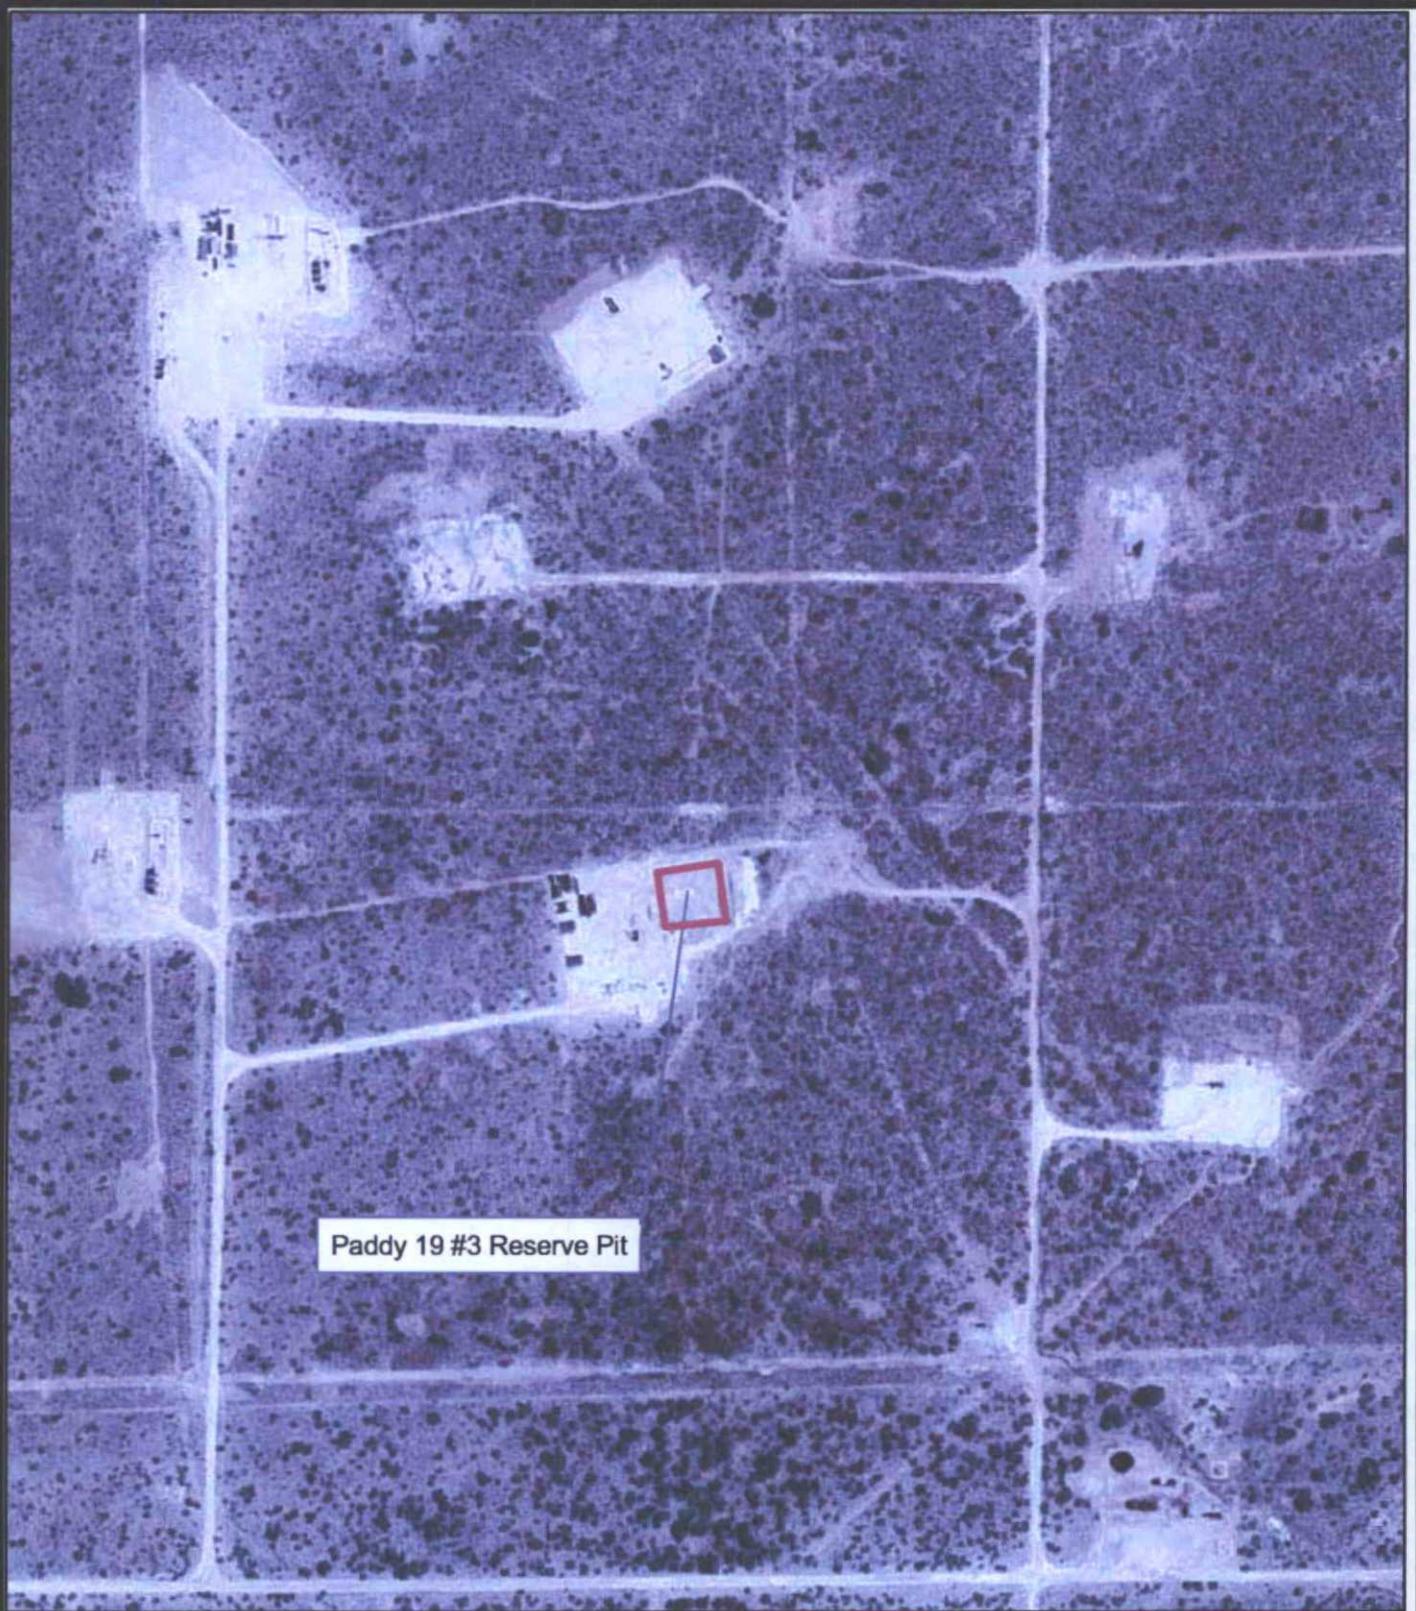
Figure D1

1. Ground water gradient in the area flows to the southeast at a gradient of 0.005 ft/ft as shown on Plate 2.
2. This direction of flow and gradient is consistent with regional data (see regional ground water flow map in Appendix A).
3. Background chloride concentrations in ground water are less than 50 mg/L (MW-2).
4. Ground water chloride concentration up-gradient from the former pit exceeds 10,000 mg/L.
5. Between 1996 and 2006, damage to vegetation occurred along the pipeline right-of-way north of the Paddy 19 #3 reserve pit area.
