Date: March 14, 2008  
To: **Mr. Glenn Von Gonten**  
Company Name: New Mexico Oil Conservation Division  
Environmental Bureau  
Address: 1220 South St. Francis Drive  
City / State / Zip: Santa Fe, New Mexico 87505  
From: David P. Duncan  
CC: Billy A. Anderson, Chevron USA - Eunice, NM  
Targa Midstream, LLC - Eunice, NM  
Project #: OCD Case No. AP081  
NMOCD Ref. #NSL-5227-A: EPI Ref. #200074  
Project Name: Mark #13 Drill Pit  
Subject: **Initial NMOCD Form C-141**

RE: **Initial NMOCD Form C-141**

Reference: OCD Case No. AP081

Chevron USA – Mark #13 Drill Pit

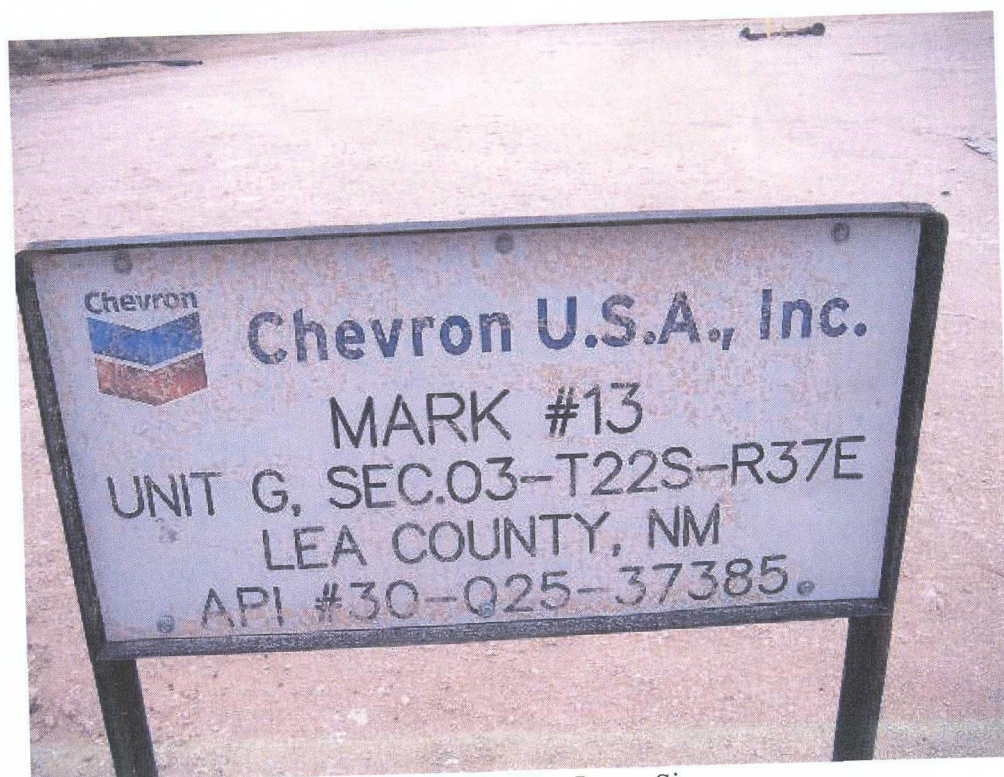
Photograph No. 1 – Lease Sign.
