Release Notification and Corrective Action

Name of Company	McElvain Oil & Gas Properties, Inc.	Contact	E. Reed Fischer
Address	1050-17 th St, Ste. 1800 Denver, Colorado 80265	Telephone No.	(303) 893-0933
Facility Name	McElvain # 5	Facility Type	Tank Battery

SPCC PLAN
 Facility Layout & Surface Drainage
 Date of Inspection: 1-22-2008

Facility Description
 McElvain Lease Well No.5
 # NMNM 0245247
 SW SW, Sec. 25, T18S, R33E
 Lea County, New Mexico

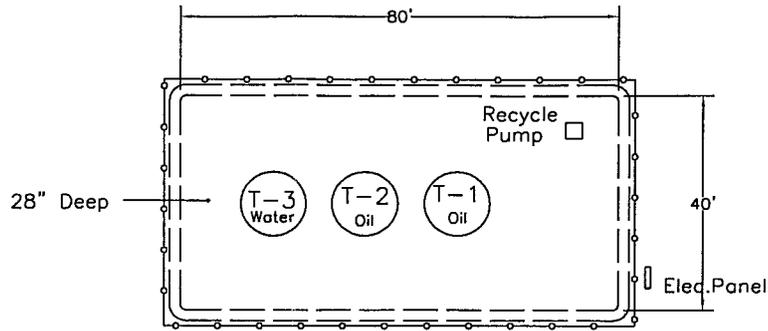
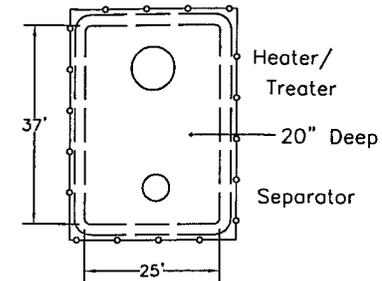
Note:
Meter is located off site at the
McElvain Fed. #4 location

Note:
T-4, 5 & 6 are 55 Gal Drums.
T4 has 38"x62"x9" plastic
secondary containment.
T5 & T6 are not being used.

Note:
To meet SPCC Plan requirements the following
repairs or changes need to be made:
-Tanks T5 & T6 need to be removed from
the site.
