**MODIFICATION
SITE
ASSESSMENT**

**RE: Request for Additional Information - Surface Waste Management Facility Landfill
Permit Application Review
Artesia Aeration: Permit NM-1-0011
Location: Sections 5, 6, and 7, Township 17South, Range 32 East, NMPM
Lea County, New Mexico**

**Groundwater Investigation Report
Artesia Aeration
Section 7, Township 17S, Range 32E
Lea County, New Mexico**

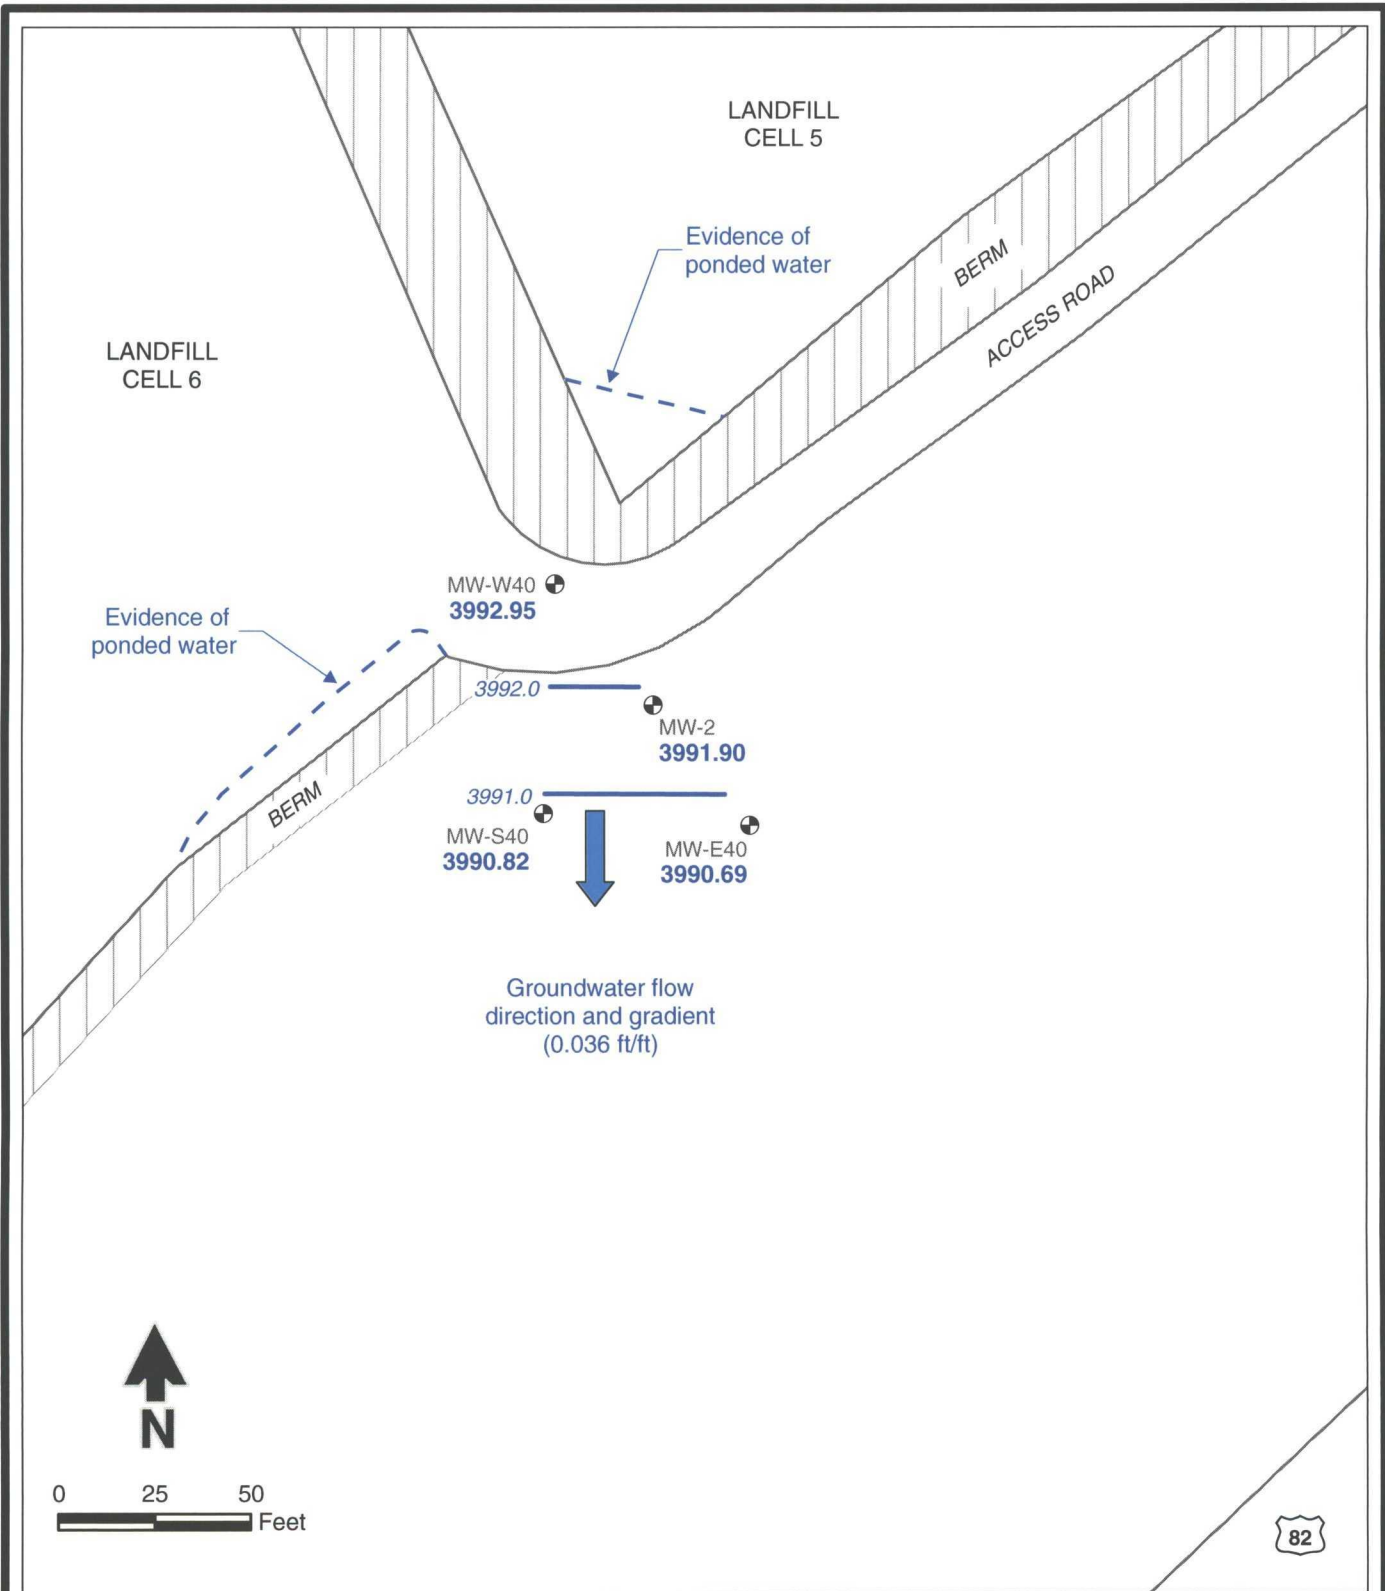
Figure 2

At the time of the field investigation, DBS&A observed evidence of ponded water behind the southern berms of cells 5 and 6 (Figure 2), in the topographic low between MW-2 and landfill cell 6, and in several other low lying spots around MW-2 that have resulted from settling of the backfilled trenches.

The results of the soil boring investigation showed that groundwater in the vicinity of MW-2 is perched and of limited areal extent. The extent of perched groundwater is shown in Figure 2. Of the 15 soil borings installed during the investigation, water was encountered in nine of them (Table 1). Soil boring W20 sloughed in overnight and was not redrilled. The initial water levels gauged in the open borings after standing open overnight are shown in Table 1.

The six dry borings defined the extent of the perched groundwater to the north, east, southeast, and south (Figure 2). The perched groundwater was determined to extend from beneath landfill cells 5 and 6 toward Highway 82 for a distance of less than 80 ft (boring E40 contained water; E80 did not contain water). To the south of MW-2, the perched groundwater extends approximately 80 ft. When boring S80 was drilled, it was initially found to contain water, but after a few days went dry. This likely indicates that the boring is located on the outer fringes of the perched groundwater. To the north along the access road, the perched water extends less than 20 ft (boring N20 did not contain water). The extent of perched groundwater beneath landfill cells 5 and 6 was not determined due to site constraints and the inability to drill through landfill cell contents. Both soil borings installed between cells 5 and 6 (W40 and W90) contained significant amounts of water.
