# Caprock Maljamar Unit #38

## REMEDIATION WORK PLAN

API No. 30-025-01485

**RE: Linn Energy Caprock Maljamar Unit #38 – Remediation Work Plan**  
UL/C, Section 19, T17S, R33E  
API No. 30-025-01485

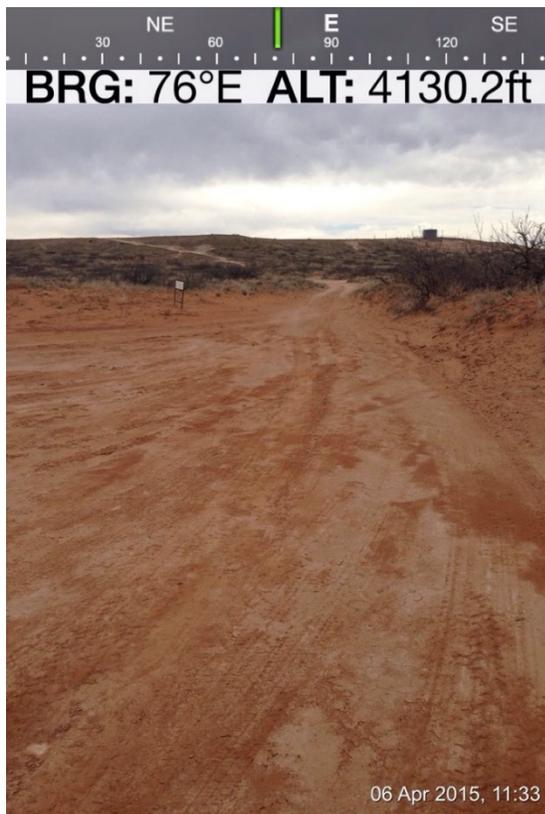
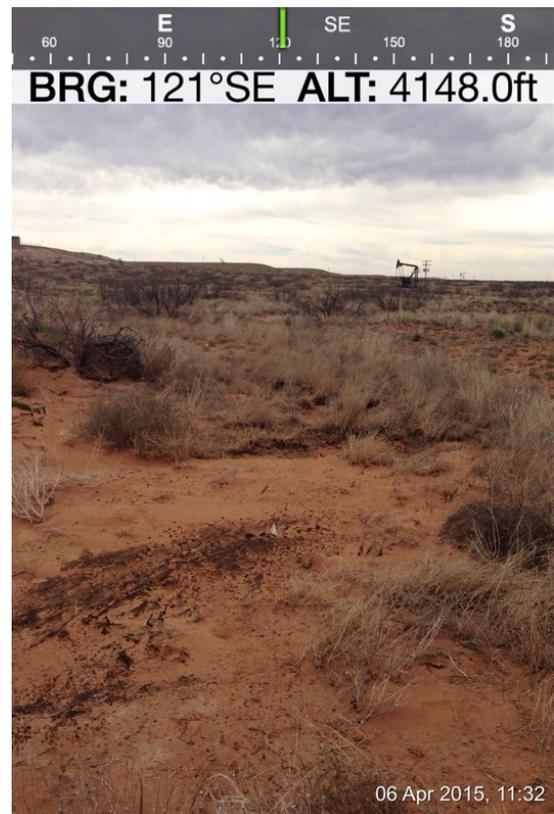
## PHOTO PAGE

The site is located southeast of Maljamar NM, in Lea County. The leak site resulted from a failure of an injection line. The impacted area is the north and east sides of the caliche pad and some pasture impact east of the pad. A C-141 was submitted to the NMOCD on October 22nd, 2014.
