Preliminary Assessment
of
Gooch's Tank Service
Tatum, New Mexico

February 6, 1992

Susan A. Morris
Environmental Specialist
New Mexico Environment Department

Date: February 6, 1992
Prepared by: Susan A. Morris
Site Name: Gooch's Tank Service
Site Address: Highway 380 West
Tatum, New Mexico
EPA ID No: Not Assigned
TDD No: Not Assigned

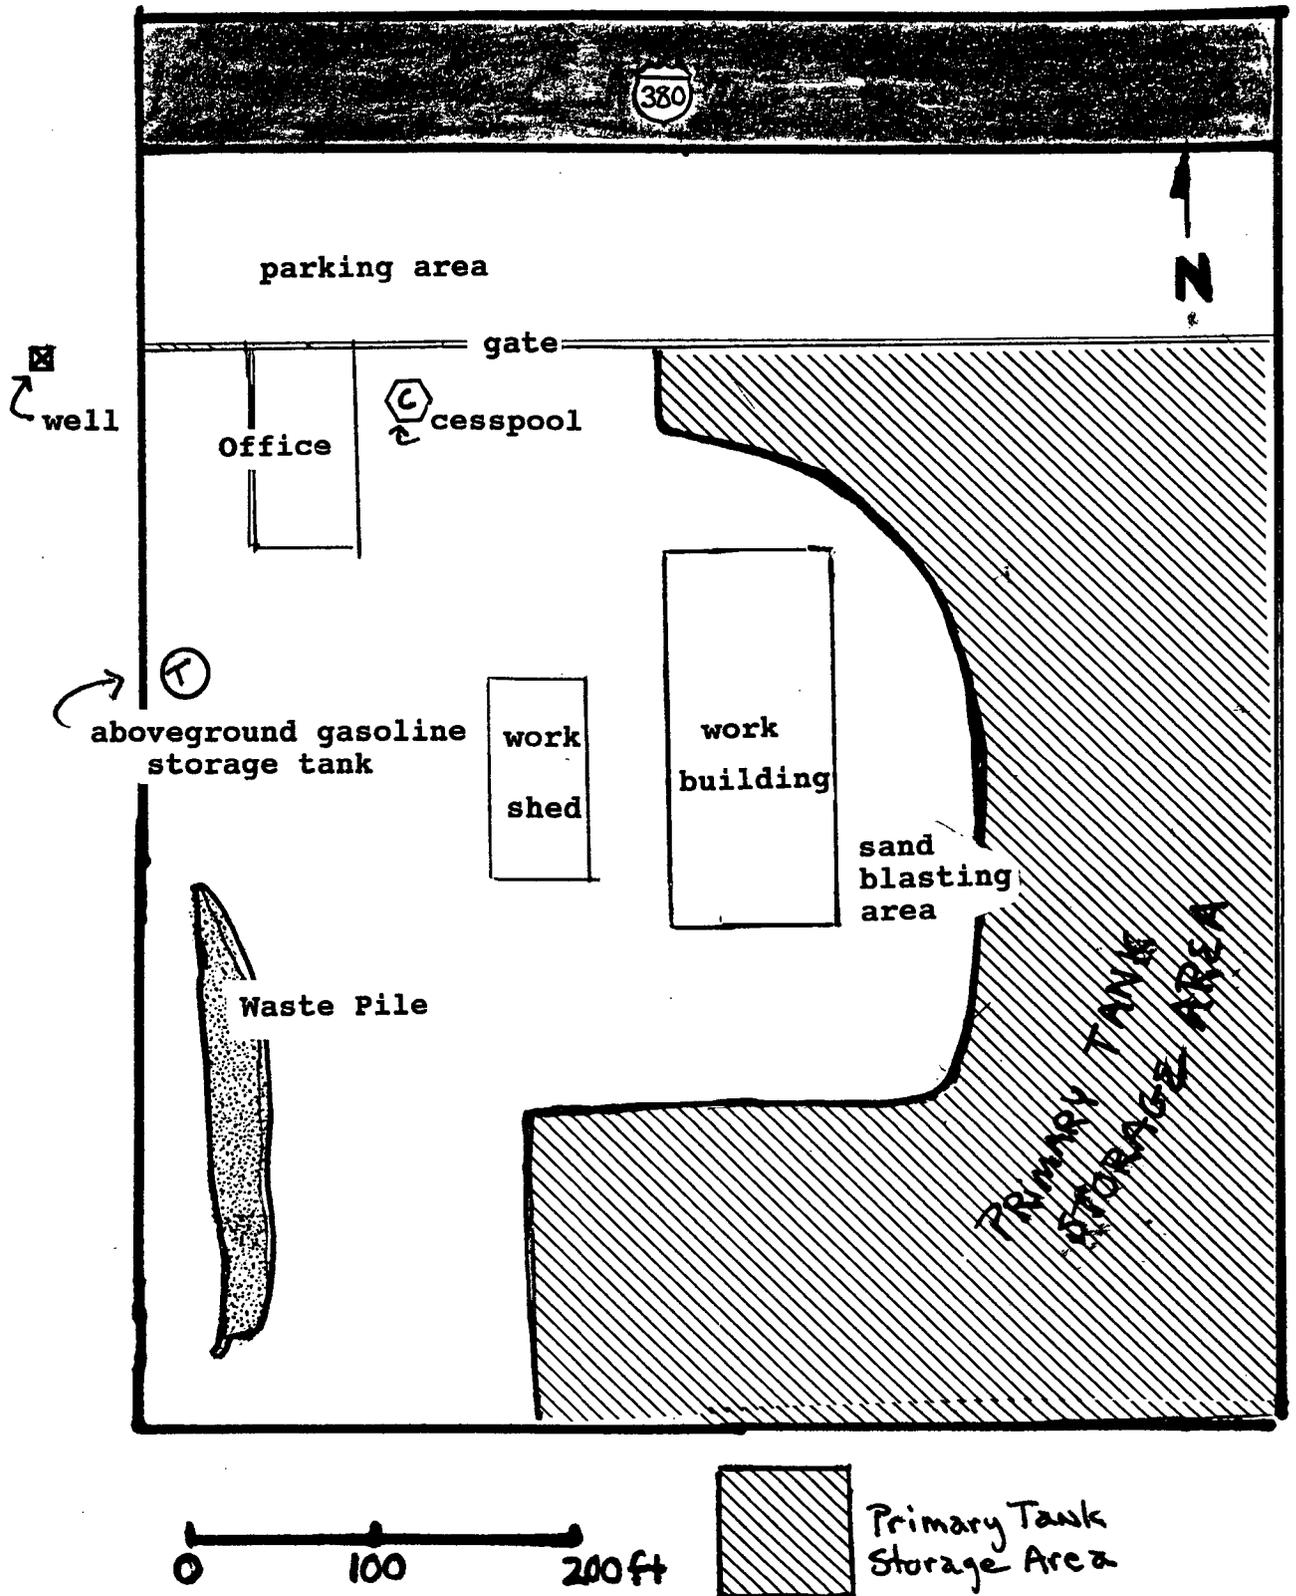
The site is a 10 acre parcel that has 3 buildings: a central office and two work sheds (Figure 3). The site is entered through the main office building or through a locked gate. Along the western property line there is an above ground gasoline storage tank and pump (Photograph 3). Numerous large, steel storage tanks line the front fence along Highway 380 and occupy the yard east of the main building (Figure 3). A cesspool is located on the western side of the office building and serves the restroom facilities on site. Ms. Meyers spoke with Mr. Gooch about the feasibility of connecting to the Tatum Sewer line and informed him that a cesspool was a violation of the New Mexico Liquid Waste Regulations.

Figure 3. Site map of Gooch's Tank Service, Tatum, New Mexico

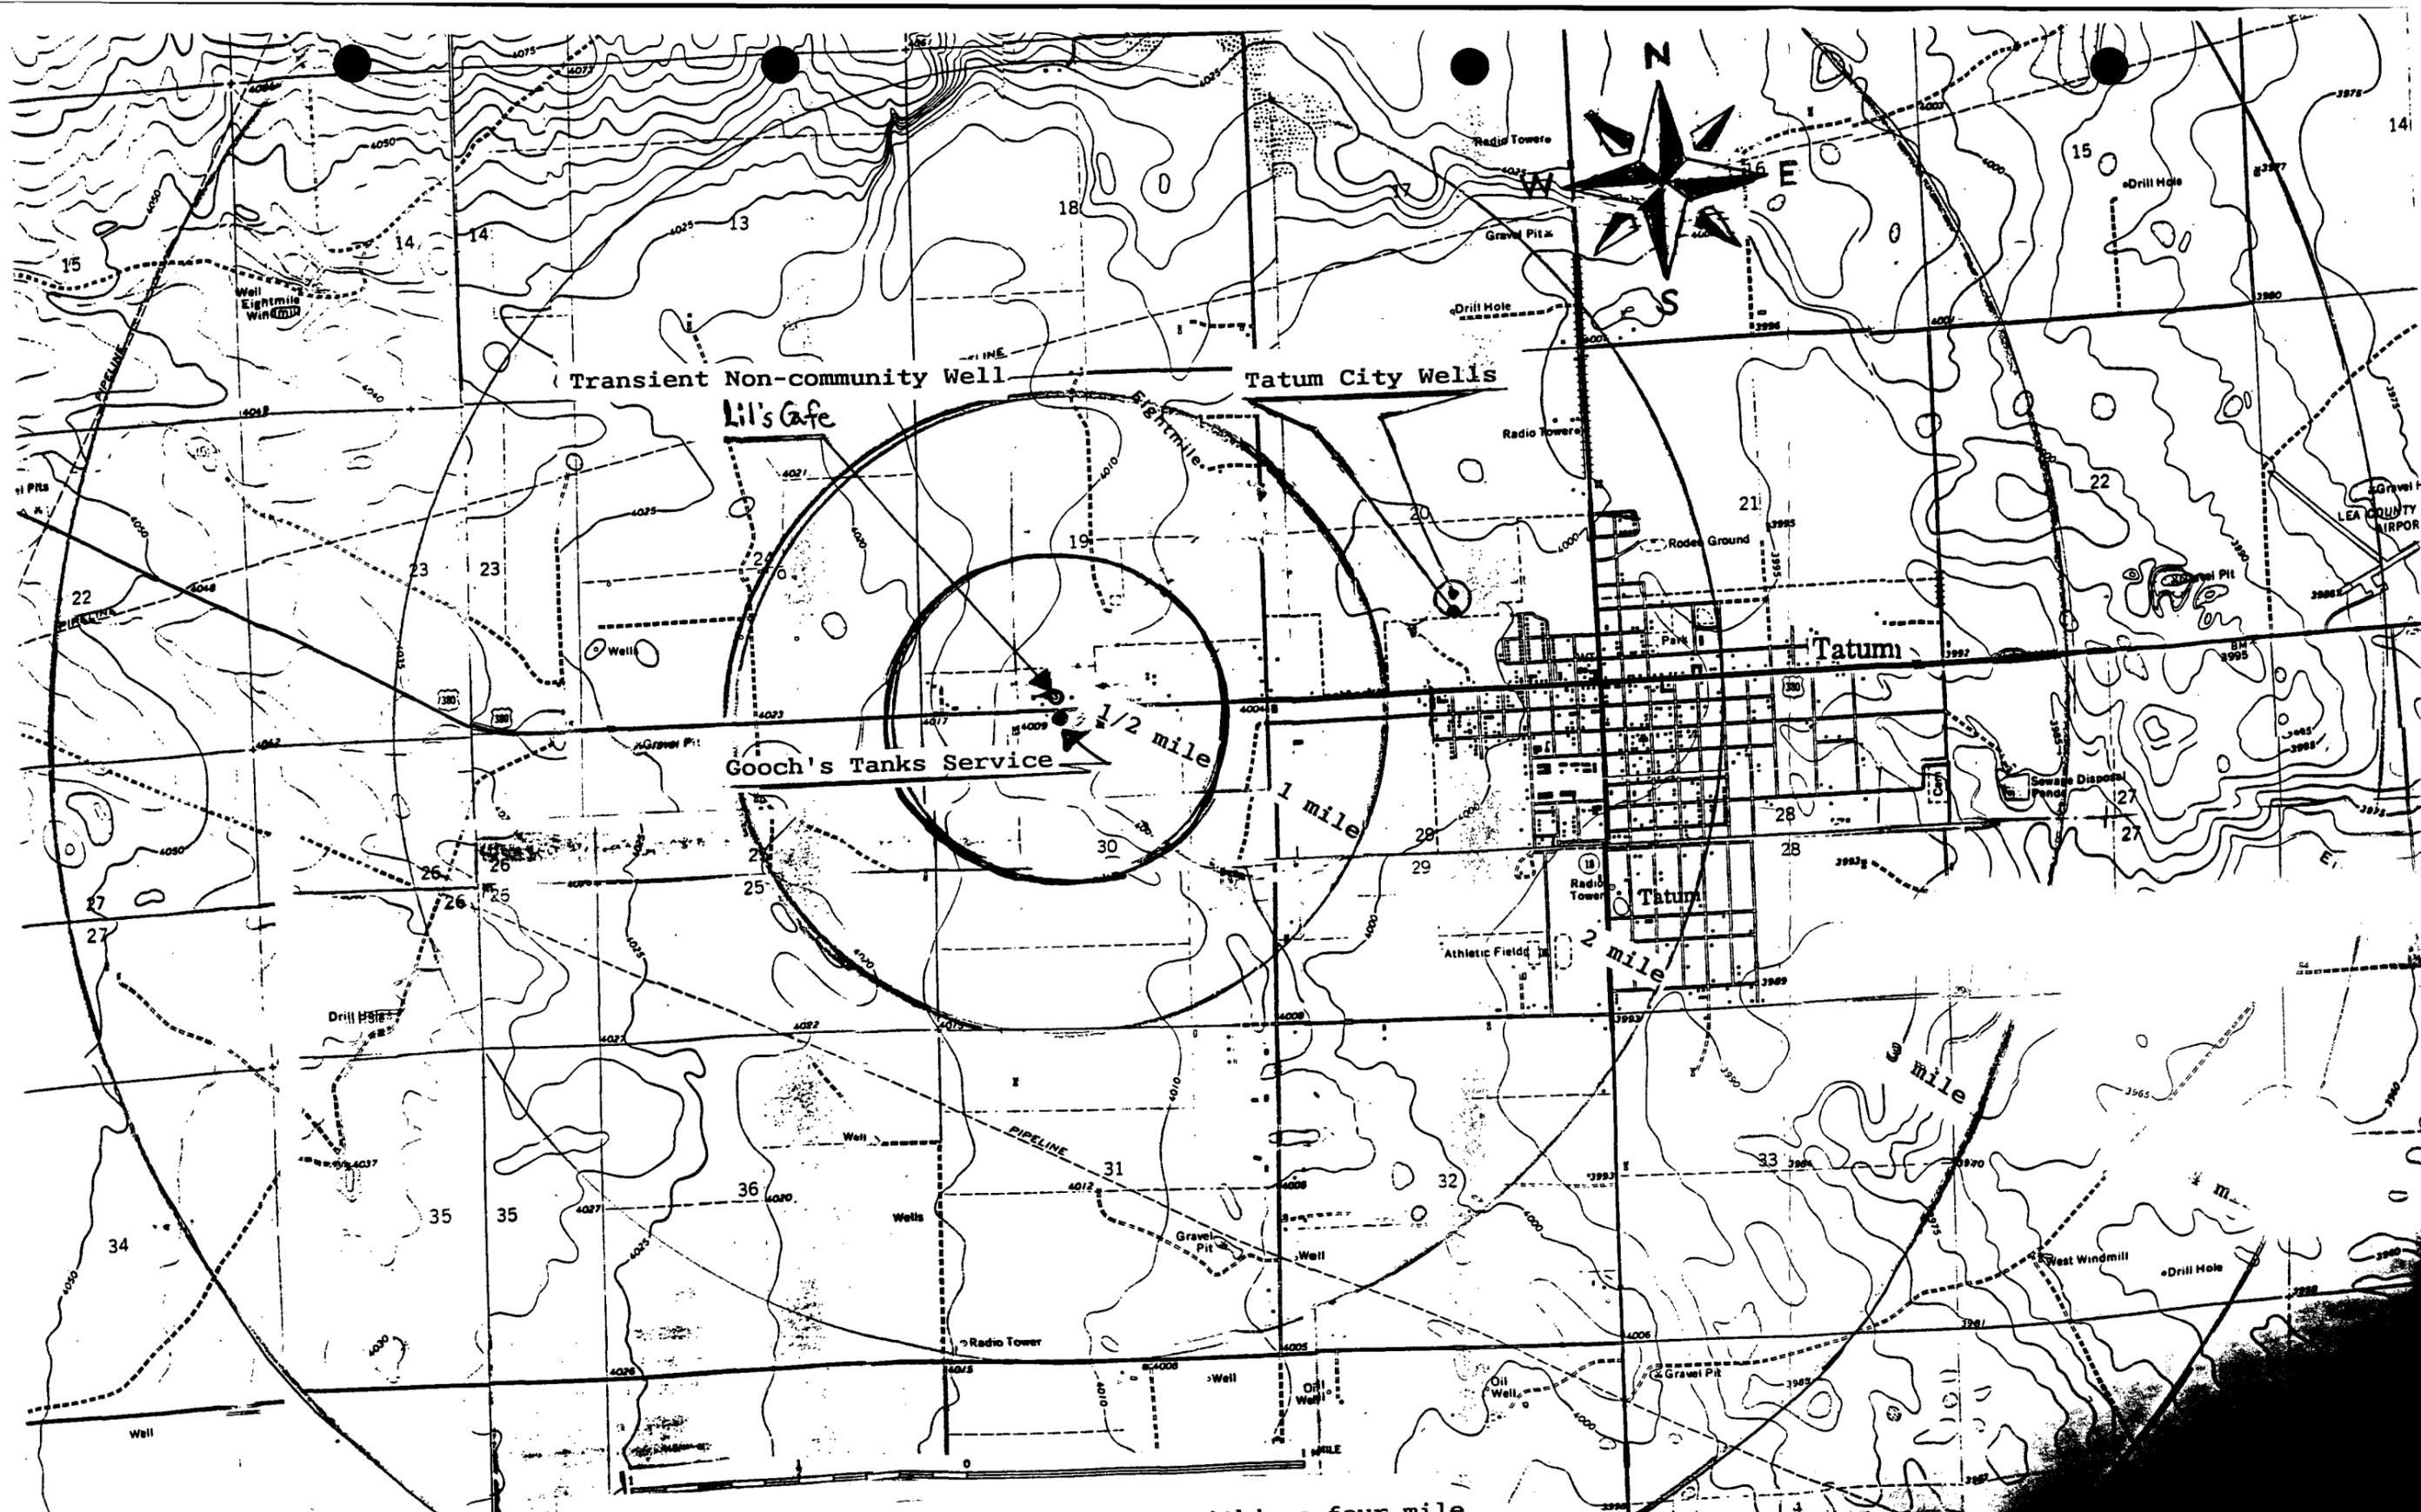
Ground water is the only source of drinking water in Lea County. Within a 1-2 mile radius of the site are two operating municipal water supply wells (Figure 4). A transient non-community water supply well that serves Lil's Cafe and service station, (Figure 2), is located approximately 200 feet north and upgradient of the site. Four of Tatum's municipal wells have been taken off line since 1989, due to contamination by leaking underground gasoline storage tanks (Figure 5). There are approximately 50 private wells within a four mile radius of the site (Reference 8).

Figure 4. Location of public water supply wells within a four mile radius of Gooch's Tank Service site, Tatum, New Mexico

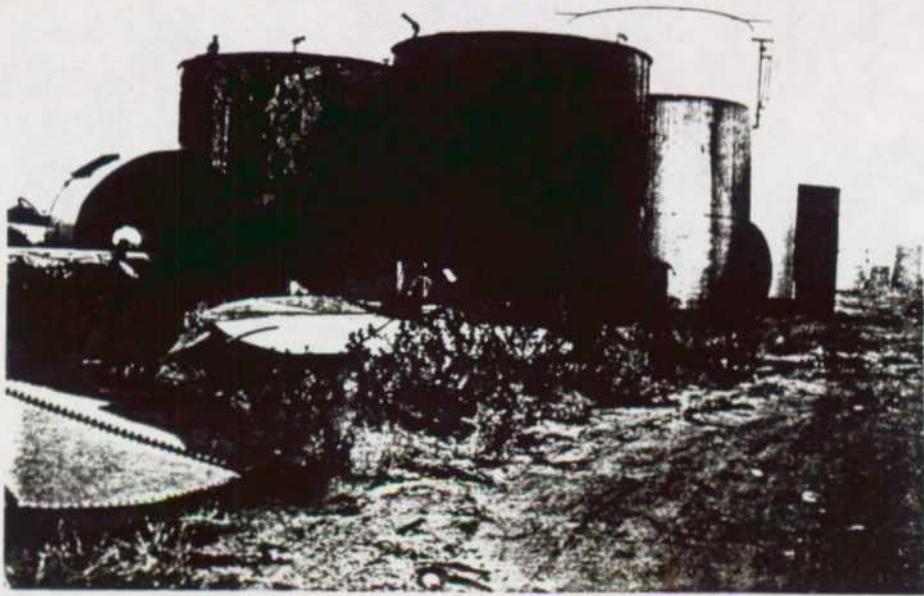
Photograph 1. Refurbished and restored tanks are stored on the eastern portion of the Gooch's Tank Service property. Photographer: Susan A. Morris, Date: 12/11/91

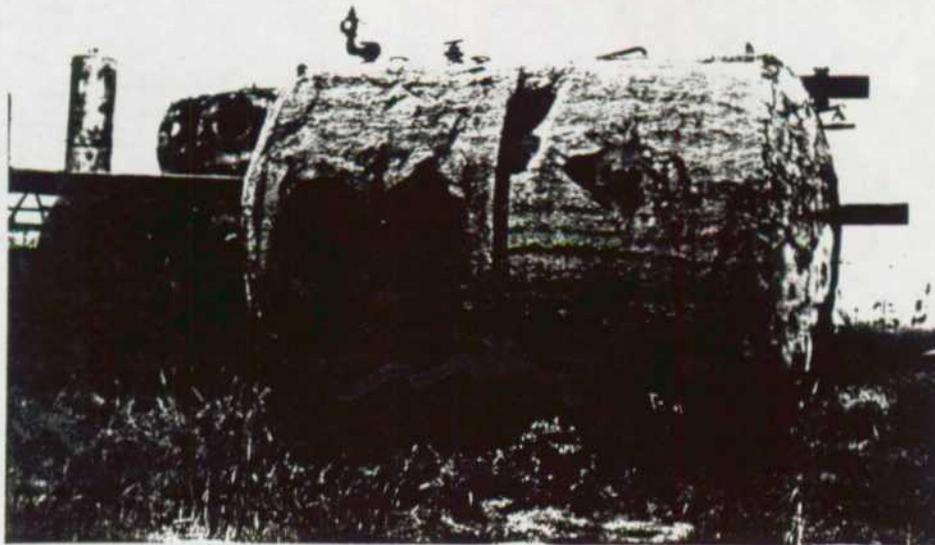
Photograph 2. An old oil field tank used to separate oil/water phases. Photographer: Susan A. Morris, Date: 12/11/91
