RE: Indian Basin Gas Plant
Pipeline Spill (Line #1) Remediation Report

**INDIAN BASIN GAS PLANT
PIPELINE (LINE #1) SPILL
REMEDICATION REPORT**

**Indian Basin Gas Plant
329 Marathon Road
Lakewood, New Mexico 88254
Eddy County**

**Submitted by
Marathon Oil Company
on behalf of the
Indian Basin Gas Plant Owners**

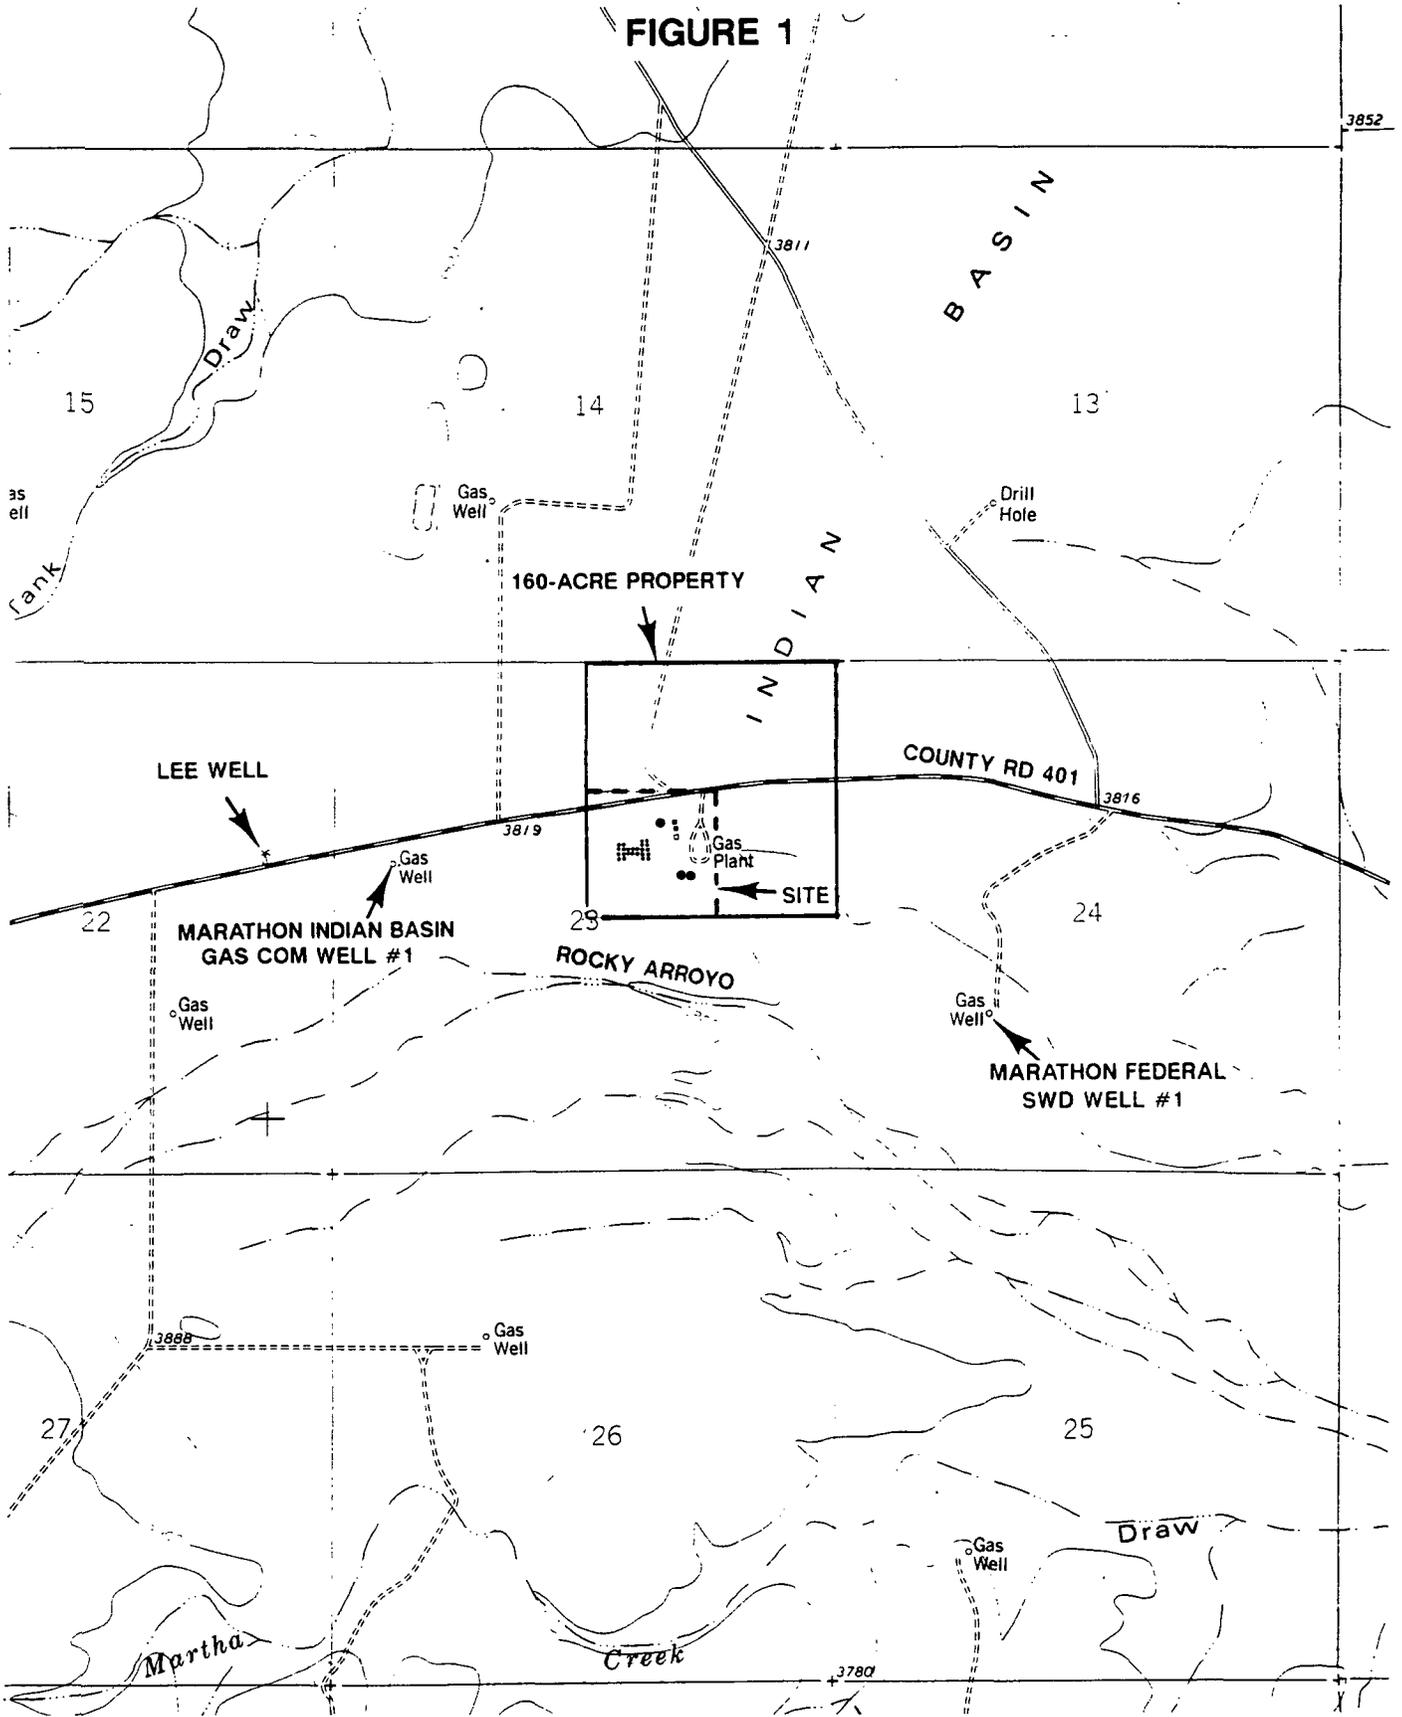
FIGURE 1

On July 15, 1994, a 552-barrel spill of condensate and produced water occurred from a production pipeline within the Indian Basin Gas Plant on Marathon-owned property. The spill consisted of approximately 125 barrels of condensate and 427 barrels of produced water. The Indian Basin Gas Plant is located in Eddy County, New Mexico (Figure 1).
