**STAGE 1 & 2
REPORTS**

Re: Pipeline Assessment Report, Dynegy Midstream Services, L.P., NW/4, SW/4, Section 21, Township 19 South, Range 37 East, Lea County, New Mexico

DYNEGY MIDSTREAM SERVICES, L.P.
MONUMENT PIPELINE ASSESSMENT REPORT
PHOTOGRAPHS

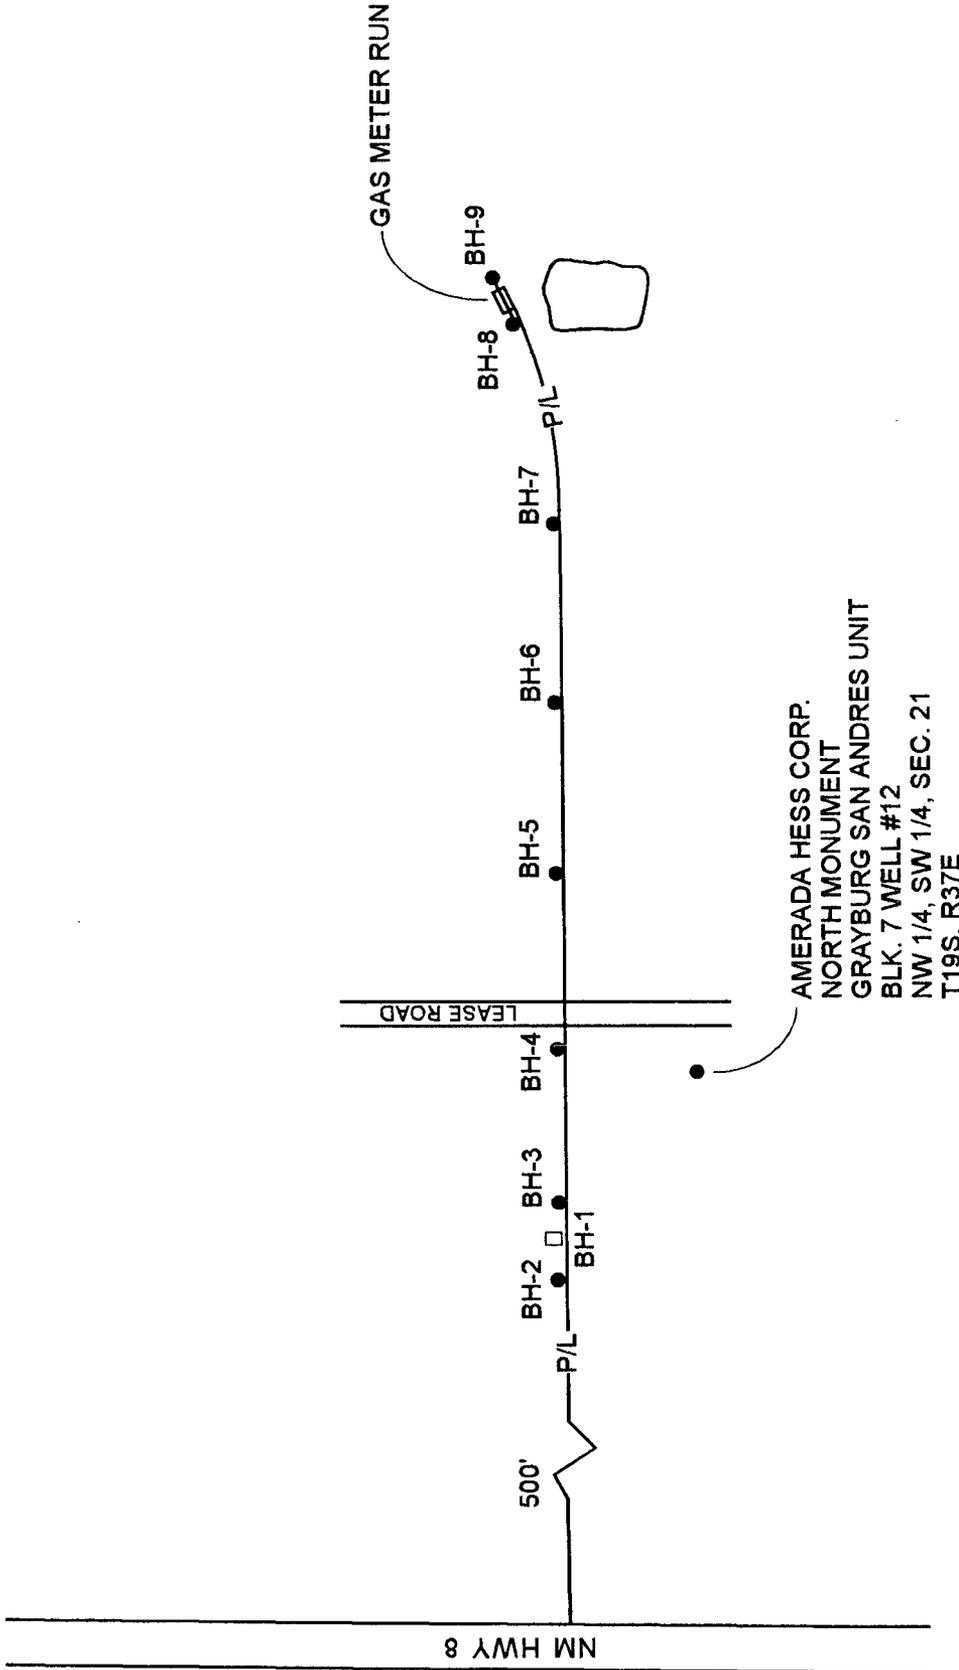
FIGURE #2

This report presents findings of a subsurface investigation of an inactive gas-gathering pipeline owned by Dynegy Midstream Services, L.P. (Dynegy), and located in the northwest quarter (NW/4) of the southwest quarter (SW/4), Section 21, Township 19 South, Range 37 East, Lea County, New Mexico. Larson and Associates, Inc. (LA) conducted the investigation on March 27, 2001, to determine if the gathering line was a source for hydrocarbon impacts identified in a domestic well and irrigation well located approximately ¾-mile east of the investigation area. The investigation consisted of collecting soil samples for field and laboratory analysis from nine (9) rotary-drilled borings (BH-1 through BH-9). Figure 1 presents a location and topographic map. Figure 2 presents a drawing of the investigation area.
