HUNGRY HORSE, LLC
ENVIRONMENTAL SERVICES

To: Mike Bratcher, NM OCD Dist II
Reference: Remediation Work Plan
Operator: Alamo Permian Resources, LLC
Location: West Area Grayburg Unit Battery
API: 30-015-02649 (WAGU #12)
Legals: SW1/4, Sec. 8, T18S, R28E
GPS: N32.7590 W-104.2011

Release Notification and Corrective Action

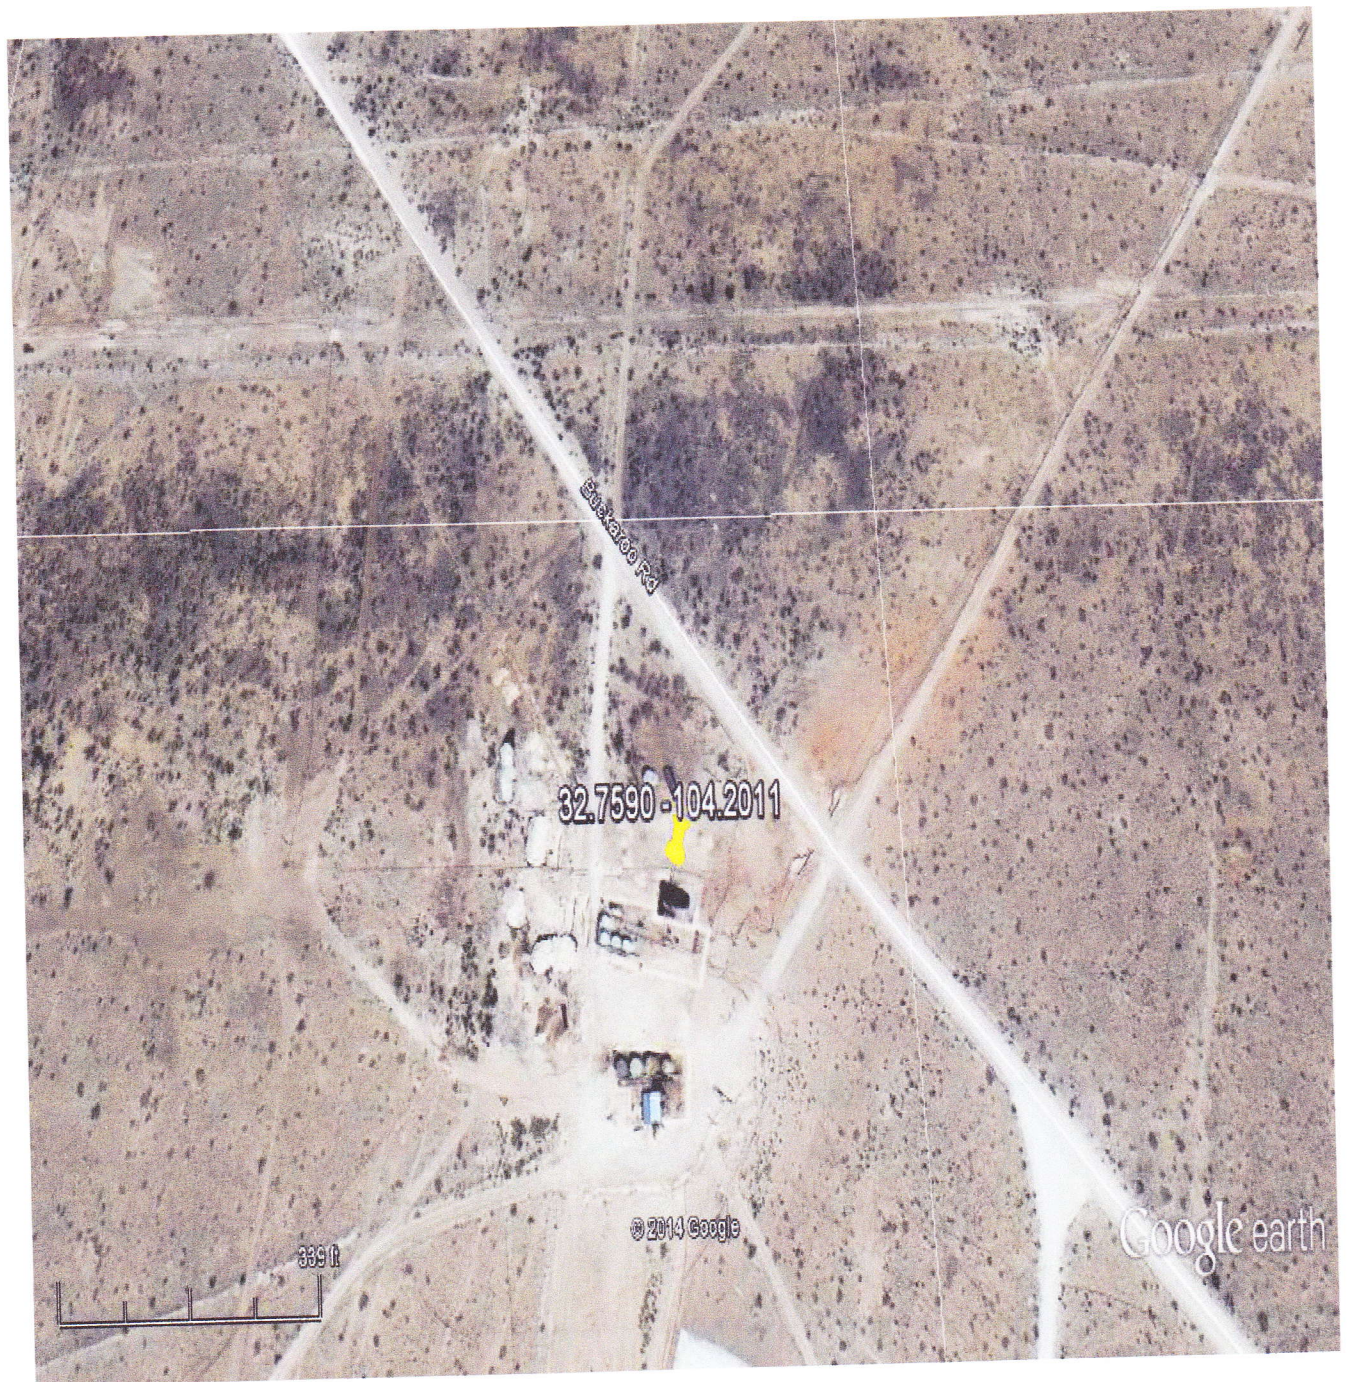
Alamo Permian Resources-WAGU

The impacted area inside the fire walls is a congested area consisting the two open top tanks, a pump, valves, and piping on all four sides (see attached photos). Due to the congestion and a possible safety hazard of conducting extensive excavation in and around the tanks/equipment, I propose to hand excavate and remove 1' of material from inside the firewalls and replace the material with fresh soil with the stipulation that a full and complete remediation be conducted when this system is removed from service. Soil samples from each of the four corners will be collected upon removal of the 1' of material and lab analysis conducted for TPH, BTEX, and Chlorides. Lab results will be submitted as matter of record with the closing documents.
