Site Assessment/Characterization/Closure

3Bear Cottonwood Water Treatment and Impound

3Bear Field Services, LLC

June 2019

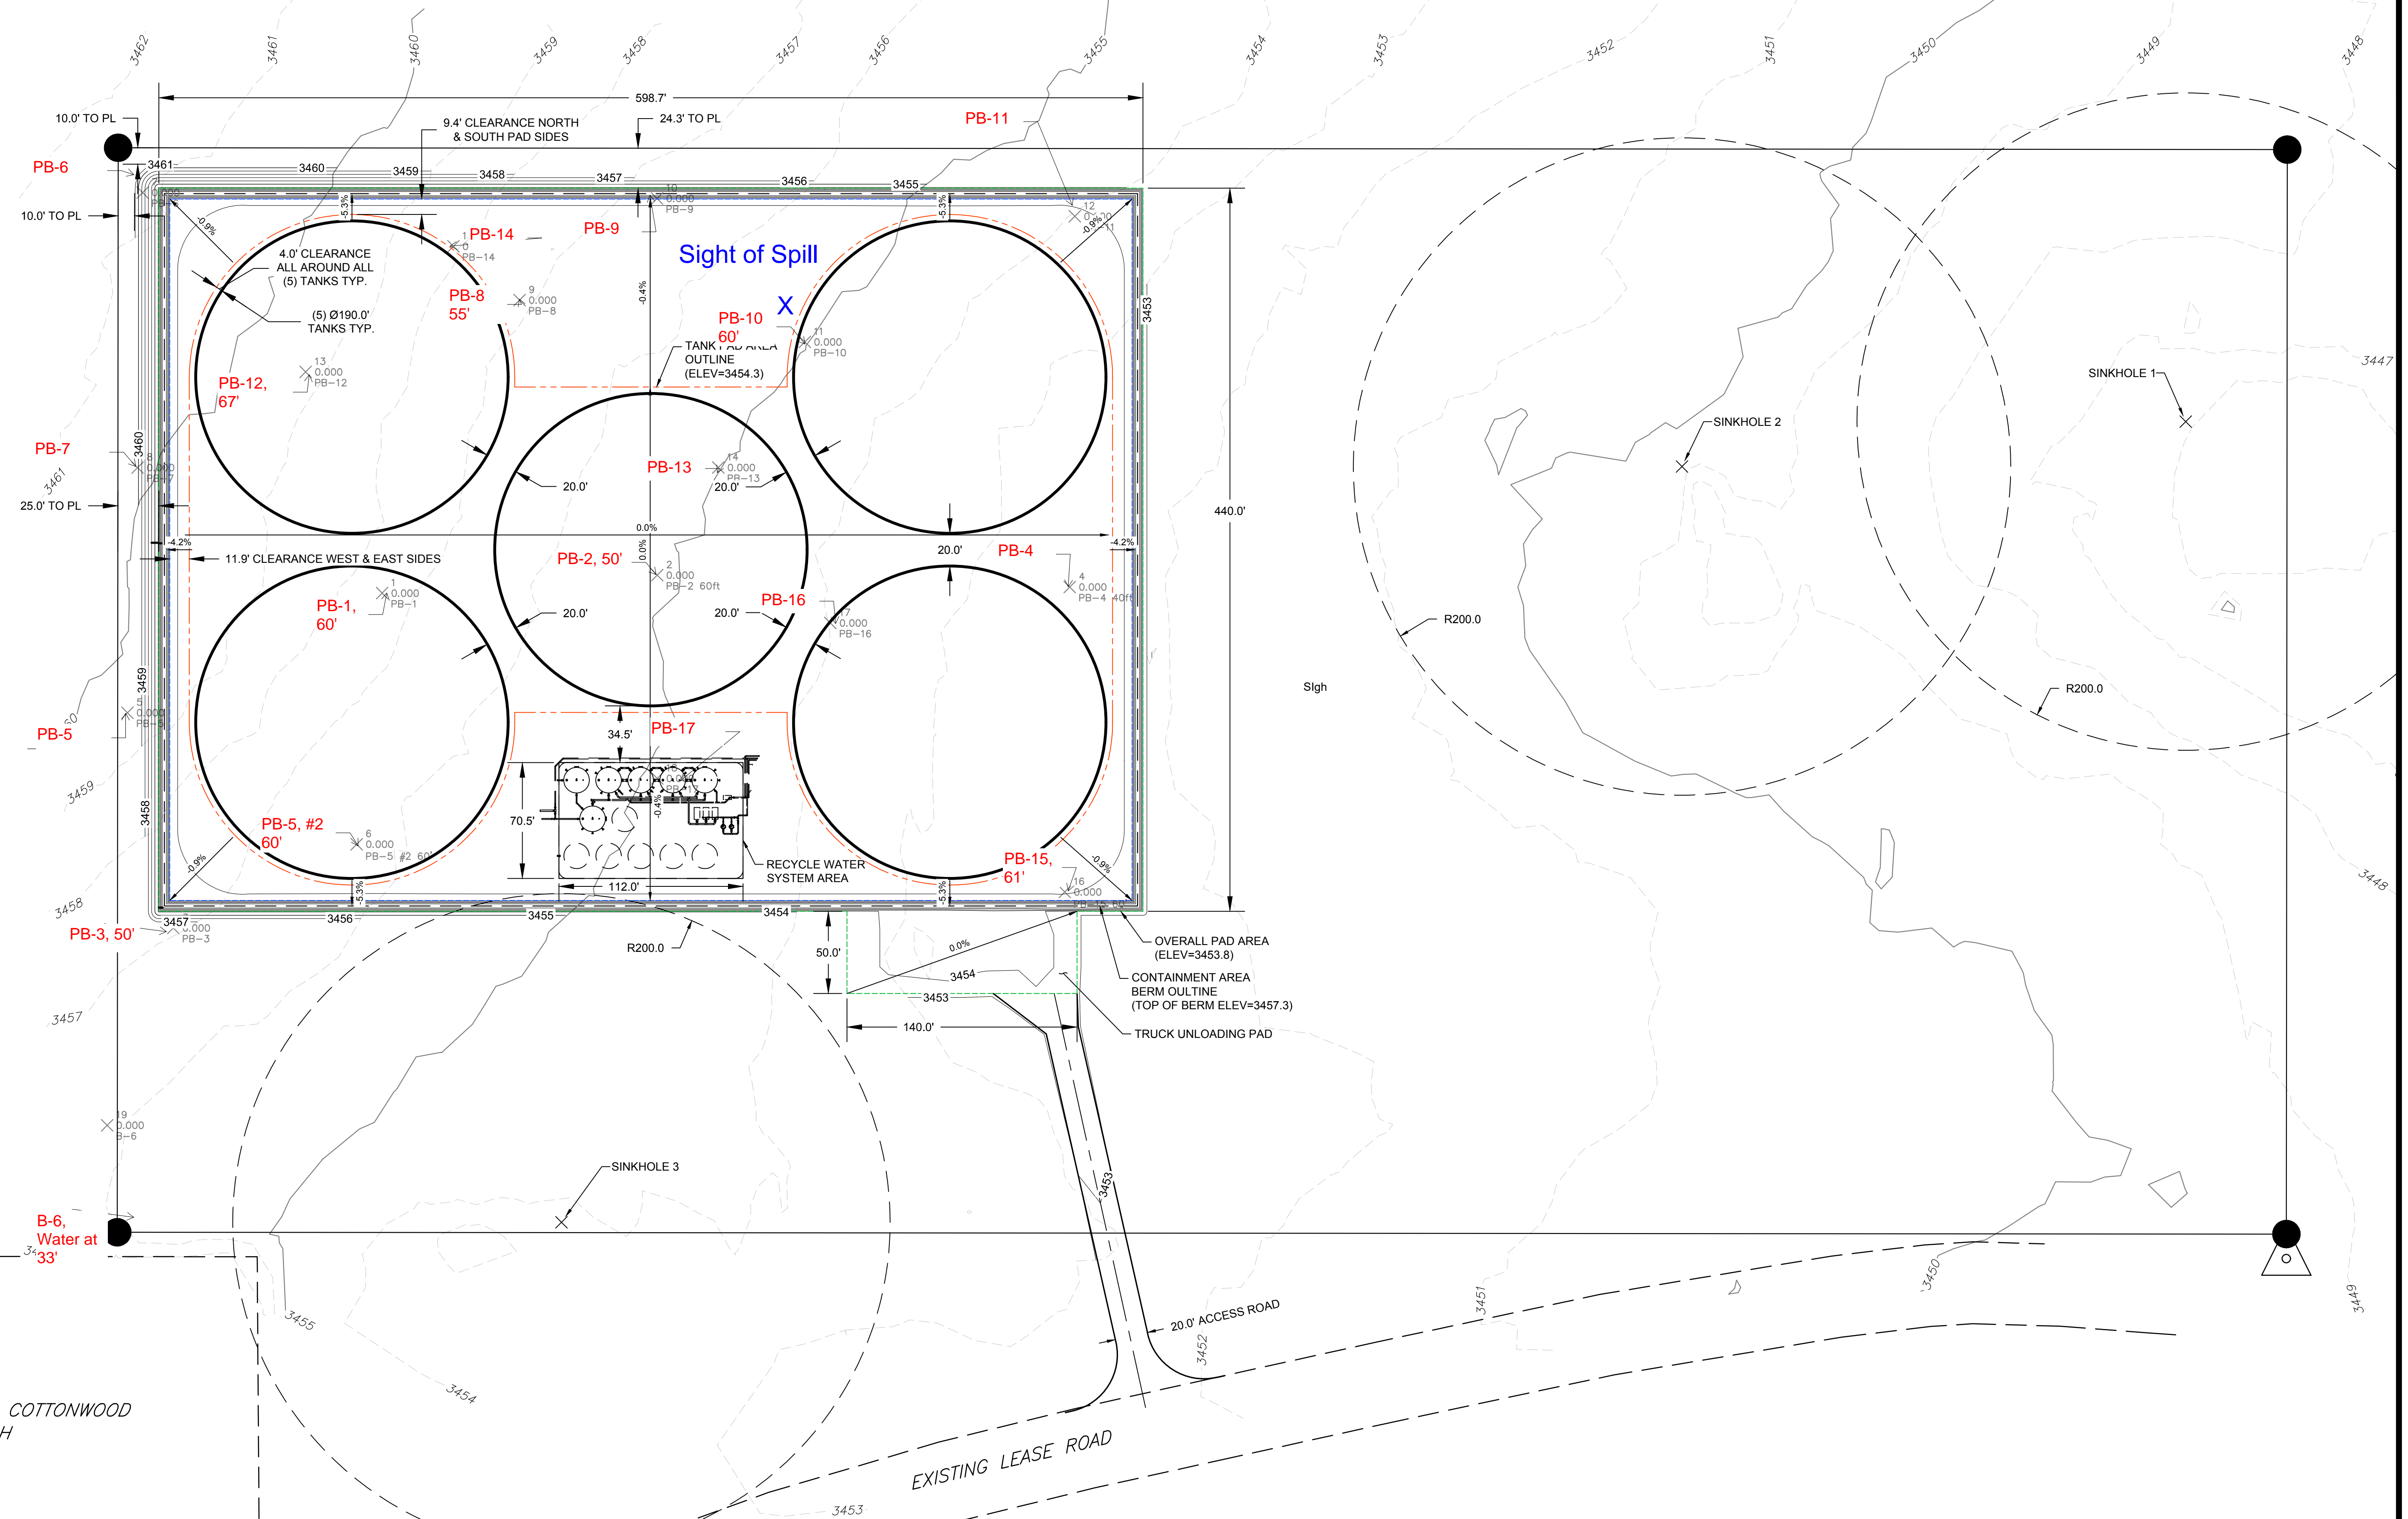
Figure 1 and Figure 2 show the impact area, surface features, and delineation points. There are not any monitoring wells on site.

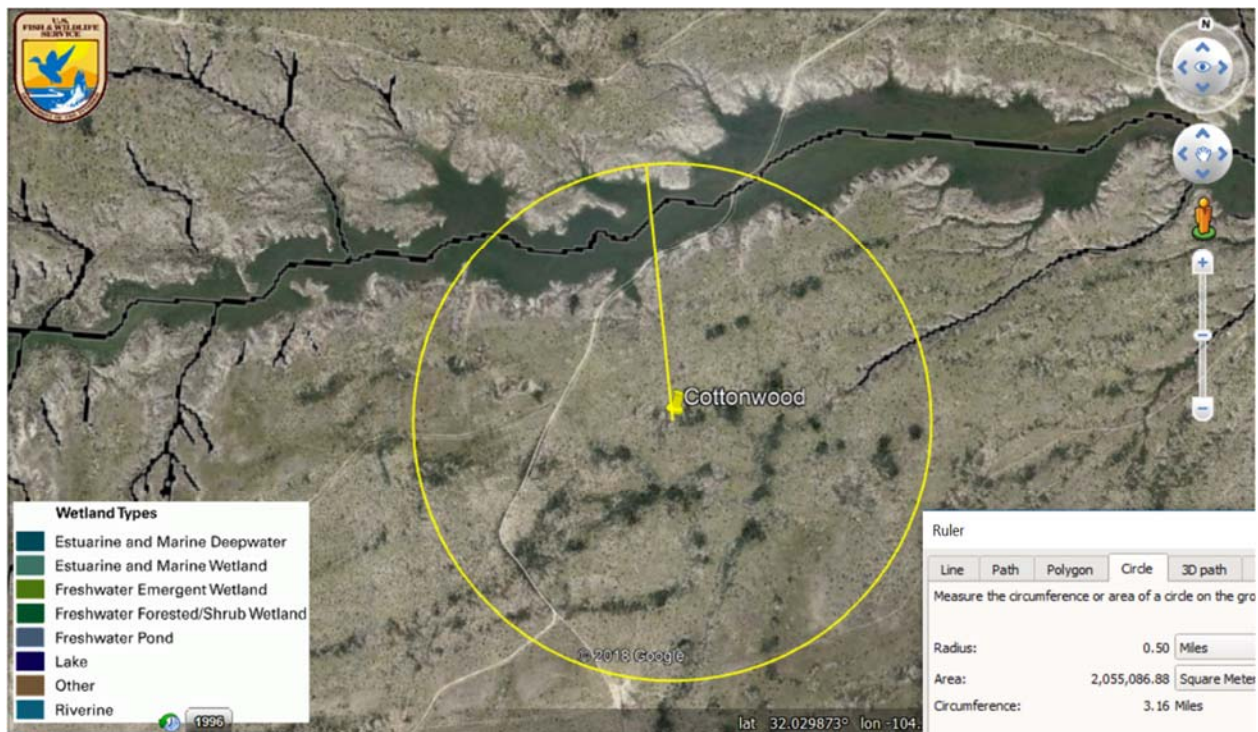
Figure 4

Butcher Spring is a watercourse north of Cottonwood. The spring is within a half mile of the release. Please see Figure 4.
