Incident ID	NVF1830934126
District RP	
Facility ID	
Application ID

Release Notification

Site Name La Plata 33 1	Site Type Gas Well
Date Release Discovered 10/16/2018 @ 9:30am	API# 30-045-29272

Photographs – 11/13/18 Liner Integrity Inspection

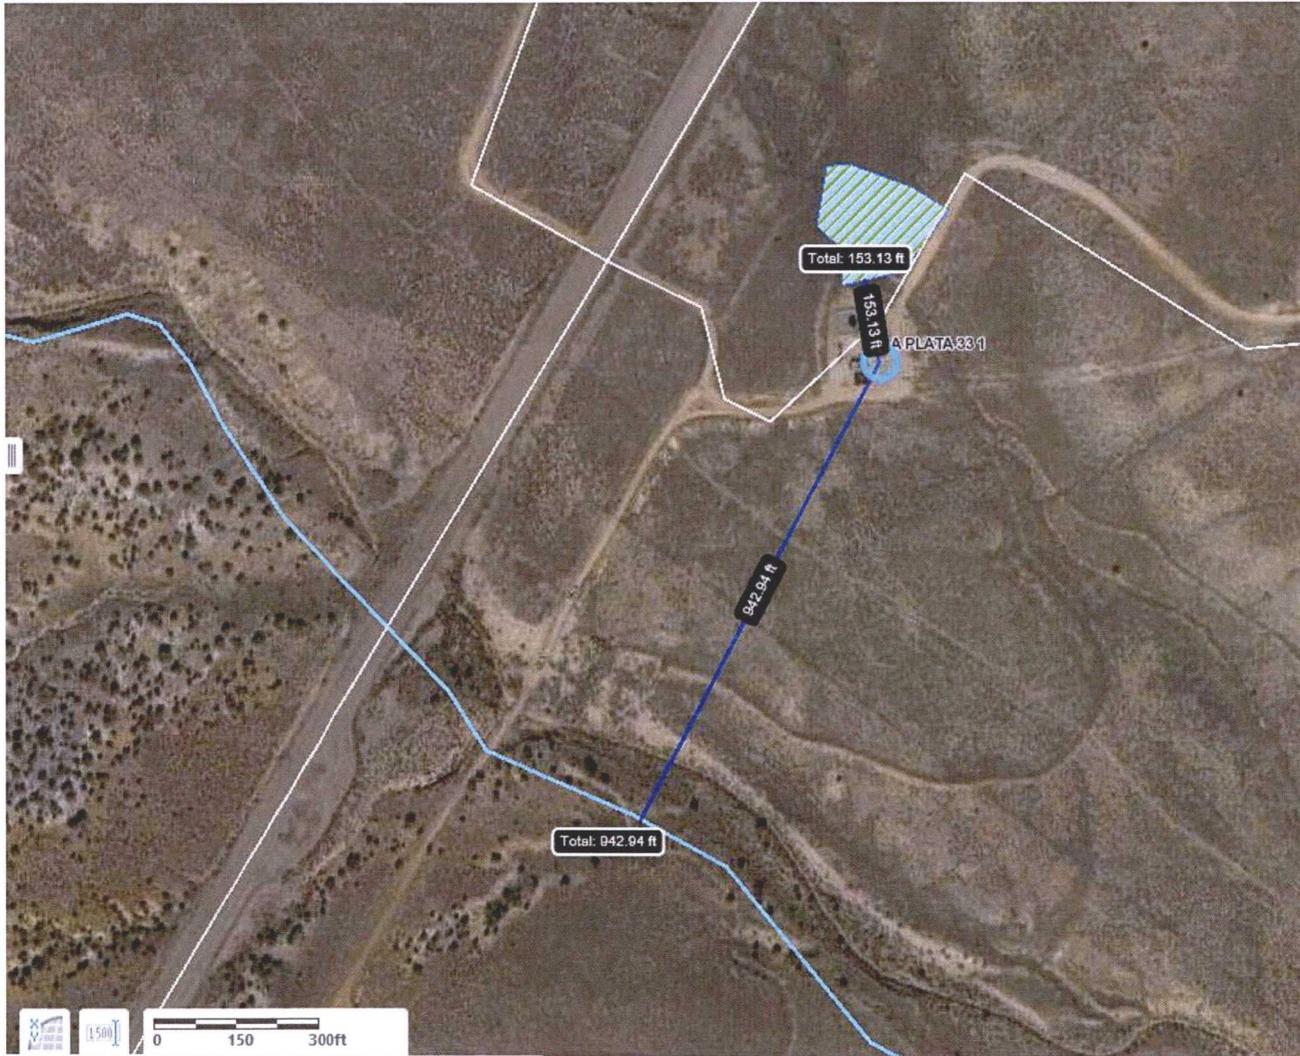
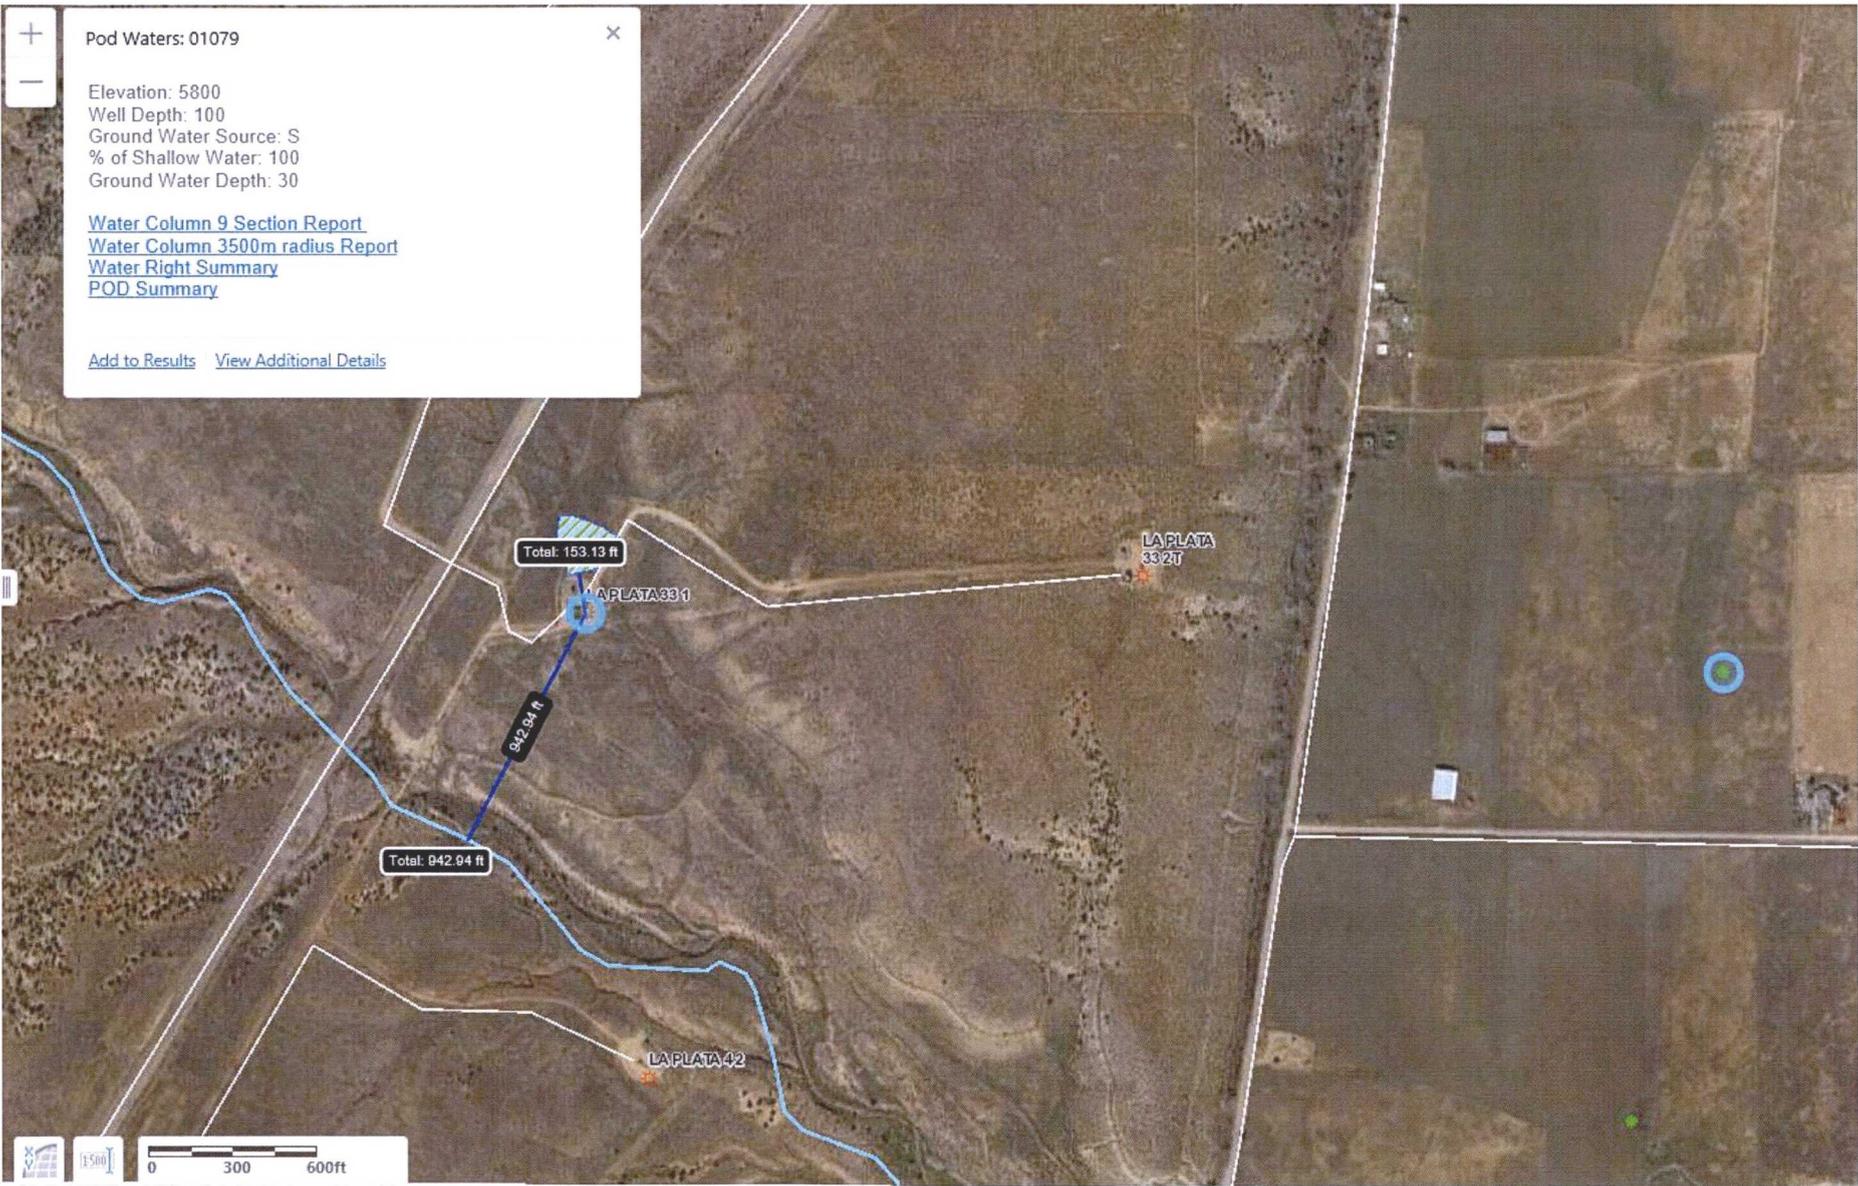
Determination of water sources

Ground water Depth (picture on previous slide)

- Nearest POD Water shows ground water depth is at 30 ft with an elevation of 5800.
- Elevation of La Plata 33 1 is 5896
- Ground water depth at La Plata 33 1 is approximately 126ft deep
($5896 - 5800 = 96\text{ft} + 30\text{ft} = 126\text{ft}$ deep)
