1RP-3979 DELINEATION PLAN Devon Lease Illegal Dumping Spill Lea County, New Mexico

LAI Project No. 17-0201-01

November 7, 2017

Prepared for: Penroc Oil Corporation 1515 Calle Sur, Suite 174 Hobbs, New Mexico 88240

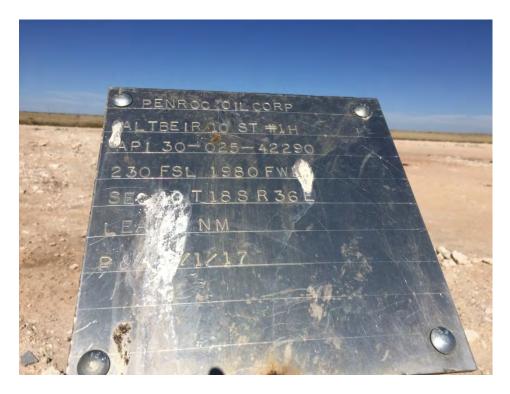
Altbeir 10 State 1H Site Location

LAI personnel collected photographs at the Altbeir 10 State #1H in similar orientation and direction as photographs by Devon. LAI personnel mapped the visible spill area with a Trimble sub-meter GPS receiver. A spill area was observed just off the lease road to the north of the now plugged and abandoned Altbeir 10 State #1 well. The vegetative cover has improved since the spill was initially reported but scarring is visible. LAI mapped the impact area as about 9,400 square feet or about 0.22 acre. Figure 2a presents an aerial map. Appendix B presents photographs.

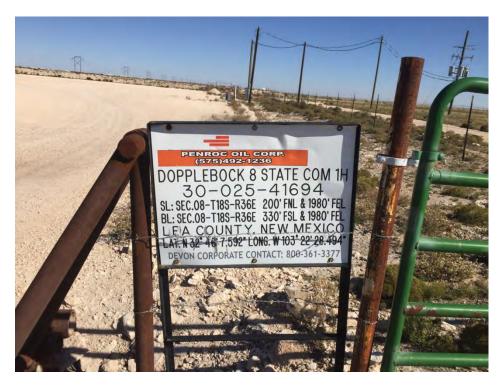
Dopplebock 8 State Com 1H Site Location

LAI personnel collected photographs at the Dopplebock 8 State Com #1H in similar orientation and direction as photographs taken by Devon and mapped the visible spill area using a Trimble sub-meter GPS receiver. An area of discolored vegetation similar to what Devon photographed was visible along the east side of the lease road leading up to the tank battery. The area of discolored vegetation measures approximately 6,200 square feet or about 0.14 acre. There were no visible signs of impact within the tank battery pad. Figure 2b presents an aerial map. Appendix B presents photographs.

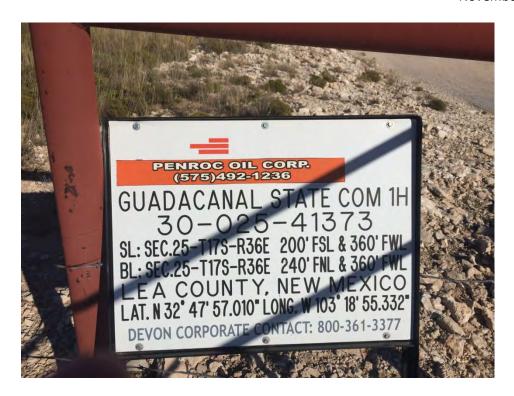
Guadacanal State Com 1H Site Locaation

LAI personnel conducted a site reconnaissance at the Guadalcanal State Com #1H on November 1, 2017. No impacted vegetation or discolored soil was observed in the vicinity of the well or tank battery. LAI observed an area of discolored soil near the lease entrance about 2 miles west of the location. Figure 2d presents an aerial map. Appendix B presents photographs.

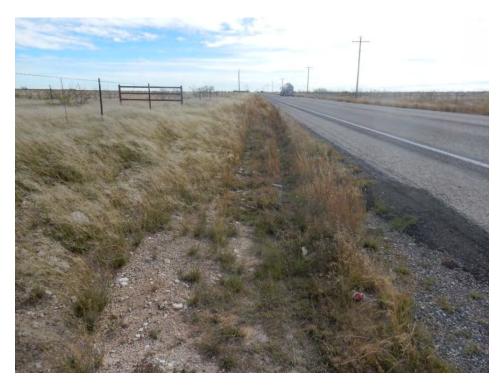
Guadacanal Site Viewing South, November 6, 2017
