## Release Notification

Site Name: Red Hills 32 Federal Com	Site Type: Battery
Date Release Discovered: 9/14/2023	API# (if applicable)

# Liner Integrity Certification

## Daily Site Visit Report

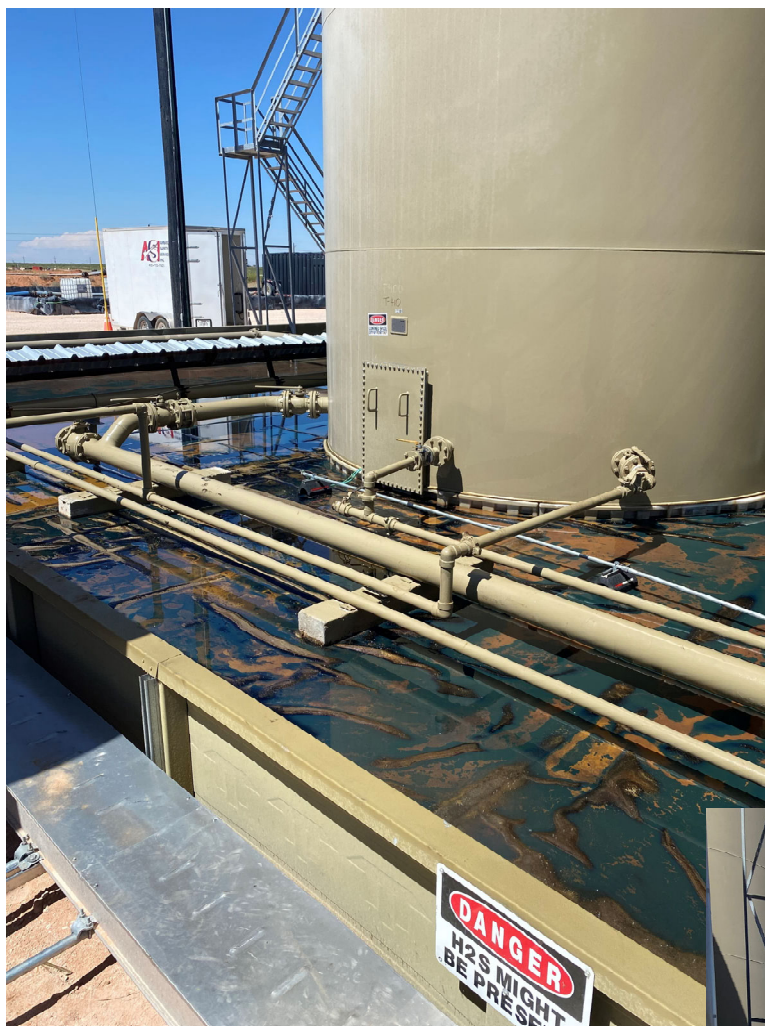
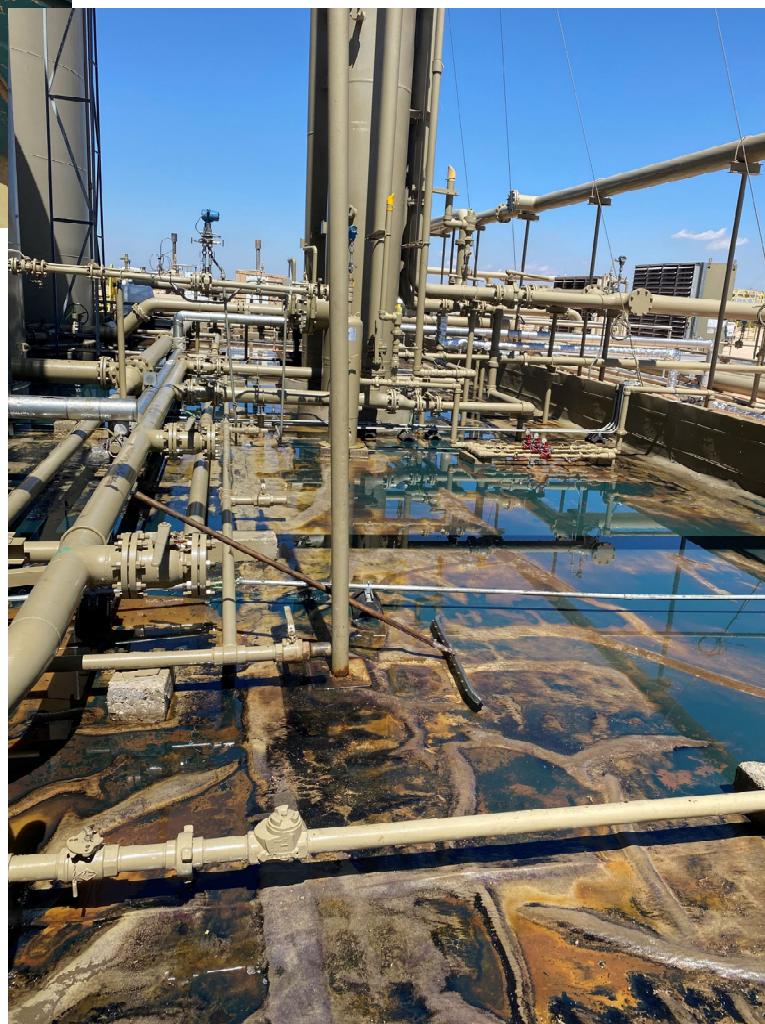
CIMAREX ENERGY  
RED HILLS 32-5 FED COM CTB  
LEA, NM

- ☒ Responsible Party has visually inspected the liner.
- ☒ Liner remains intact and was able to contain the leak in question.
- ☒ At least two business days' notice was given to the appropriate division district office before conducting the liner inspection.
- ☒ Photographs illustrating liner integrity are included.
