COTTON DRAW 14 BATTERY

April 25, 2024

RE: Liner Inspection and Closure Report
Cotton Draw 14 Battery
API No. N/A
GPS : Latitude 32.13675214 Longitude -103.7534162
UL- D, Section 14, Township 25S, Range 31E
Eddy County, NM
NMOCD Reference No. NAPP2410024170

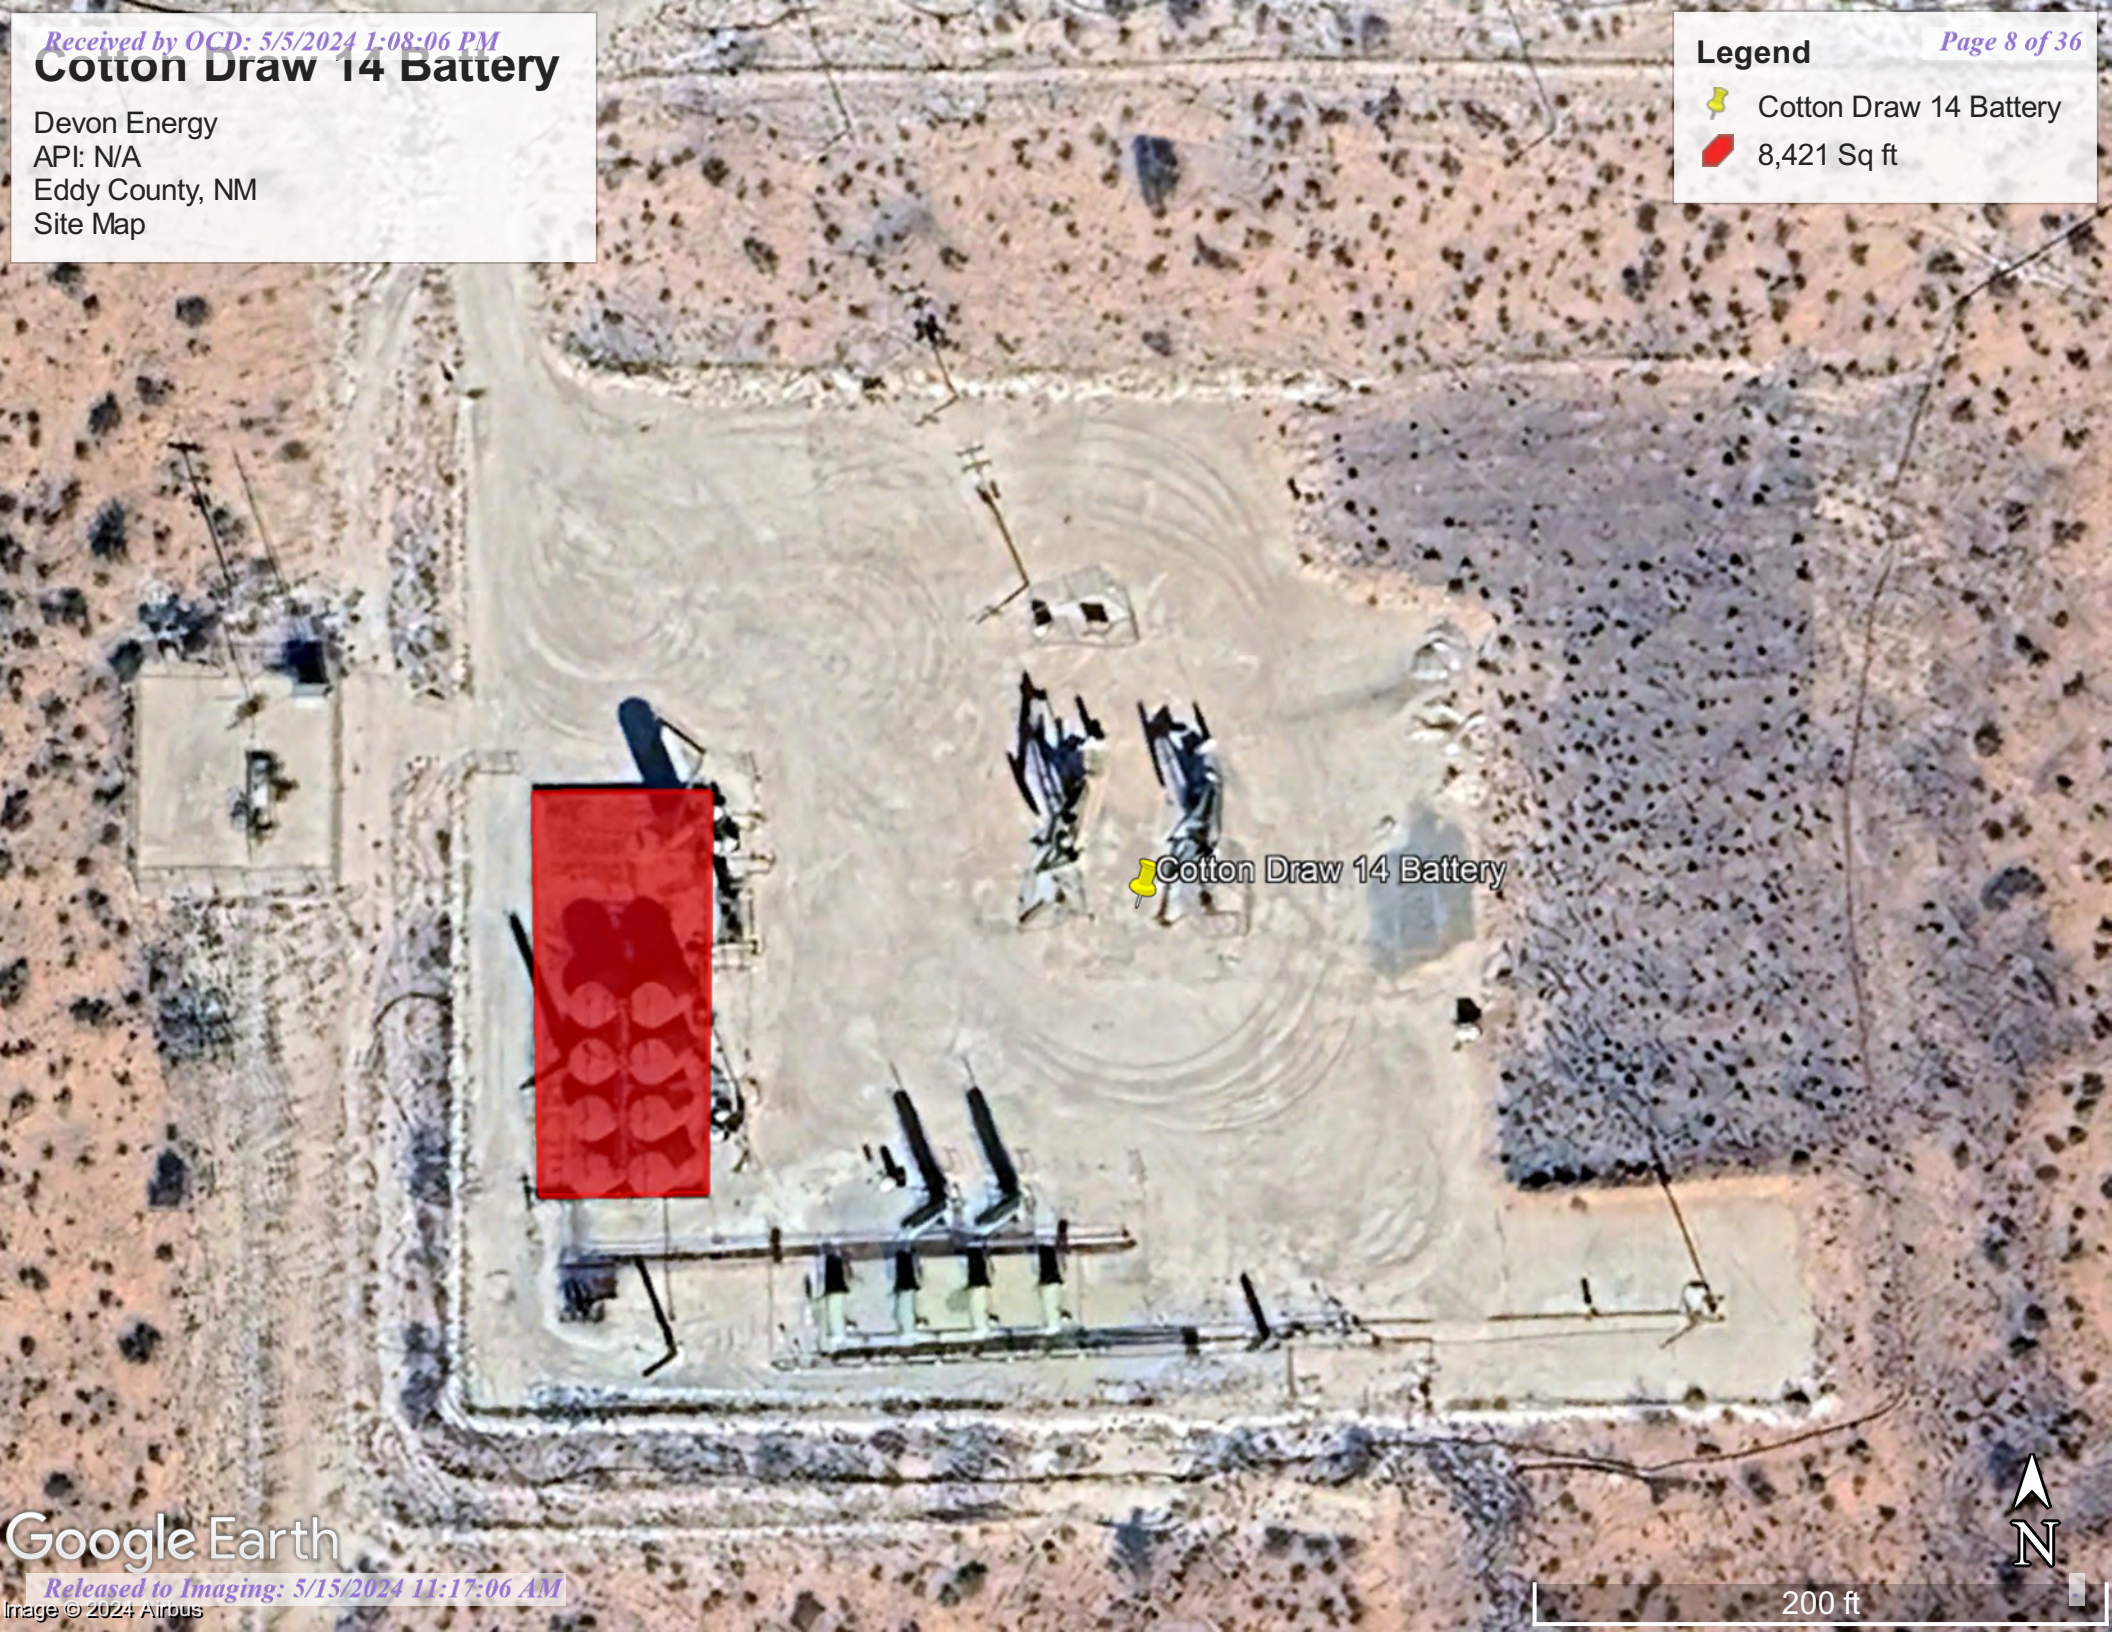
Devon Energy
API: N/A
Eddy County, NM
Site Map

NAPP2410024170: On April 5, 2024, there was a leak on a water transfer pump. Approximately 6 barrels (bbls) of produced water were released from the pump, into the lined containment. A vacuum truck was called and was able to recover 6 bbls of standing fluid. The liner was visually inspected by Devon field staff for any pinholes or punctures; none were found. Based on this inspection there is no evidence that the spilled fluids left containment.
