SUBJECT: Liner Inspection and Closure Report for Cotton Draw Unit 219 Battery – May 16, 2025 Site Visit

Incident ID: nAPP2511826834  
Facility ID (Name): fAPP2123135798 (COTTON DRAW UNIT 219 CTB)  
Facility Location: Unit M of Section 2, Township 25 South, Range 31 East, New Mexico  
Facility GPS Coordinates: 32.152331, -103.743680  
Eddy County, New Mexico

# Environmental Liner Inspection Field Notes & Photolog Report

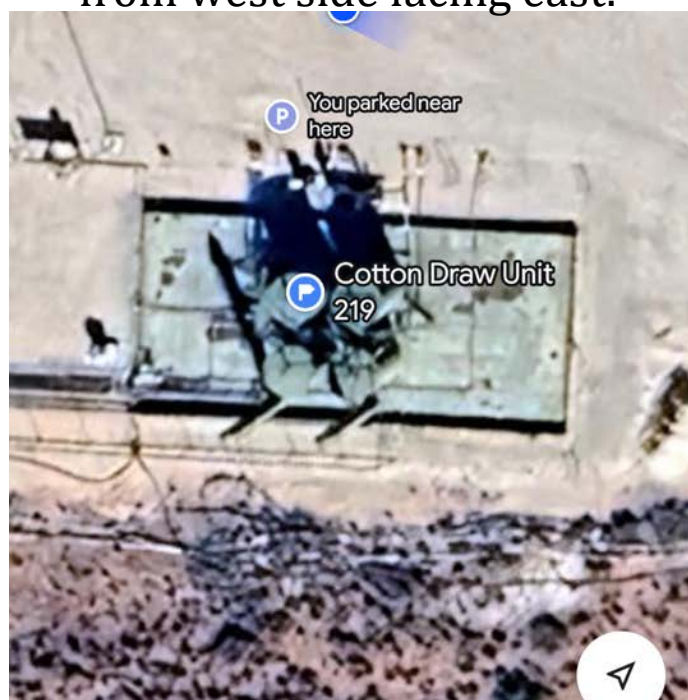
Aerial view of containment screenshot from google maps.

- Upload documents to folder
- Compile data and start drafting closure report
- Submit report for approval
- Liner integrity is confirmed. No signs of degrading or wear and tear of liner, photos taken as visual observation
- Liner is capable of containing fluids from going onto the ground outside of the secondary containment.
