Subject: Liner Inspection Report for Nageezi Unit H33

MPLX submits this Liner Inspection Report for the Nageezi Unit H33 release (nAPP2514851289) which describes the release, corrective actions, and the results of the liner inspection at the site.

Liner Inspection Report
Nageezi Unit H33 Release (nAPP2514851289)

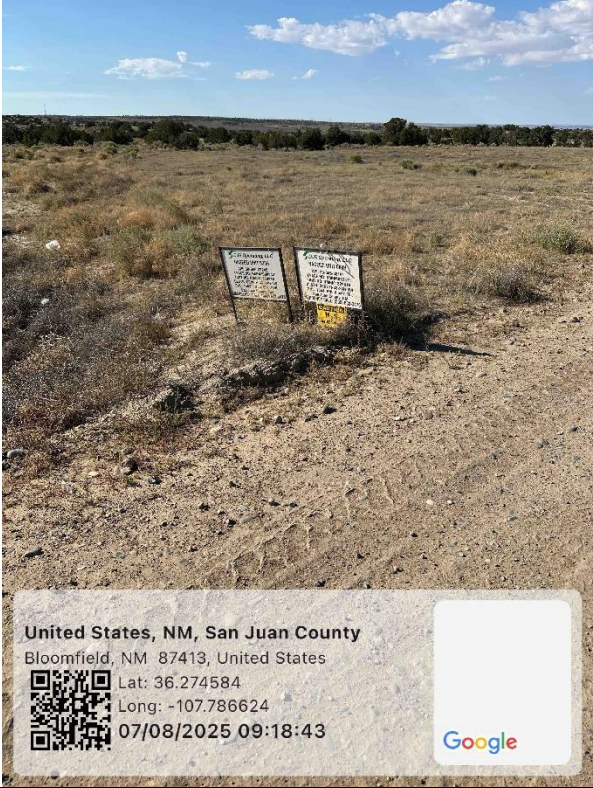
Description: Well signs at entrance to location. *Note: Date format from app on all photos is DD/MM/YYYY.
Incident: nAPP2514851289		
GPS: 36.27432, -107.78736		
Date of Photo: 8/7/2025		
Taken by: Heather Woods		
Site: Nageezi Unit H33
