## Release Assessment and Closure

Mustang 8 CTB 3

FAPP2510041275

Devon Energy Production Company, LP

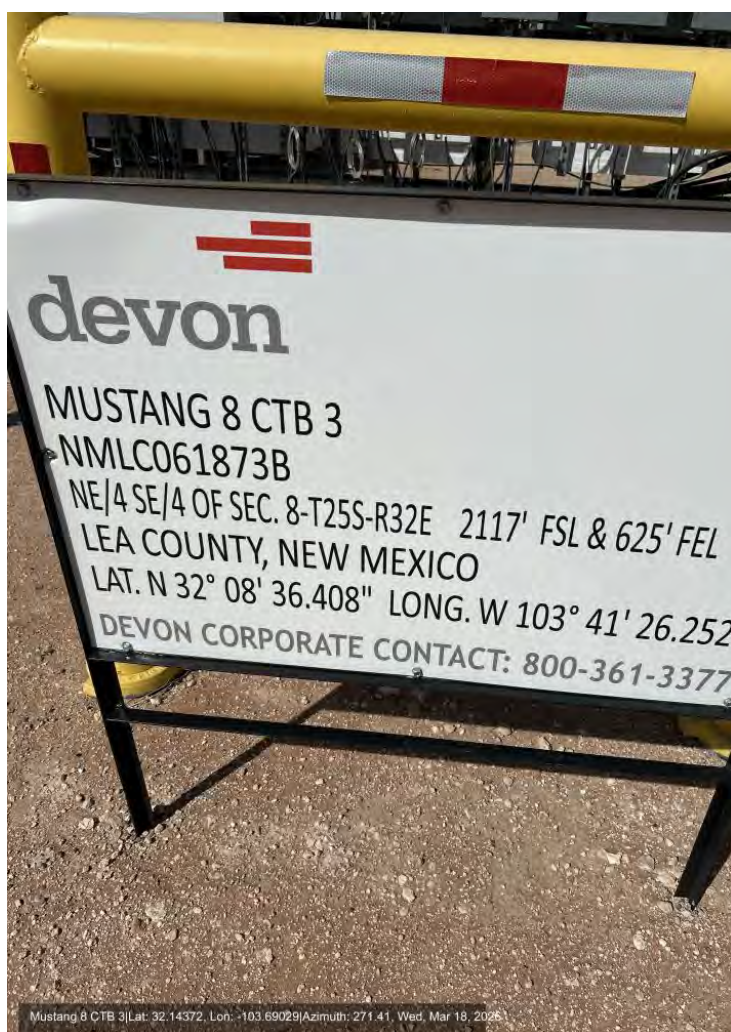
Date: 3/18/2026  
 Time: 10:42  
 Notes: Site Information placard.  
 Latitude: 32.14371944444444  
 Longitude: -103.69028611111112  
 Direction: N
