Our Ref.: 12679377 – NMOCD – 2

April 15, 2026

Closure Report
Devon Energy Production Company, LP
Exmoor 15 CTB 2
Unit Letter A, Section 15, TS25, R31E
GPS: 32.134225, -103.757538
Eddy County, New Mexico

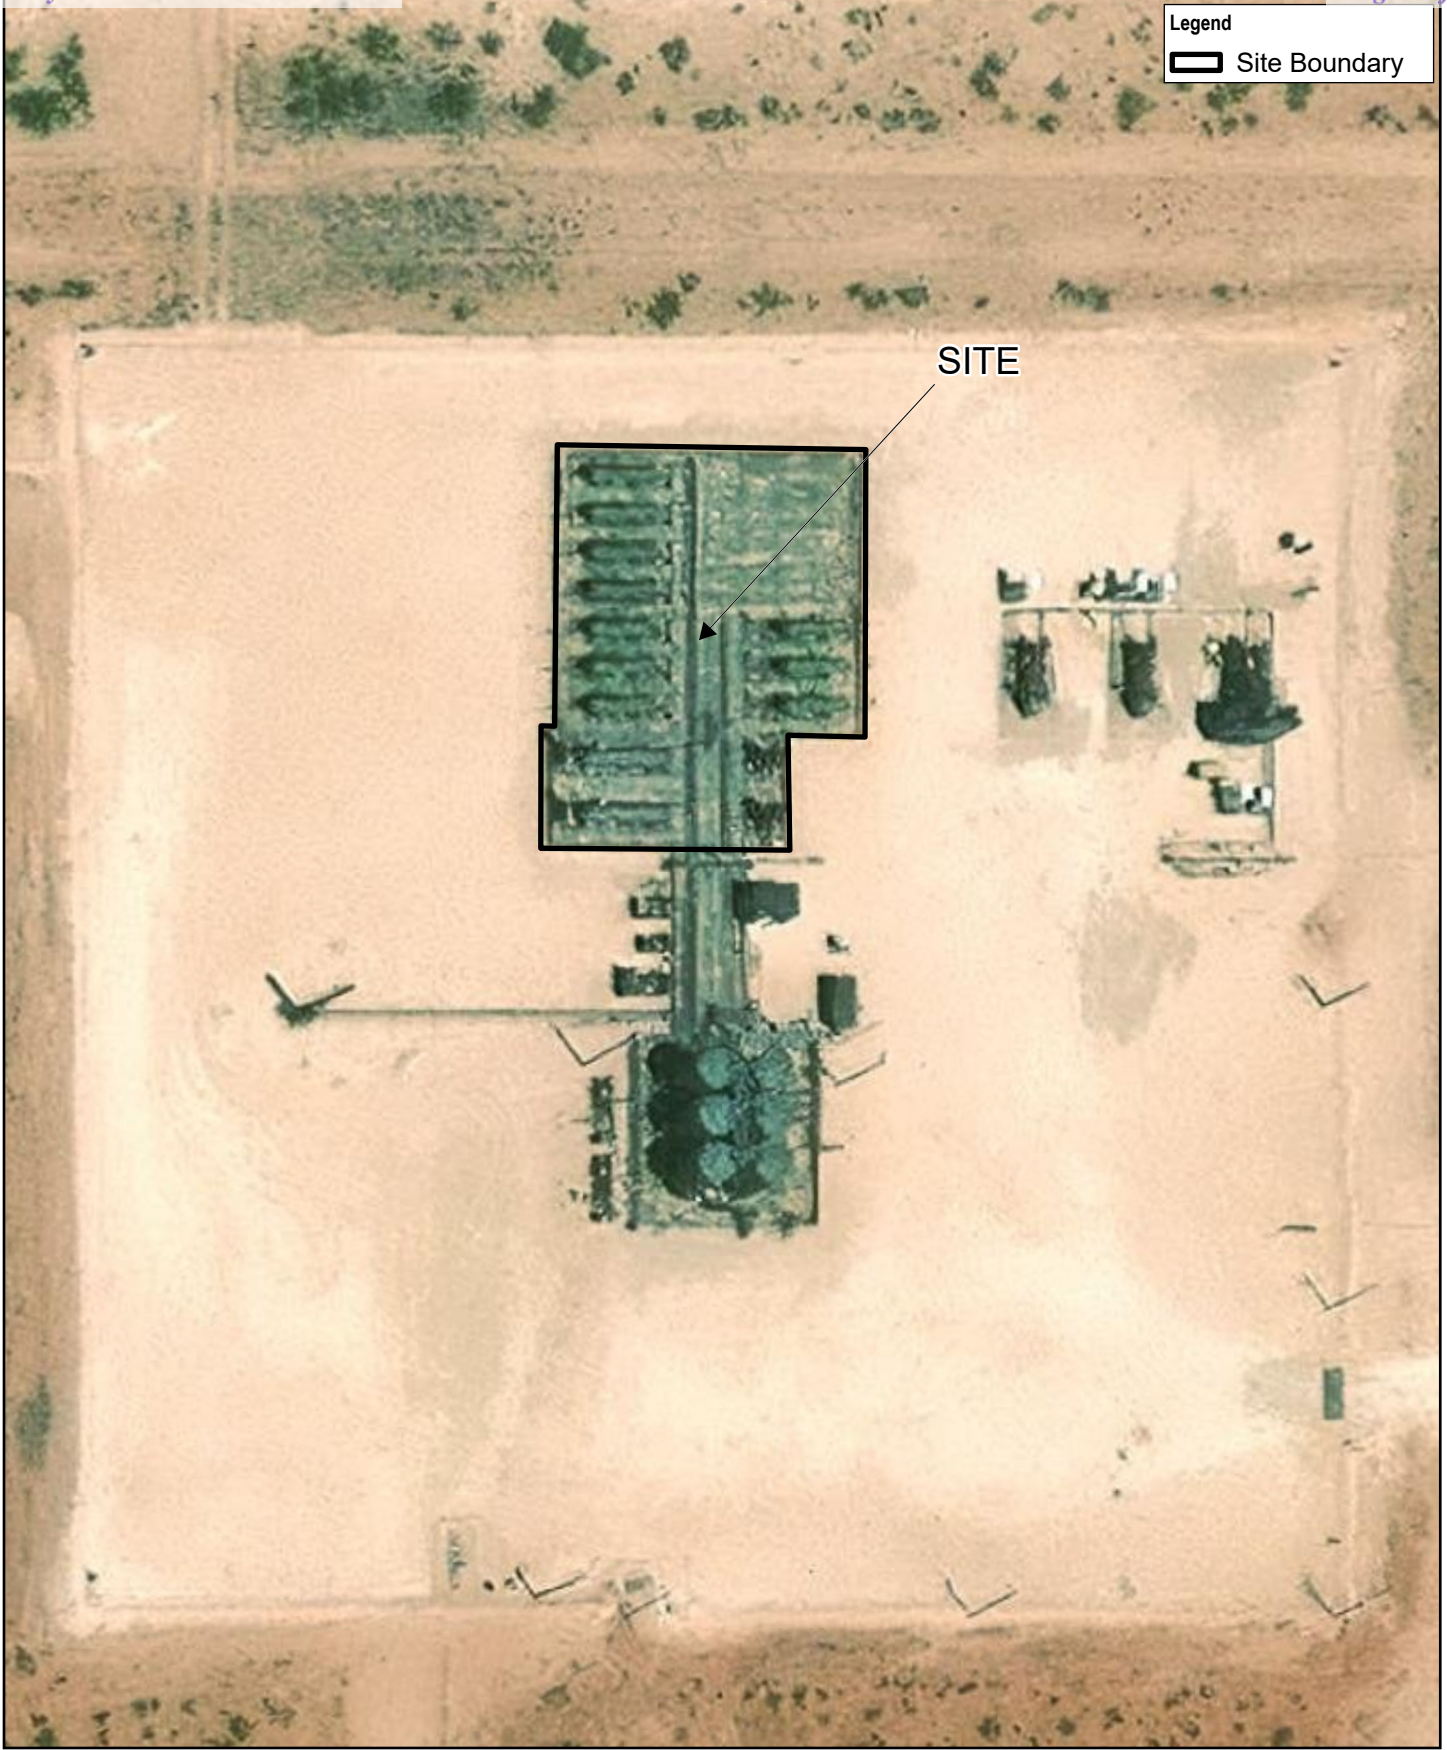
FIGURE 2

The Site is not within 300 feet of any continuously flowing watercourse or any other significant watercourse. There are no lakebeds, sinkholes or playa lakes within 200 feet of the Site. The closest playa is approximately 0.50 miles west of the Site, and the nearest riverine wetland is approximately 3.65 miles southwest. There are no permanent residences, schools, hospitals, institutions or churches within 300 feet of the Site. The closest residence is approximately 4.69 miles southeast of the Site. The nearest fresh water well utilized for livestock watering is approximately 2.04 miles southwest of the Site. There are no subsurface mines or 100-year floodplains within 300 feet of the Site. The location of the Site is depicted on **Figure 1**. A detailed map of the Site is provided on **Figure 2**. The Site Characterization Documentation is included in **Attachment 2**.
