**Wingate Fractioner BGT
Retrofit Proposal**

RE: Wingate Fractionator Below Grade Tank Retrofit Proposal

Wastewater Below Grade Tank Retrofit Closure Report Outline

Ground Water Discharge Plan – GW 54

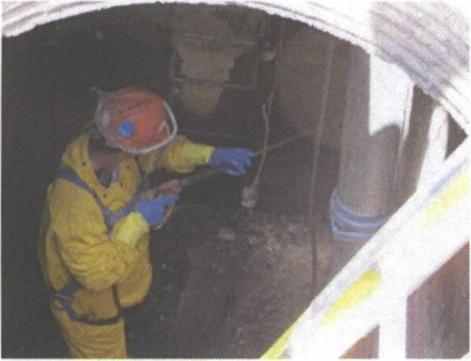
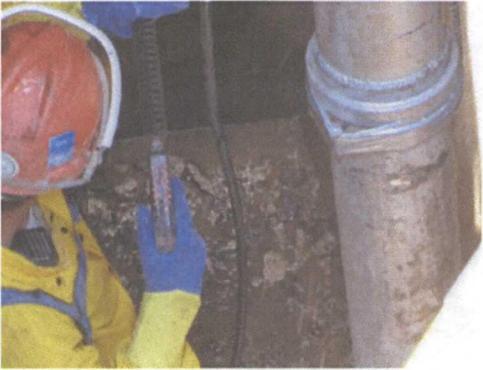
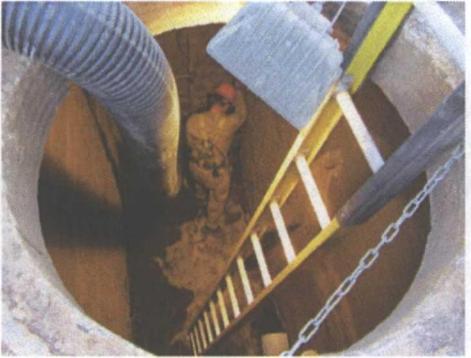
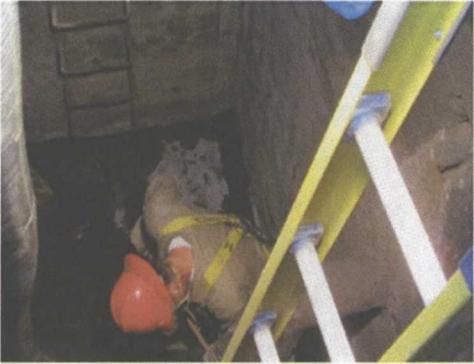
Appendix B
Water Rinsing and Sand Blasting

4. All waste from this rinse was sent to the evaporation ponds.
5. Various small cracks, pitting of the cement and scale build up on the walls were observed. Some cracks have sealant. No signs of seepage on the walls or floor.

7. The bgt walls, floor and extruding pipes were sand blasted to remove loose concrete, scale and to etch the surface. (**Appendix B**)
8. A large area of scale was removed by the sandblasting work and a slight weep was detected. This area was cleaned, a sealant applied and filled with cement. (**Appendix C; C1 & C2**)
