# SITE INFORMATION

## Report Type: Work Plan

Site:	BKU #146 Flowline					
Company:	COG Operating LLC					
Section, Township and Range	Unit B	Sec. 30	T-17-S	R-30-E		
Lease Number:	API 30-015-04394					
County:	Eddy County					
GPS:	32.81208° N			104.00906° W		
Surface Owner:	Federal					
Mineral Owner:						
Directions:	Intersection of Hwy 82 and CR-216 (west of Loco Hills), south on CR-216 0.6 mi, left on Lacey C 0.6 mi, left 500' to location.

**Re: Work Plan for the COG Operating LLC., BKU #146 Flow line, Unit B, Section 30, Township 17 South, Range 30 East, Eddy County, New Mexico.**

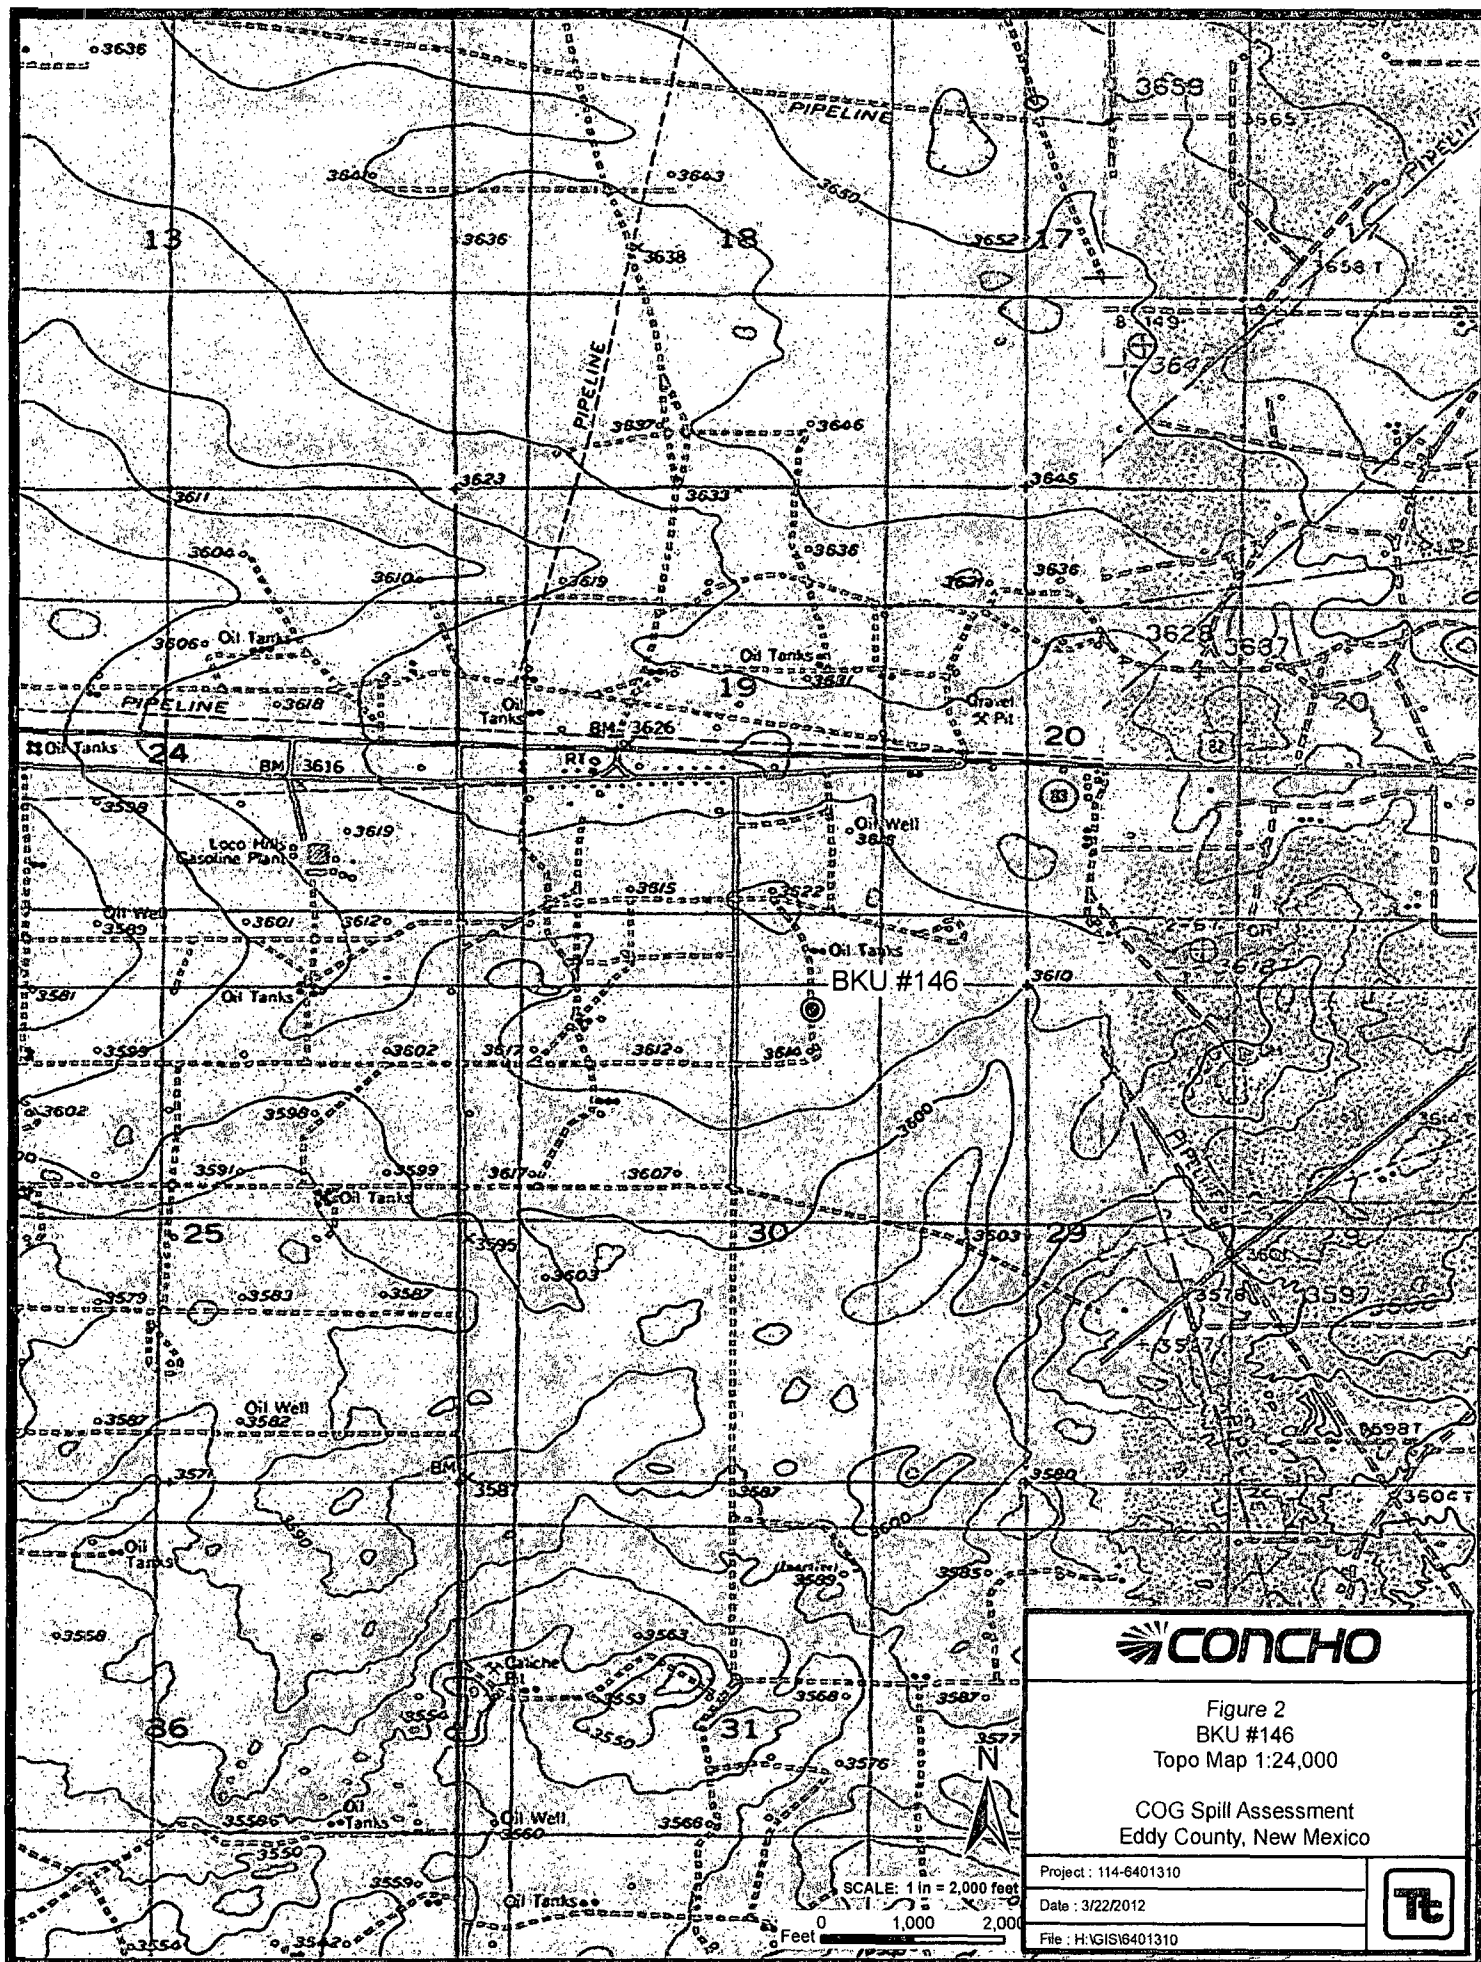
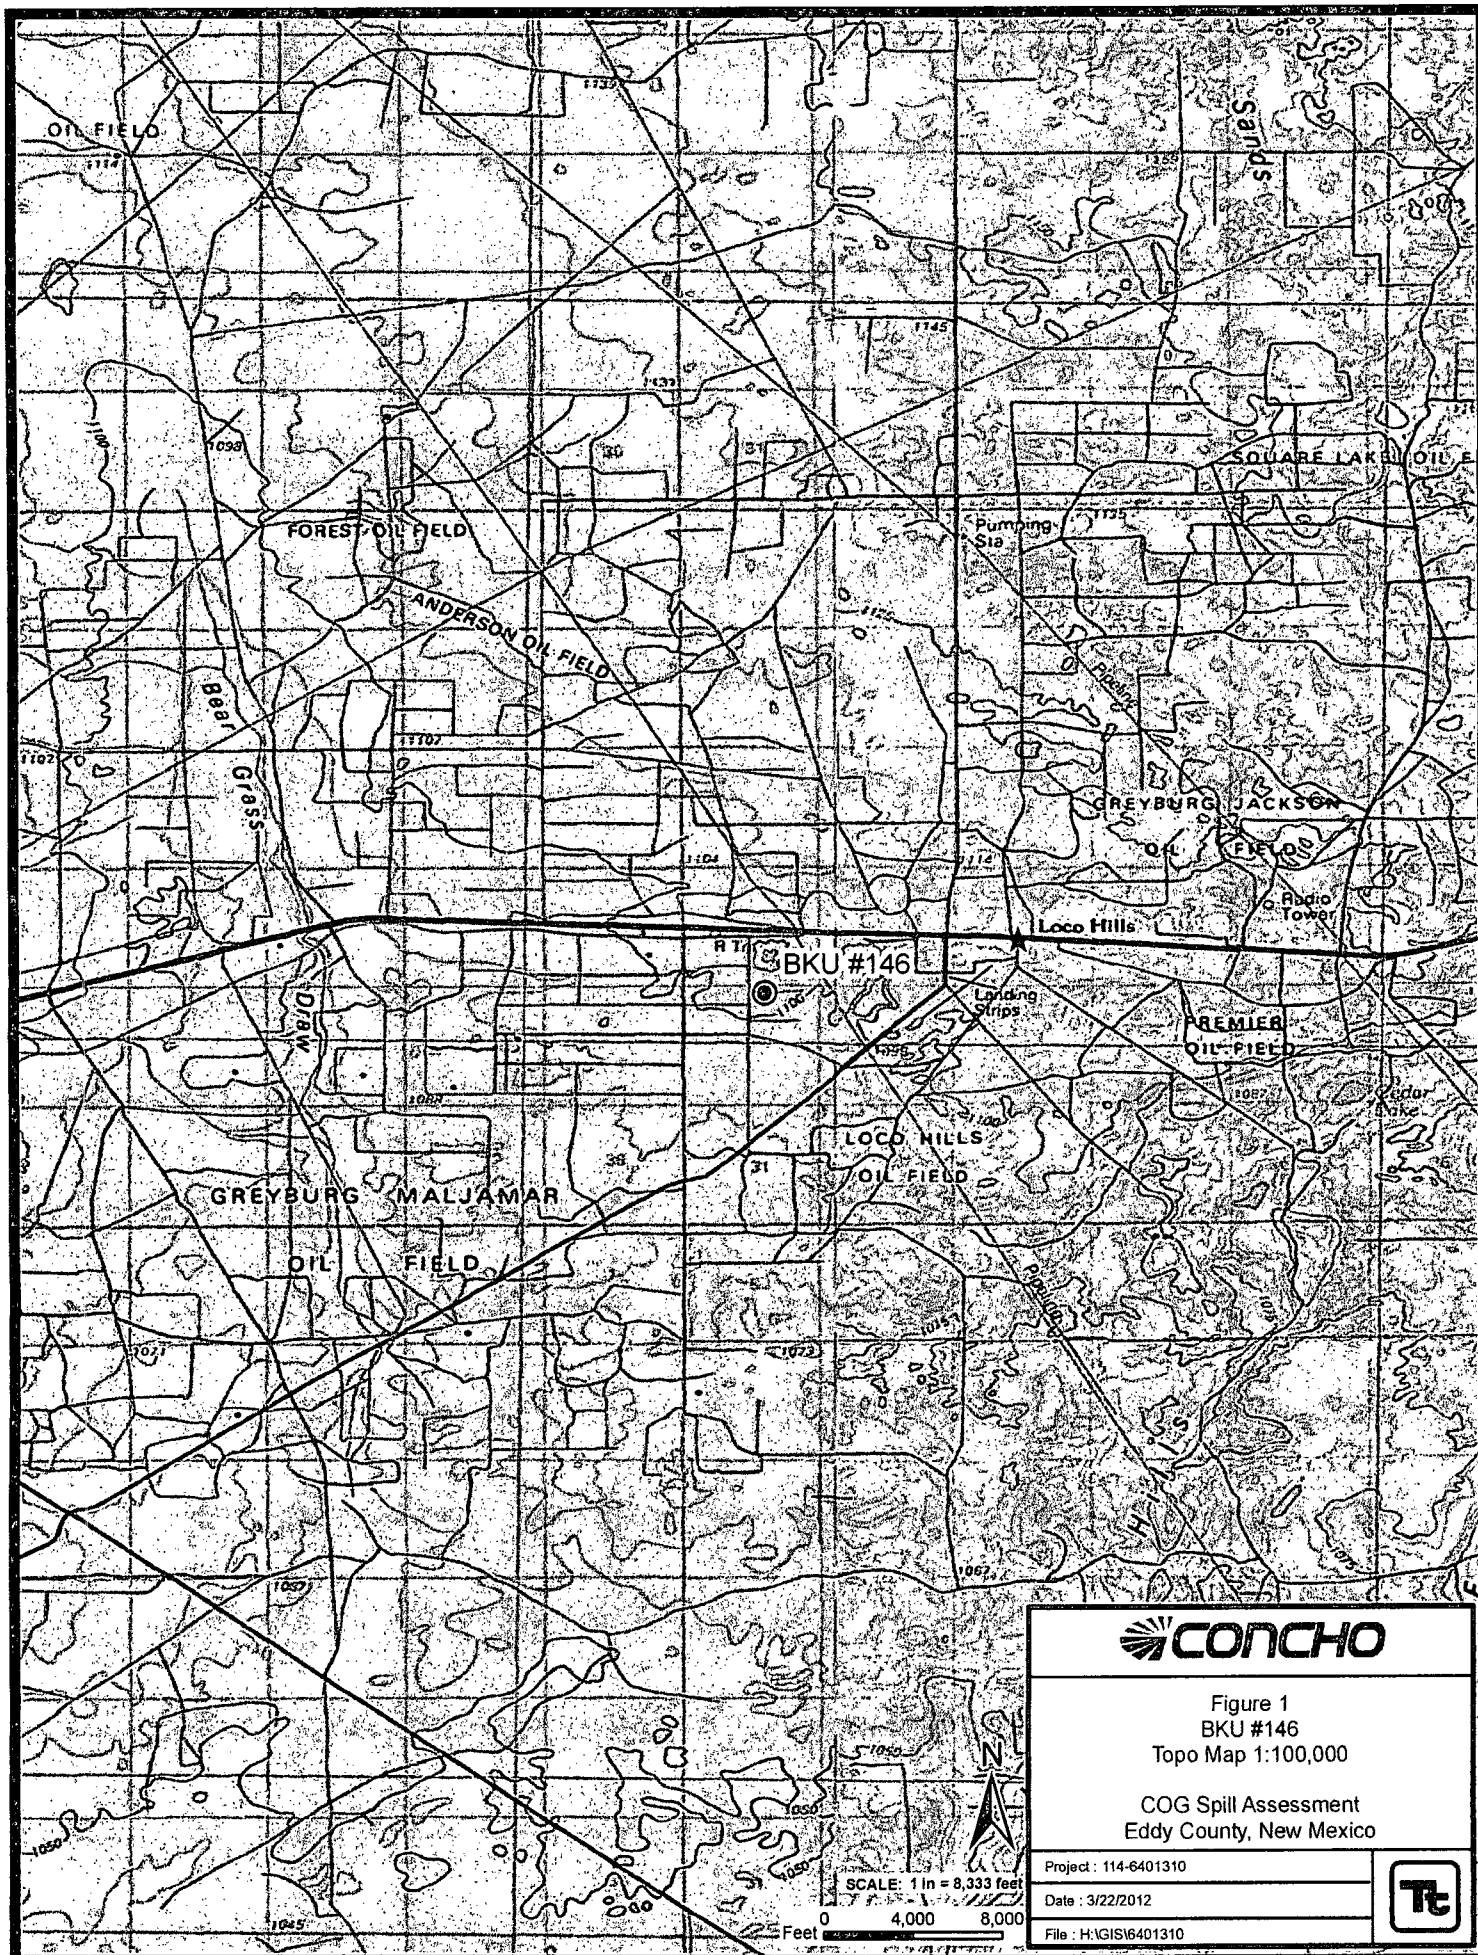
Figure 1  
BKU #146  
Topo Map 1:100,000

Tetra Tech, Inc. (Tetra Tech) was contacted by COG Operating LLC. (COG) to assess a spill from the BKU #146 Flow line, Unit B, Section 30, Township 17 South, Range 30 East, Eddy County, New Mexico. (Site). The spill site coordinates are N 32.81208°, W 104.00906°. The site location is shown on Figures 1 and 2.

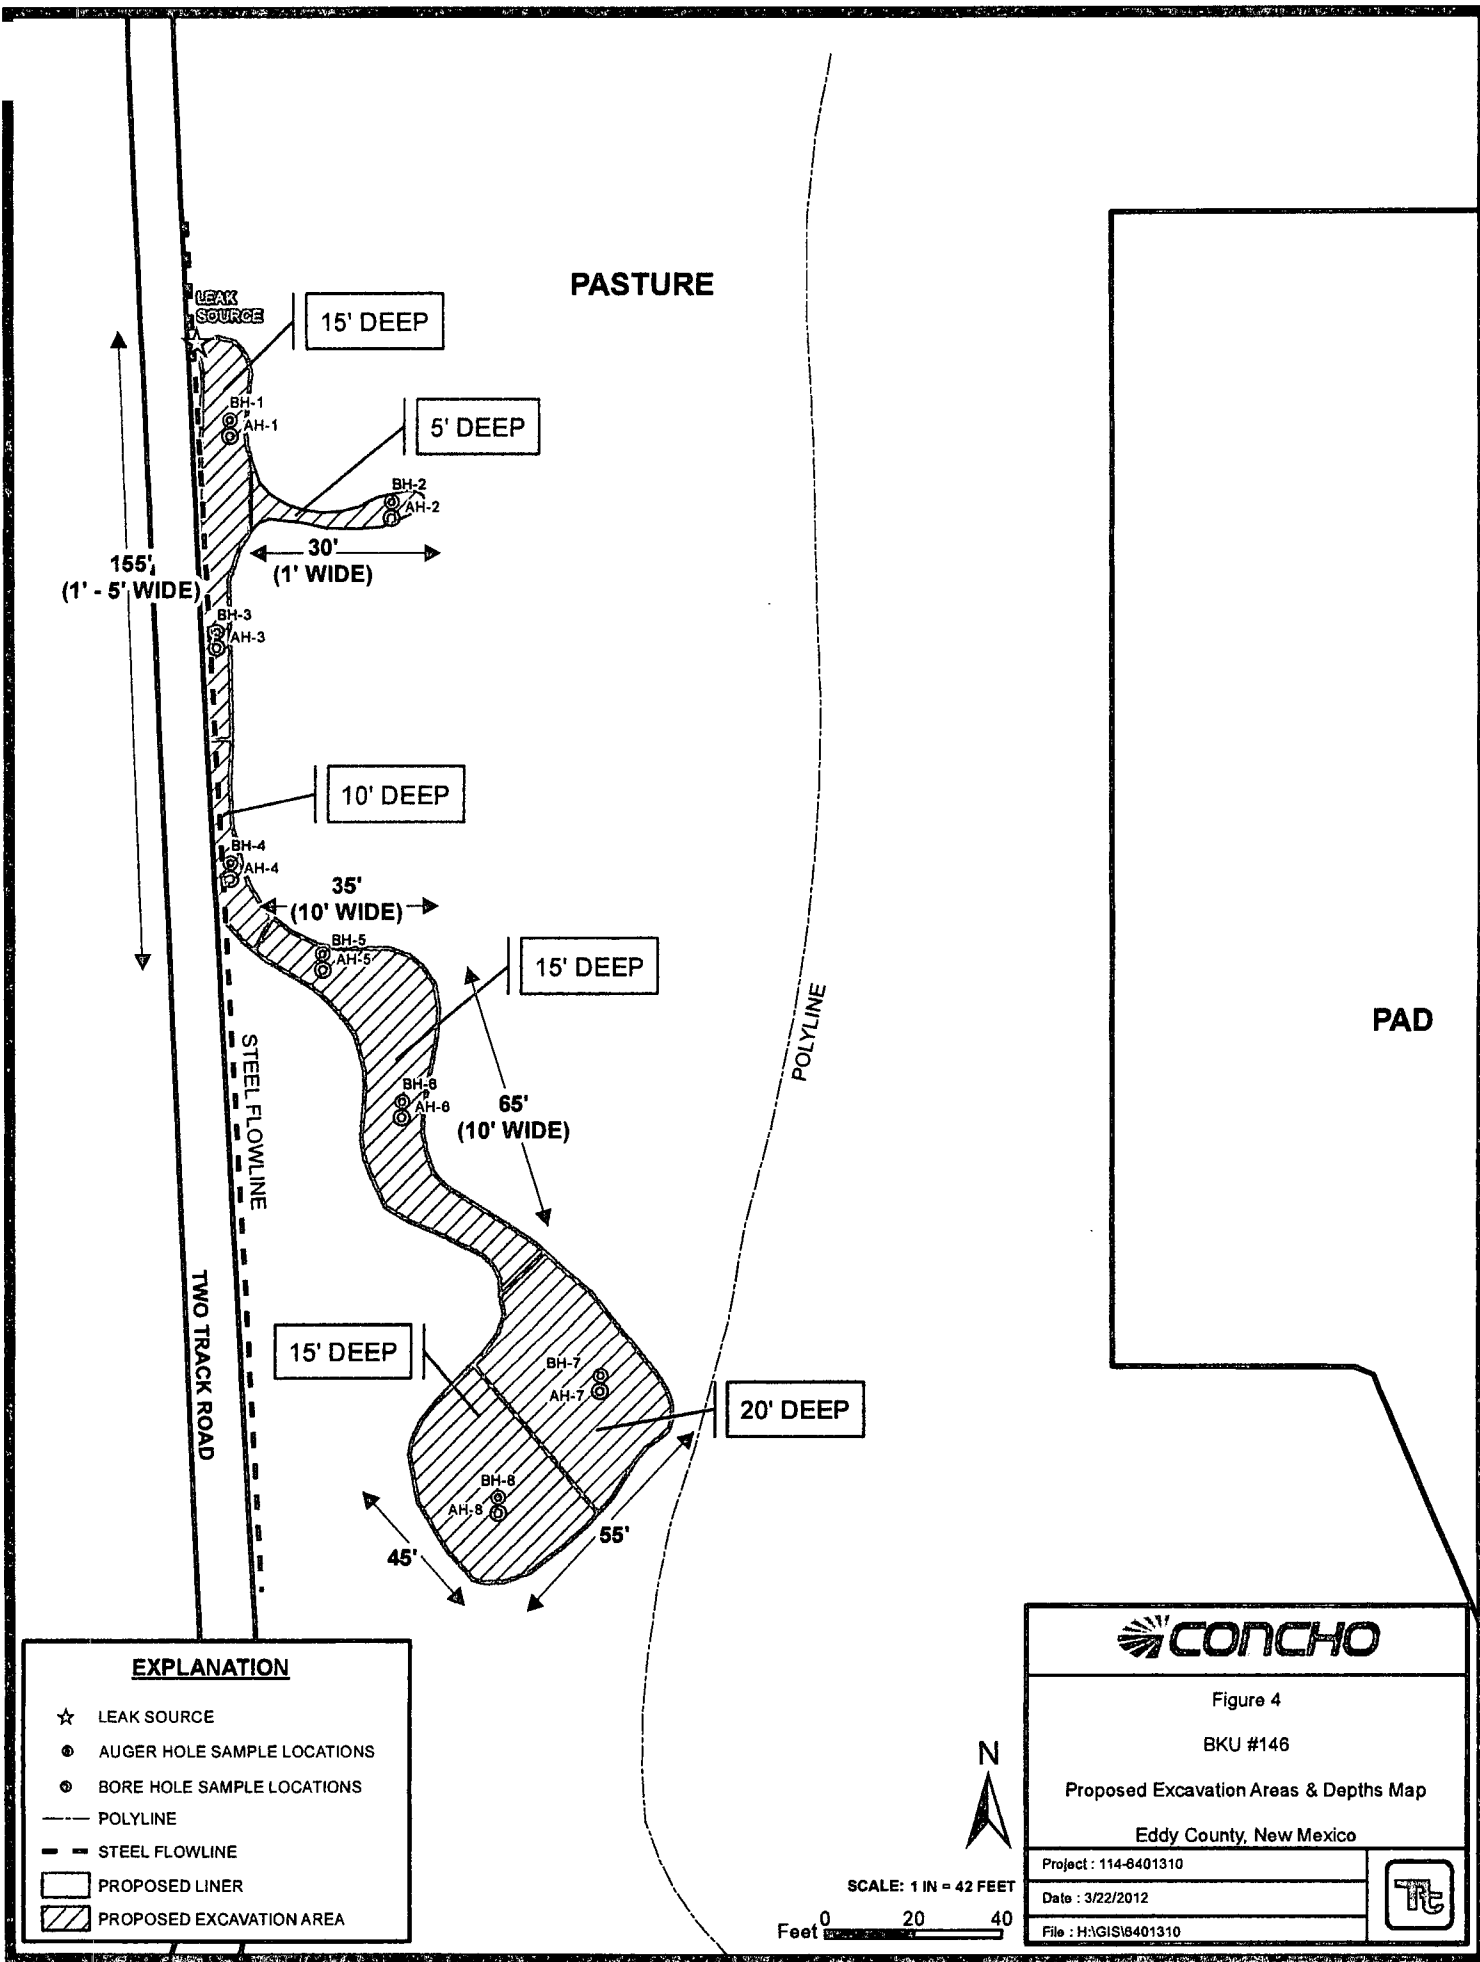
On March 8, 2011, Tetra Tech personnel inspected and sampled the spill area. Eight (8) auger holes (AH-1 through AH-8) were installed using a stainless steel hand auger to assess the impacted soils. Soil samples were collected at 0-1' below surface and deeper samples could not be collected due to a shallow dense caliche. Selected samples were analyzed for TPH analysis by EPA method 8015 modified, BTEX by EPA Method 8021B and chloride by EPA method 300.0. Copies of laboratory reports and chain-of-custody documentation are included in Appendix C. The sampling results are summarized in Table 1. The auger hole locations are shown on Figure 3.

LEAK  
SOURCE
