| | Burk Royalty Co., Ltd | Release Report<br>Cruces No. 6<br>API 025-02462<br>Lea County, New Mexico | <b>Site Location</b><br><small>Date created: 03.26.2014<br/>Revised by: J. Van Dyke</small> |

BURK ROYALTY CO., LTD  
CRUCES #6- API 025-02462  
SITE PHOTOS  
February 18, 2014

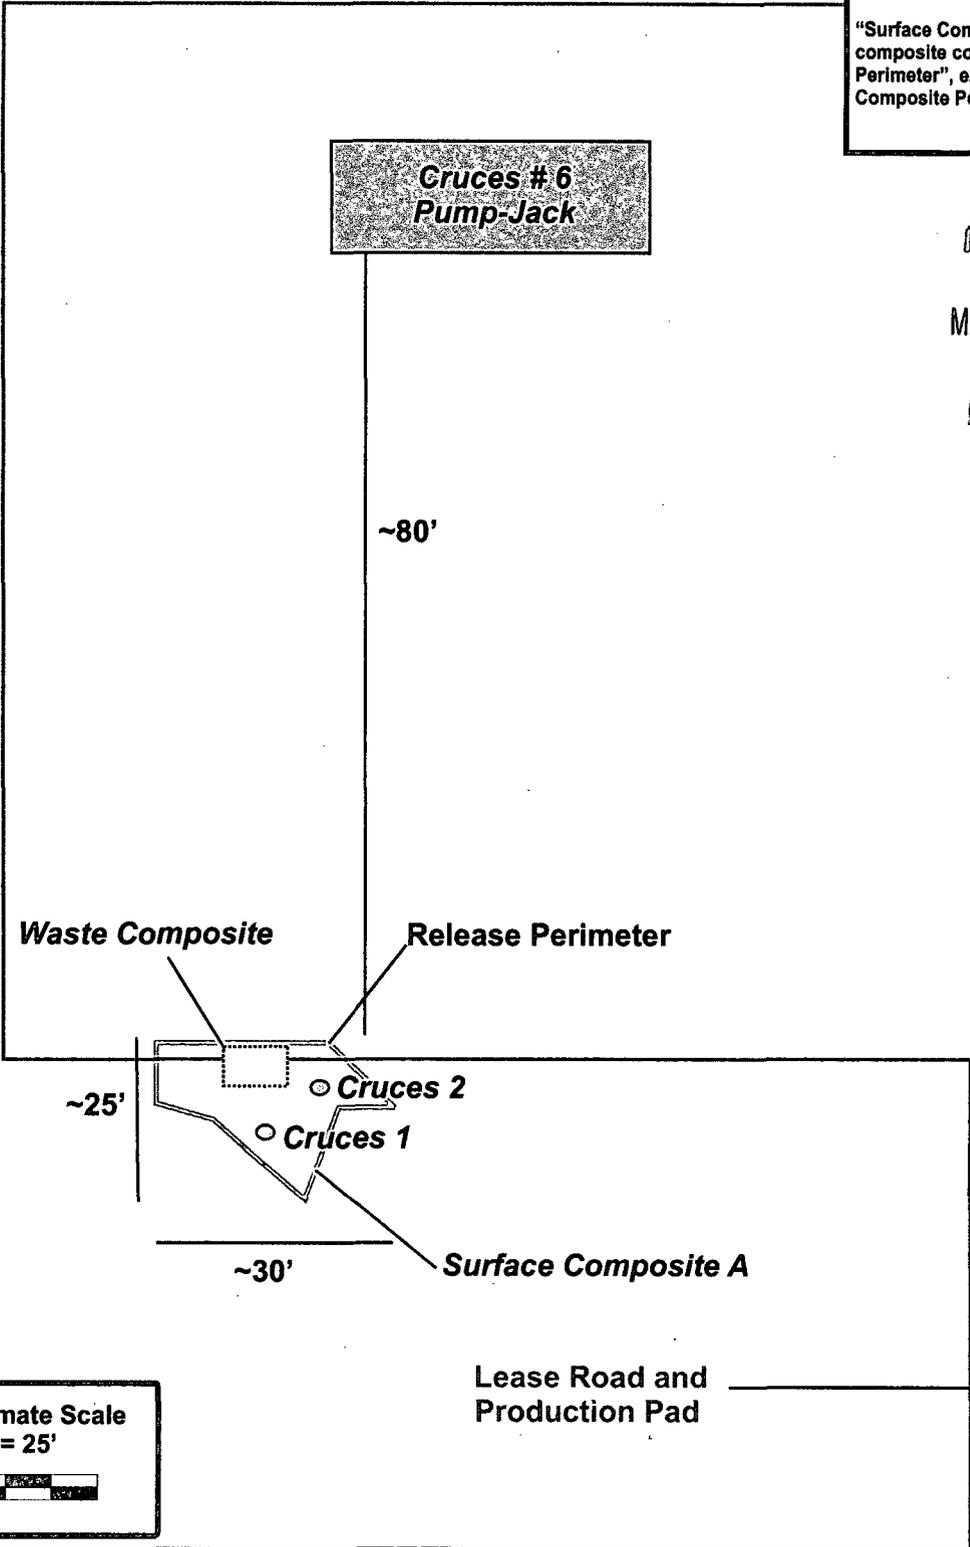
| | CLIENT | PROJECT DESCRIPTION | FIGURE 2 |

**Notes**  
"Waste Composite" is a 5-part composite collected within the given boundary.  
"Surface Composite A" is a 5-part composite collected within the "Release Perimeter", excluding the "Waste Composite Perimeter".
