Release Notification and Corrective Action

Name of Company: BOPCO, L.P. 2100731	Contact: Tony Savoie
Address: 522 W. Mermod, Suite 704 Carlsbad, N.M. 88220	Telephone No. 575-887-7329
Facility Name: Poker Lake Unit 347H	Facility Type: Exploration and Production

FIELD SPILL REPORT

LOCATION OF SPILL SITE: PLU 347H API 30-015-38668 (UL "C" 11-25S-30E) 540 FNL & 1440 FWL

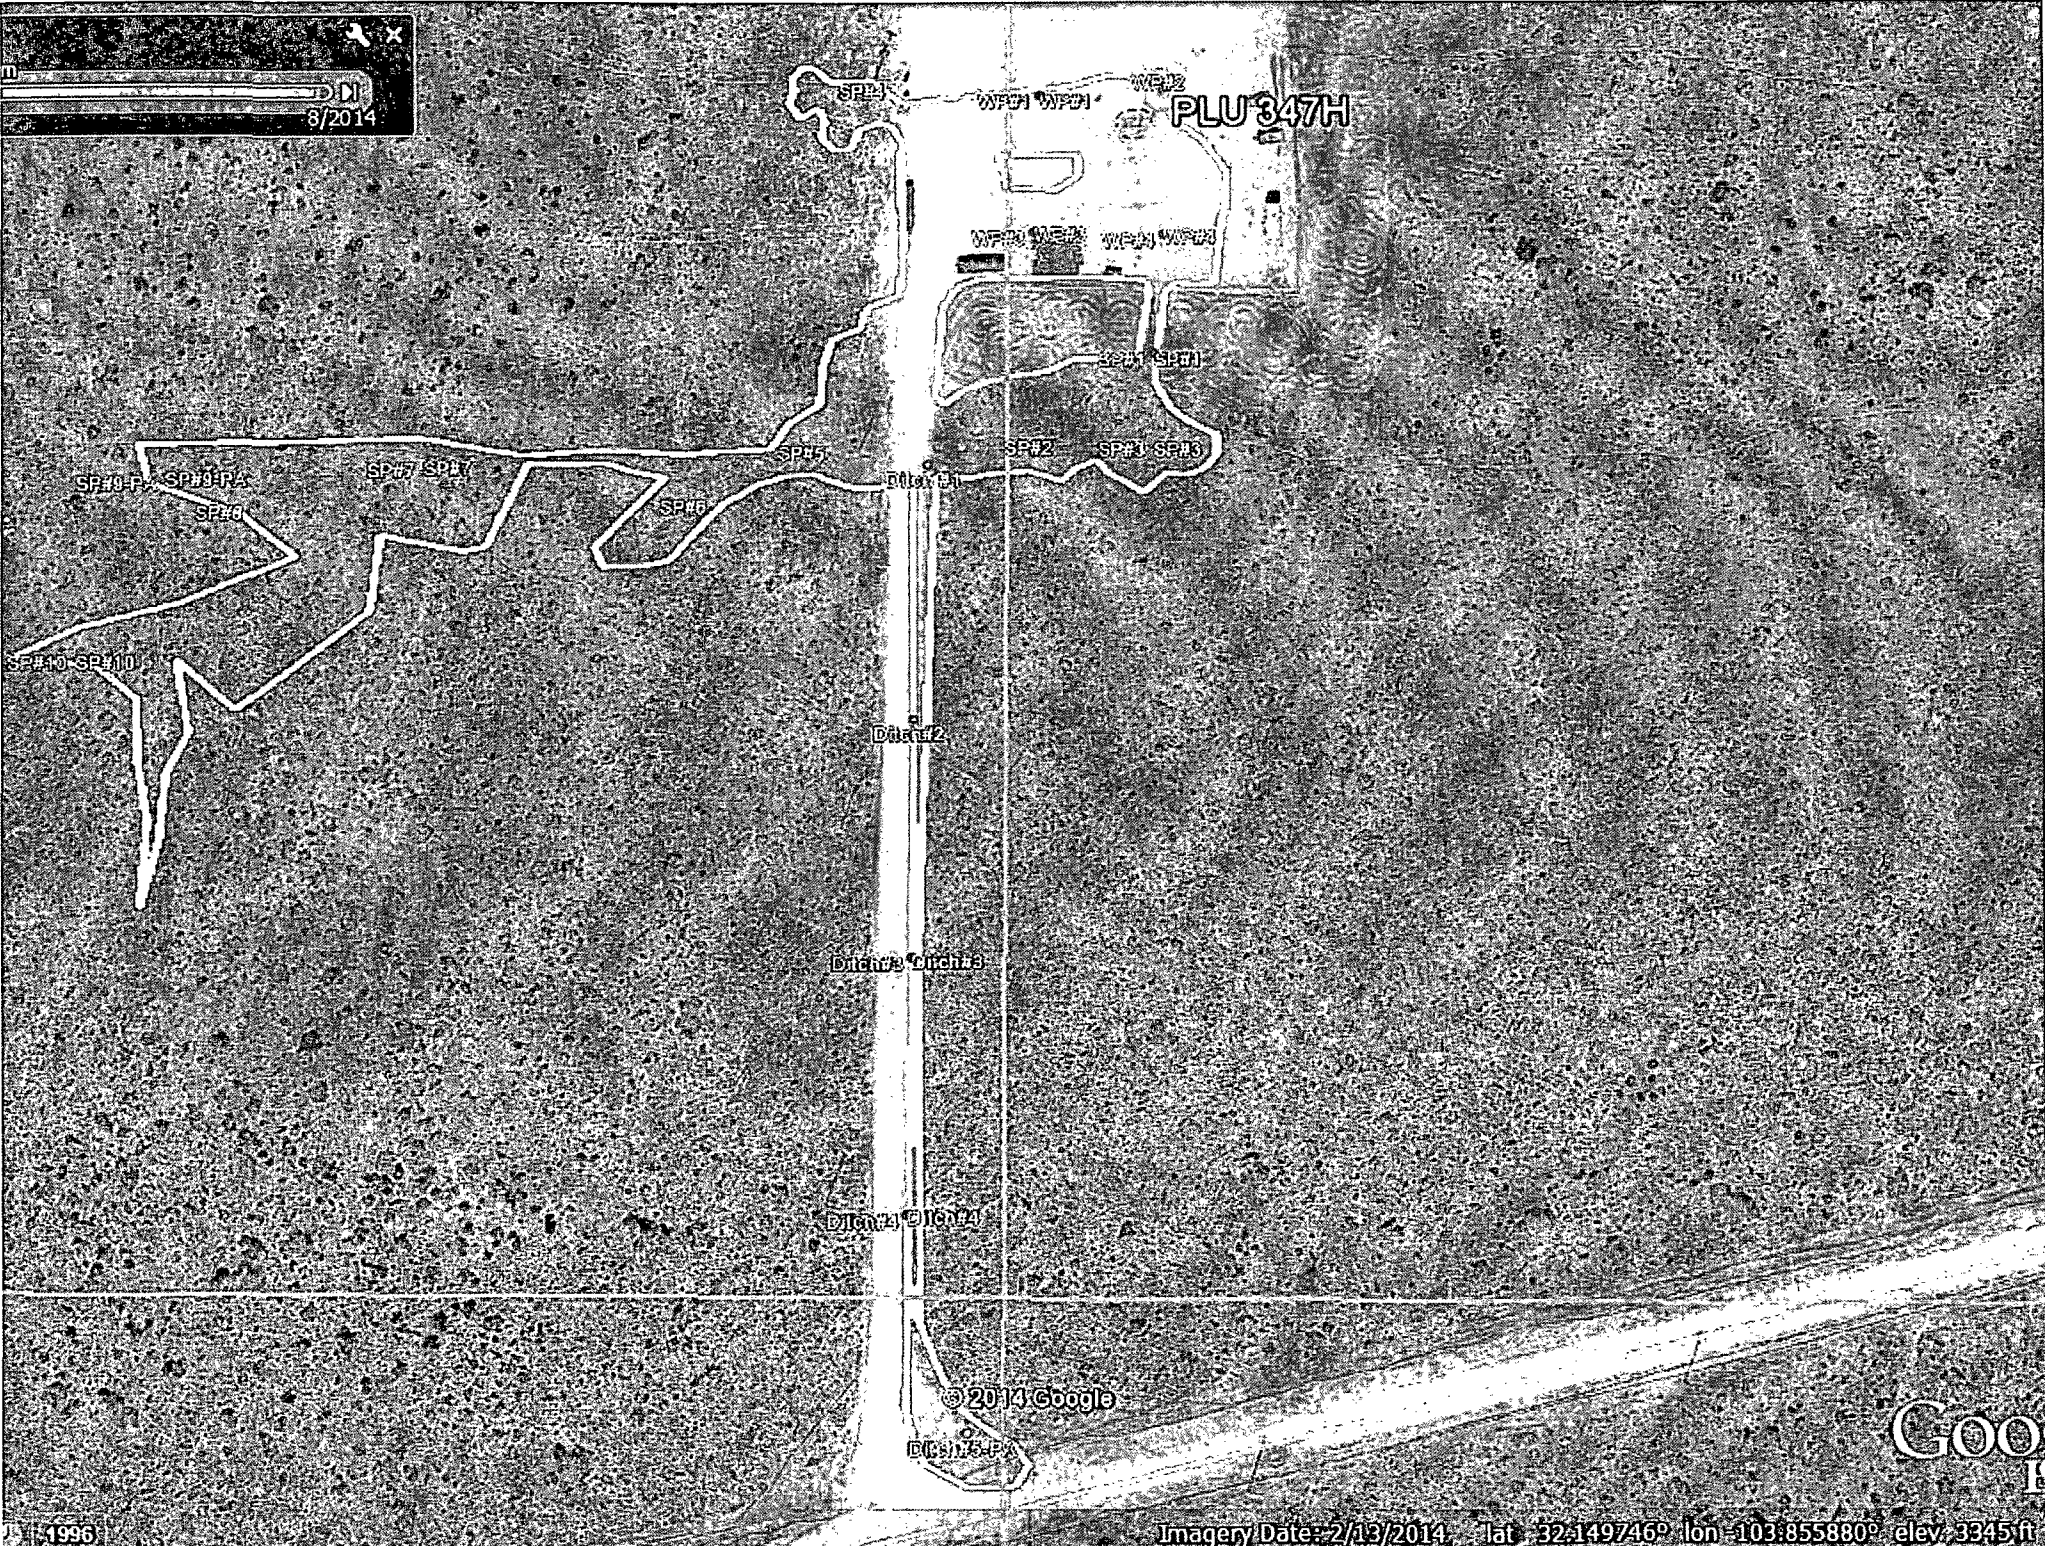
A hammer union on tubing side of the well head caused the leak. The leak covered an area of about 80,900 sq ft, of which 53,700 was in the pasture to the west and south of the site. Estimating a depth of one inch throughout the site, near 60 bbls oil remains in the soil.

Union repaired. Vac truck recovered 40 bbls total fluid (5 of which was oil) not sure yet how much was rain water or produced water.
