Release Notification and Corrective Action

Name of Company: Targa Midstream Services, L.P.	Contact: Don Embrey
Address: 6 Desta Drive, Suite 3300, Midland, TX 79705	Telephone No.: (432) 688-0555
Facility Name: Kennann 6" (Site #12)	Facility Type: Natural Gas Pipeline
Surface Owner: Winnie Kennann	Mineral Owner
Lease No.

Re: Spill Notification and Remediation Plan, Site #12, Targa Midstream Services, L.P., Unit Letter P (SE/4, SE/4), Section 30, Township 22 South, Range 38 East, Lea County, New Mexico

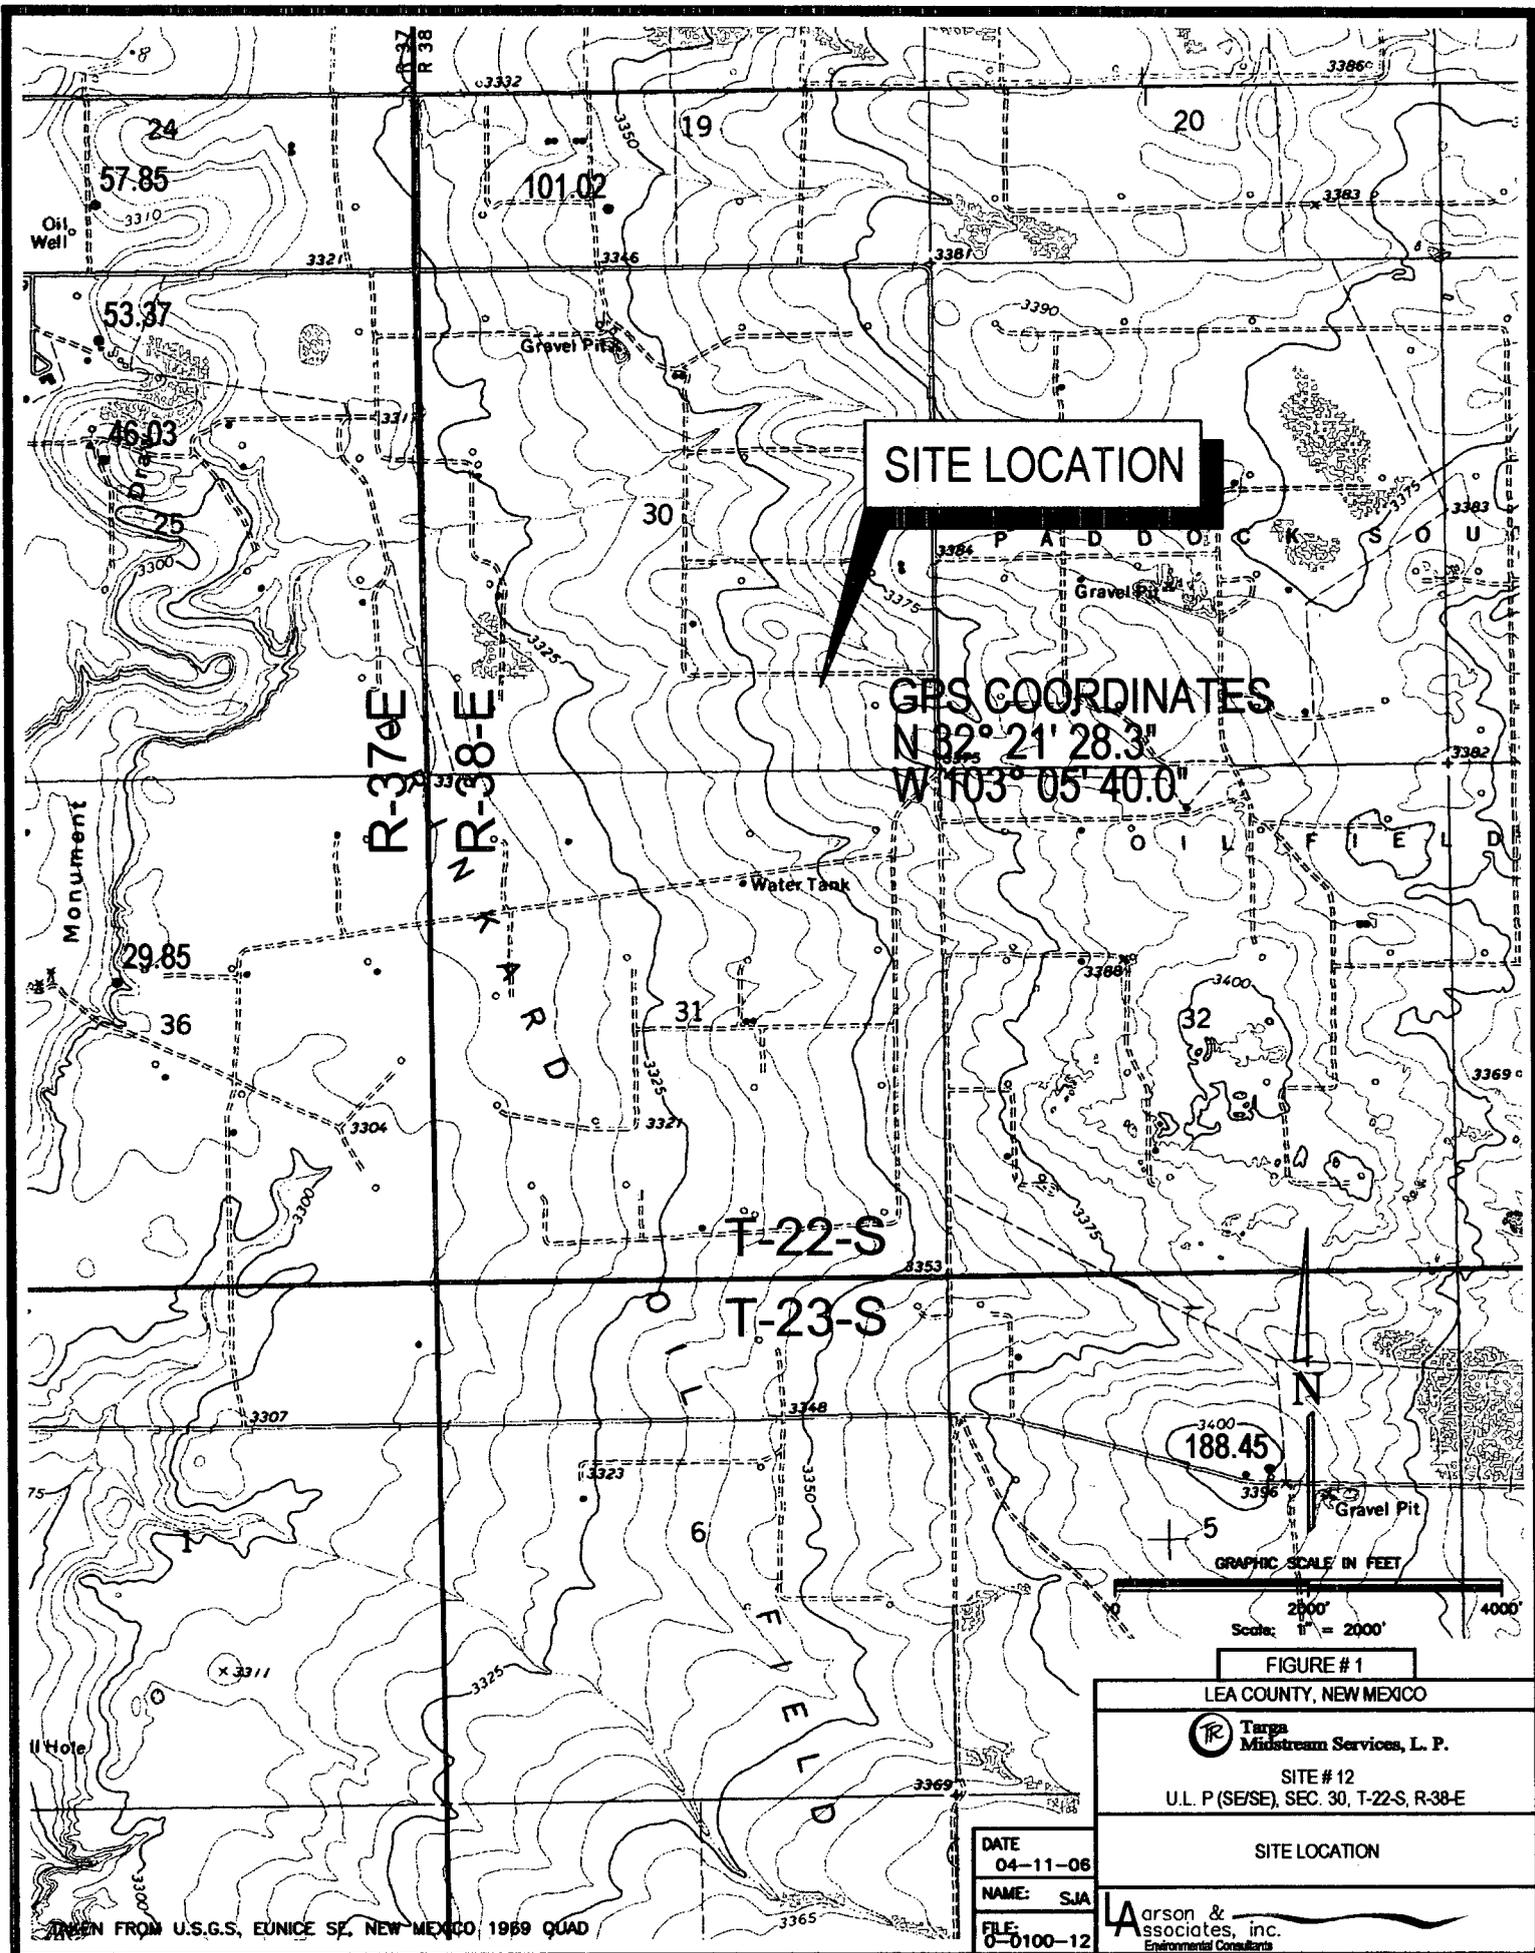
SITE LOCATION

Larson and Associates, Inc. ("LA"), as consultant to Targa Midstream Services, L.P. ("TMS") submits the attached Form C-141 to the State of New Mexico Oil Conservation Division ("OCD") for a spill from a 6-inch natural gas pipeline ("Site #12") located in unit letter P ("SE/4, SE/4"), Section 30, Township 22 South, Range 38 East in Lea County, New Mexico. The date and volume of the spill are not known, but the affected area covers approximately 25 x 150 feet or approximately 3,750 square feet. Another area of stained soil is located about 90 feet south of Site #12 and measures about 15 x 20 feet or about 300 square feet. The latitude and longitude for the site is North 32° 21' 28.3" and West 103° 05' 40.0". Figure 1 presents a location map. Figure 2 presents a drawing for Site #12. Contact information for TMS is as follows:

TMS will excavate soil from Site #12 until benzene, BTEX, TPH and chloride are reduced below the RRAL. Soil will also be excavated from the area of surface staining located about 90 feet south of Site #12. The soil will be hauled to an OCD permitted commercial landfarm. Soil samples will be collected from the sides and bottom of the excavation, submitted under proper preservation and chain-of-custody control to an environmental laboratory and analyzed for the above-referenced constituents. Benzene and BTEX will not be analyzed if headspace samples exhibit readings below 100 parts per million ("ppm"). The laboratory analyses will be submitted to the OCD within 45 days following receipt of the report from the laboratory and the excavations will be filled with clean soil following OCD approval. You may call Mr. Don Embrey with TMS at (432) 688-0555 or email dembrey@targaresources.com. I may be reached with questions at (432) 687-0901 or email mark@laenvironmental.com.
