ADDENDUM

Exhibit No.

Description

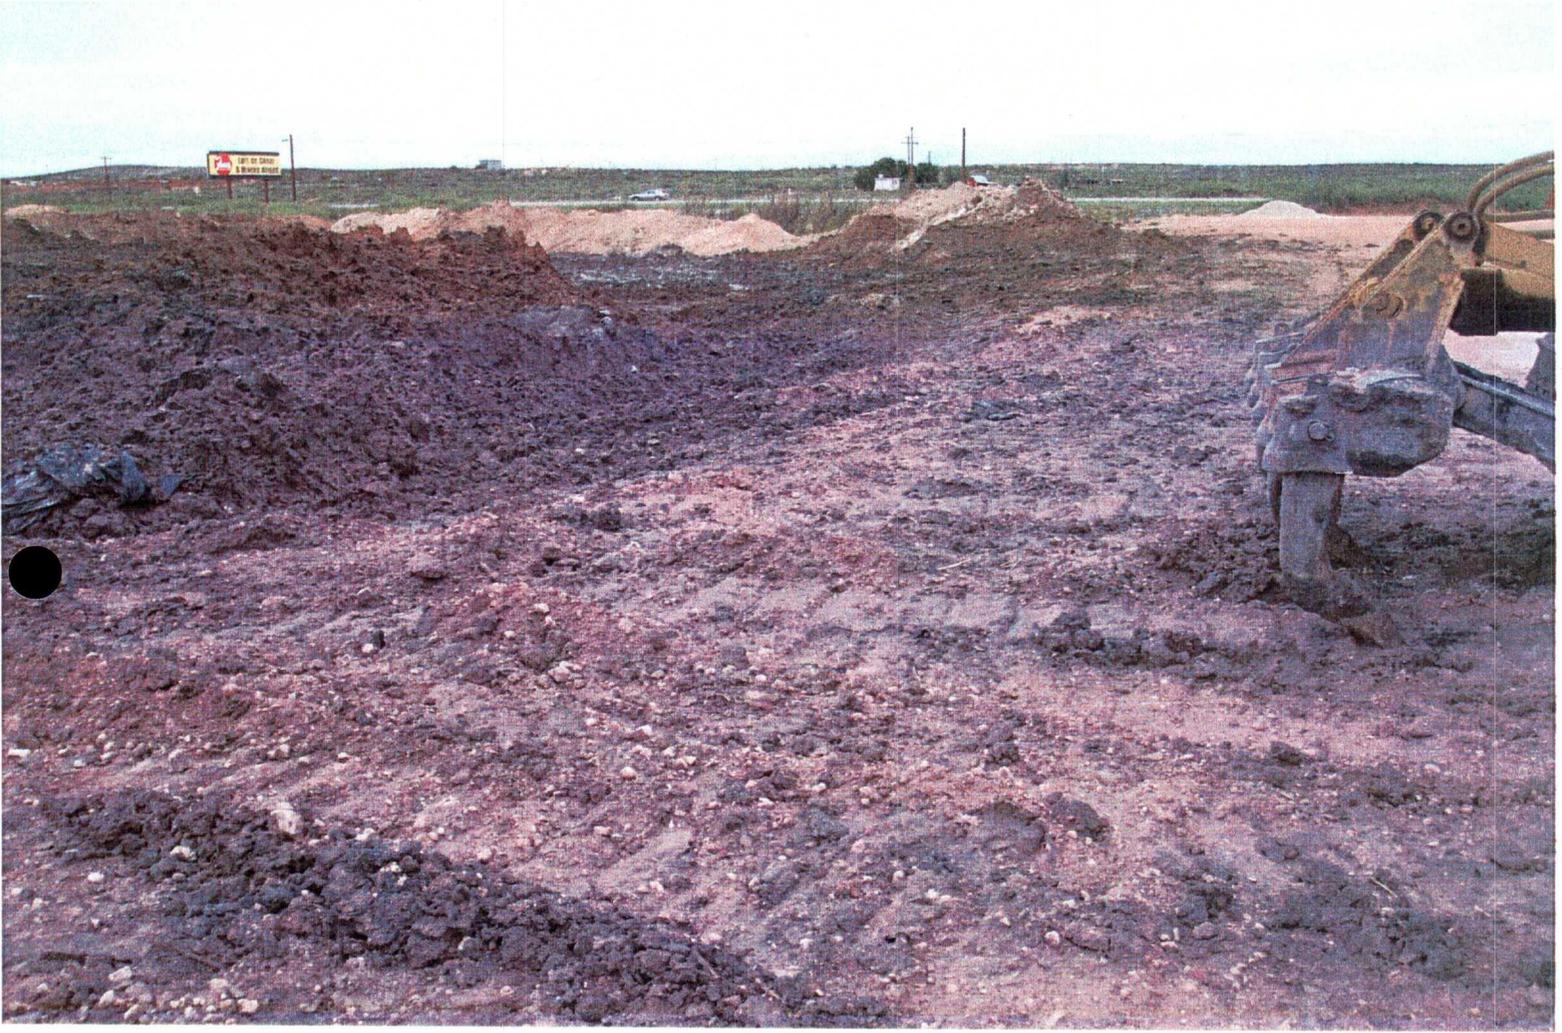
1M	Cover up stage; contamination is readily visible.
1N	Coverage and closure commences.
1O	Dozer at work; in proximity to a wash and gulley; rain water comes through Pecos River drainage.
1P	Finished (?) product.
1Q	Finished (?).
1R	Finished (?).
1S	The fly-off or drain-off frm closed pit has killed vegetation.
1T	Ditto.
1U	The fence line shows that there is either fly-off or drain-off away from the original pit site.
1V	Is this reclaimed, restored, and revegetated?
1W	Is this clean?
1X - 1LL	Miscellaneous photographs.
