1R - 425-3

Corrective Action Plan

Vacuum K-35-1 Boot
UL K Sec 35 T17S R35E
OCD Case Number 1R0425-03

February 28th, 2007

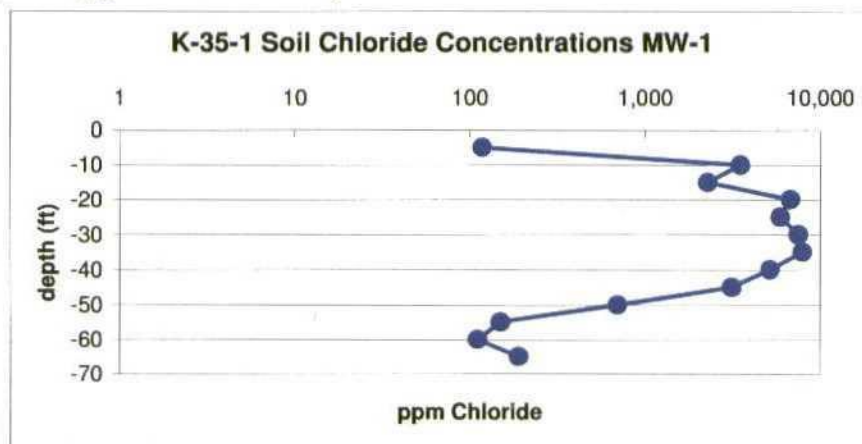
Table 1 – Soil boring log and chloride levels for MW-1.

Depth	Field	Lab	Field OVM	Lab BTEX	Cutting Description	Well Schematic
	Chloride	Chloride				
	Test (ppm)	Test (ppm)	test (ppm)	test (ppm)		
0					light gray caliche	solid pipe
-5	117		0		"	"
-10	3,497		0		"	"
-15	2,271		0		light brown sand	"
-20	6,737		0		"	"
-25	5,898		0		"	"
-30	7,464		0		"	"
-35	7,891	4,415	0		"	"
-40	5,142		0		" (thin sandstone layer at 45 ft)	"
-45	3,112		0		"	screen
-50	693		0		reddish brown sand	"
-55	149	144	0		"	"
-60	110		0		"	"
-65	189		0		"	"

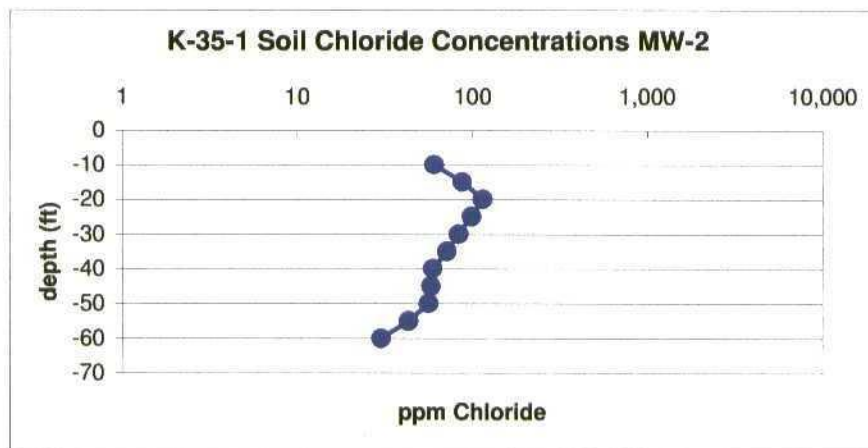
Table 2 – Soil boring log and chloride levels for MW-2. Values in red are interpolated.

Depth	Field	Lab	Field OVM	Lab BTEX	Cutting Description	Well Schematic
	Chloride Test (ppm)	Chloride Test (ppm)				
0					light gray caliche	solid pipe
-5					"	"
-10	60		0		"	"
-15	87				light brown sand	"
-20	114		0		"	"
-25	99				"	"
-30	83		0		"	"
-35	71				"	"
-40	59		0		reddish brown sand	"
-45	58				"	"
-50	56		0		"	screen
-55	43				"	"
-60	30	32	0		"	"
-65						"

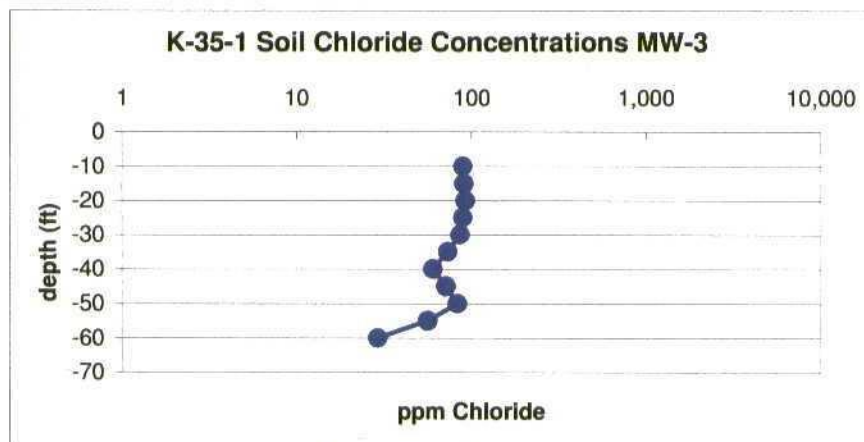
Table 3 – Soil boring log and chloride levels for MW-3. Values in red are interpolated.

Depth	Field	Lab	Field OVM	Lab	Cutting Description	Well Schematic
	Chloride Test (ppm)	Chloride Test (ppm)		BTEX test (ppm)		
0					light gray caliche	solid pipe
-5					"	"
-10	89		0		"	"
-15	91				light brown sand	"
-20	92		0		"	"
-25	89				"	"
-30	86		0		"	"
-35	73				"	"
-40	60		0		reddish brown sand	"
-45	72				"	screen
-50	83		0		"	"
-55	56				"	"
-60	29	<16	0		"	"
-65

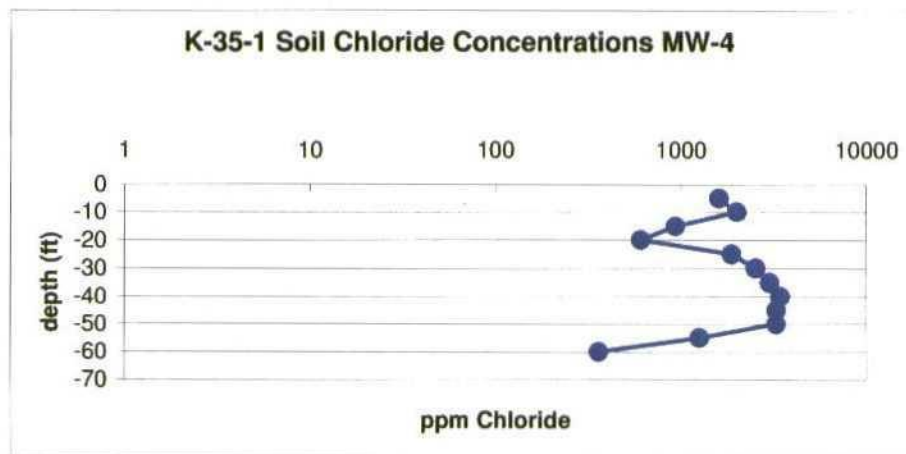
Table 4 – Soil boring log and chloride levels for MW-4.

Depth	Field	Lab	Field OVM	Lab BTEX	Cutting Description	Well Schematic
	Chloride Test (ppm)	Chloride Test (ppm)				
0					reddish brown sandy clay fill	solid pipe
-5	1,600		8		"	"
-10	2,000		61		olive brown caliche/sand	"
-15	933		27		light gray caliche/sand	"
-20	606		58		"	"
-25	1,877		4		tan sand	"
-30	2,524		5		"	"
-35	3,005		3		"	"
-40	3,430		3		"	"
-45	3,258		2		"	"
-50	3,264		3		light olive brown sand	screen
-55	1,260		1		"	"
-60	360		1		"	"
-65						"

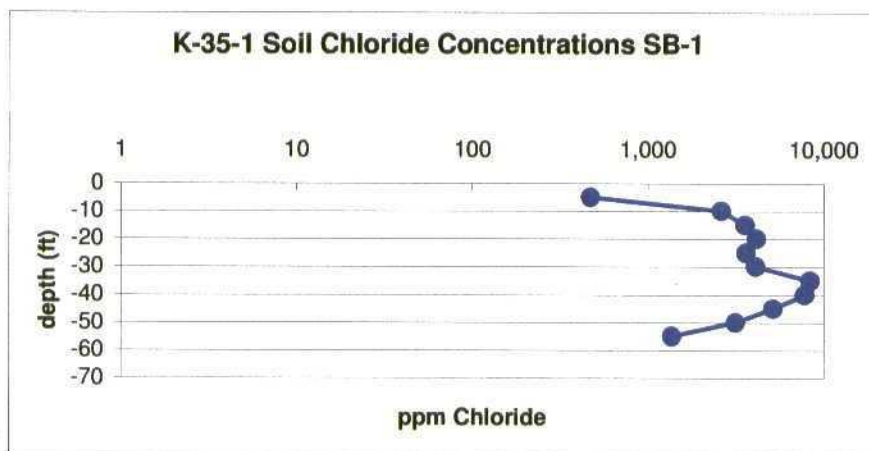
Table 5 – Soil boring log and chloride levels for SB-1.

<u>Depth</u>	<u>Field</u>	<u>Lab</u>	<u>Field OVM</u>	<u>Lab BTEX</u>	<u>Cutting Description</u>
	<u>Chloride</u>	<u>Chloride</u>			
	<u>Test</u>	<u>Test</u>	<u>test (ppm)</u>	<u>test (ppm)</u>	
	<u>(ppm)</u>	<u>(ppm)</u>			
0					light gray caliche
-5	468		0		"
-10	2,609		0		"
-15	3,561		0		light brown sand
-20	4,145		0		"
-25	3,611		0		"
-30	4,095		0		"
-35	8,347		0		"
-40	7,780		0		"
-45	5,132		0		reddish brown sand
-50	3,147	3,839	1	ND	"
-55	1,356		0		
-60

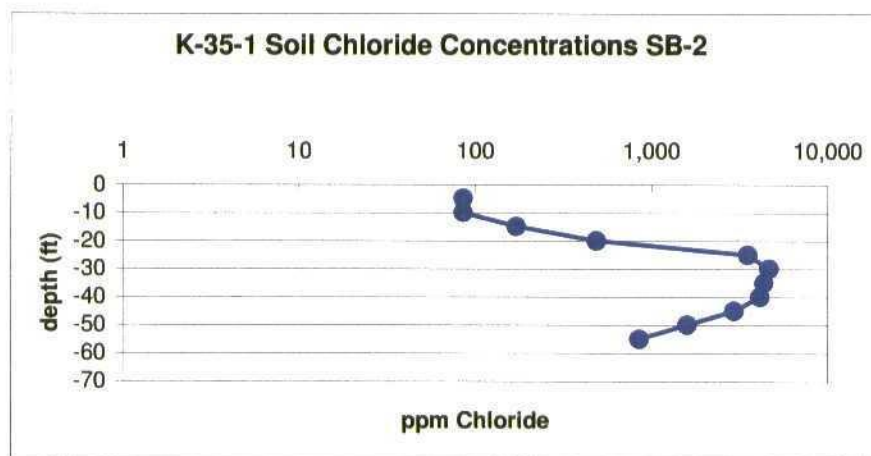
Table 6 – Soil boring log and chloride levels for SB-2.

Depth	Field	Lab	Field OVM	Lab BTEX	Cutting Description
	Chloride Test (ppm)	Chloride Test (ppm)			
0					light gray caliche
-5	85		0		"
-10	85		0		"
-15	170		0		light brown sand
-20	486		0		"
-25	3,504		0		"
-30	4,627		0		"
-35	4,332		0		"
-40	4,115		0		" (thin sandstone layer at 45 ft)
-45	2,929		0		"
-50	1,589		0		reddish brown sand
-55	848	1,104	0		"
-60					"

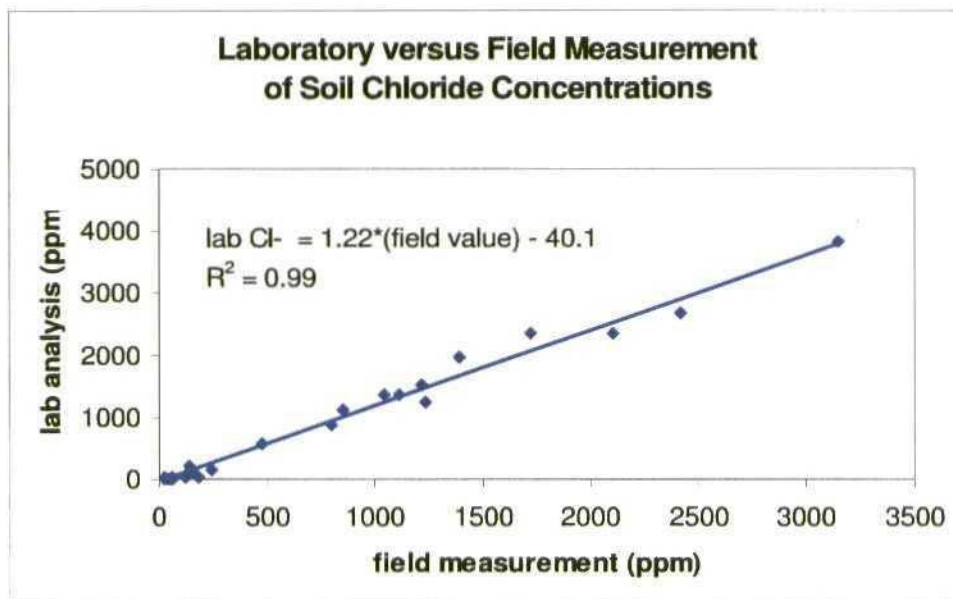
Soil chloride concentrations determined by the commercial laboratory are compared against Rice's field measurements in the graph, below. These data were from nearly 20 samples taken at Rice Vacuum locations K-35-1, E-2 and N-6-1.

These data indicate that field measurements are an extremely reliable measure of the relative magnitudes of chloride contamination.
