Souder, Miller & Associates ♦ 201 S. Halagueno St. ♦ Carlsbad, NM 88220  
(575) 689-7040

August 6, 2020

SMA #5E29133, BG59

**RE: LINER INSPECTION REPORT  
FLAGLER 8 CENTRAL TANK BATTERY 1**

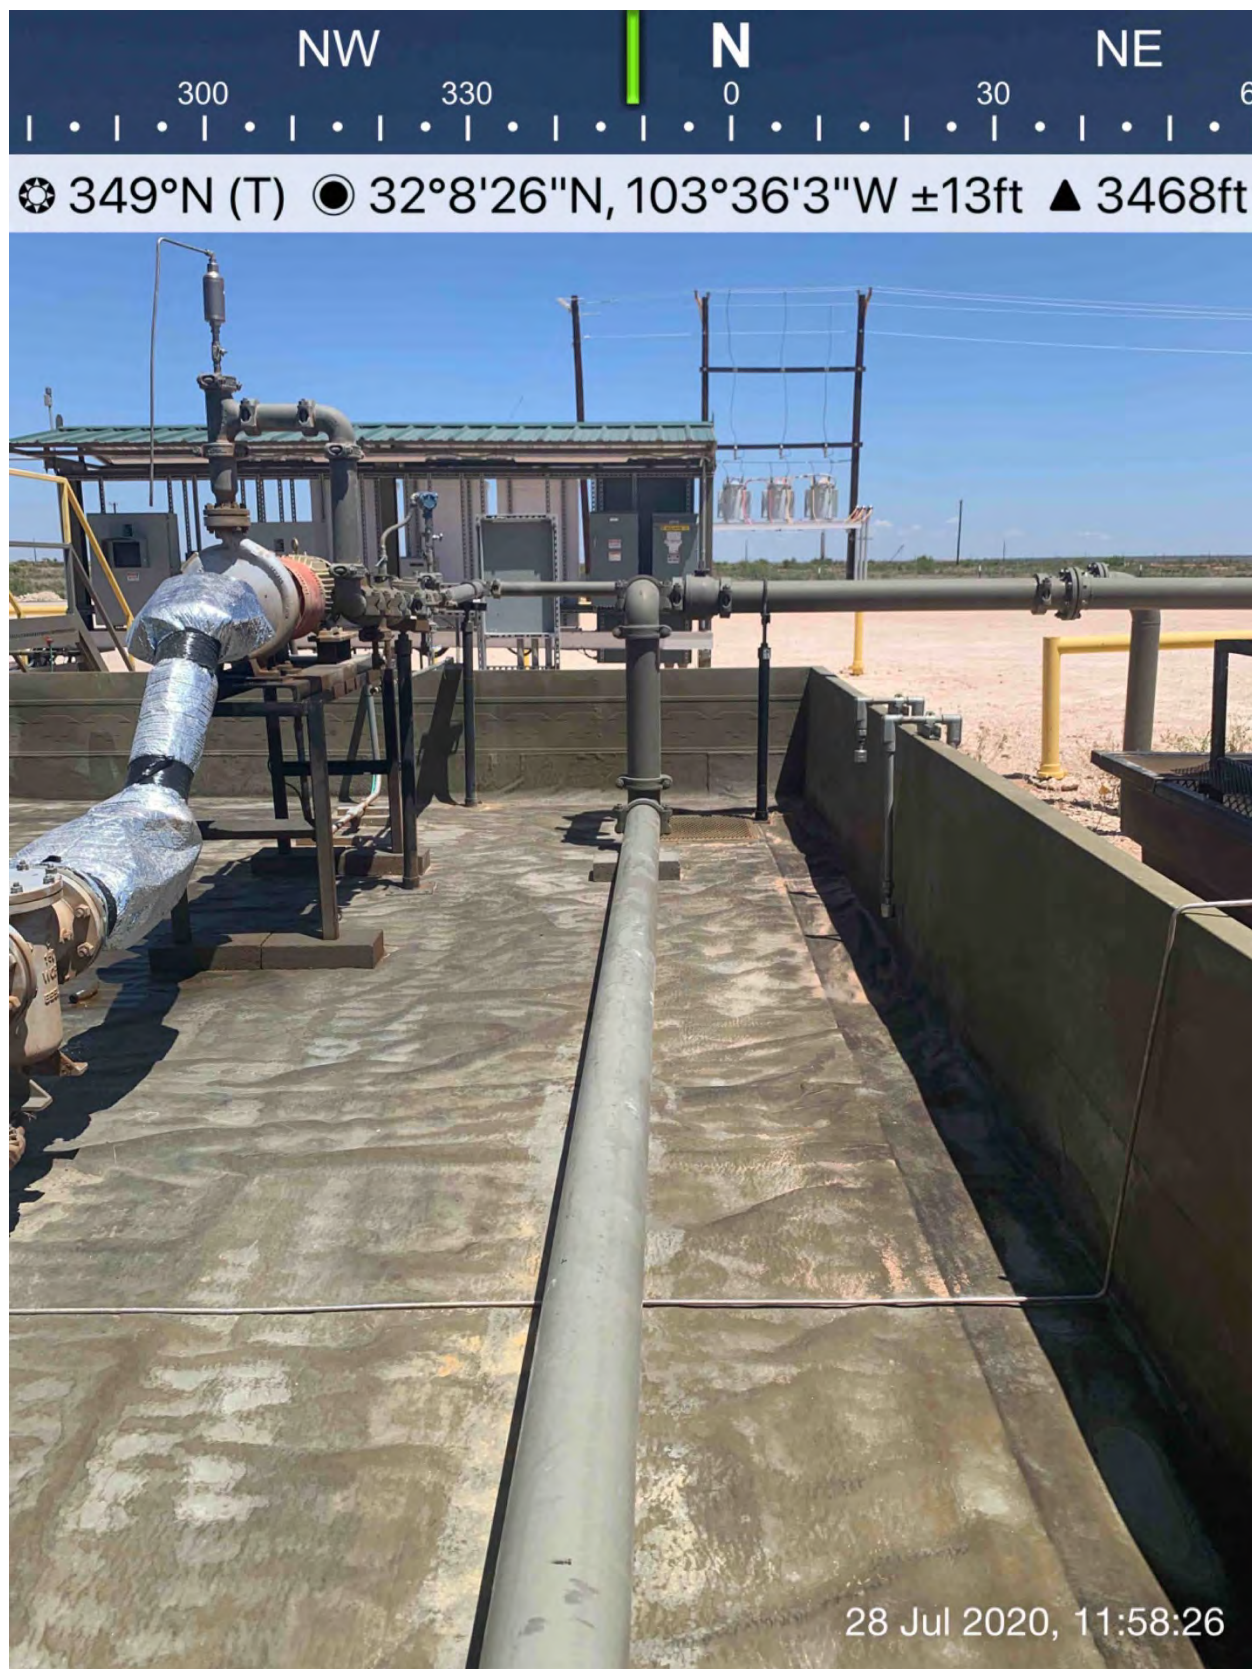
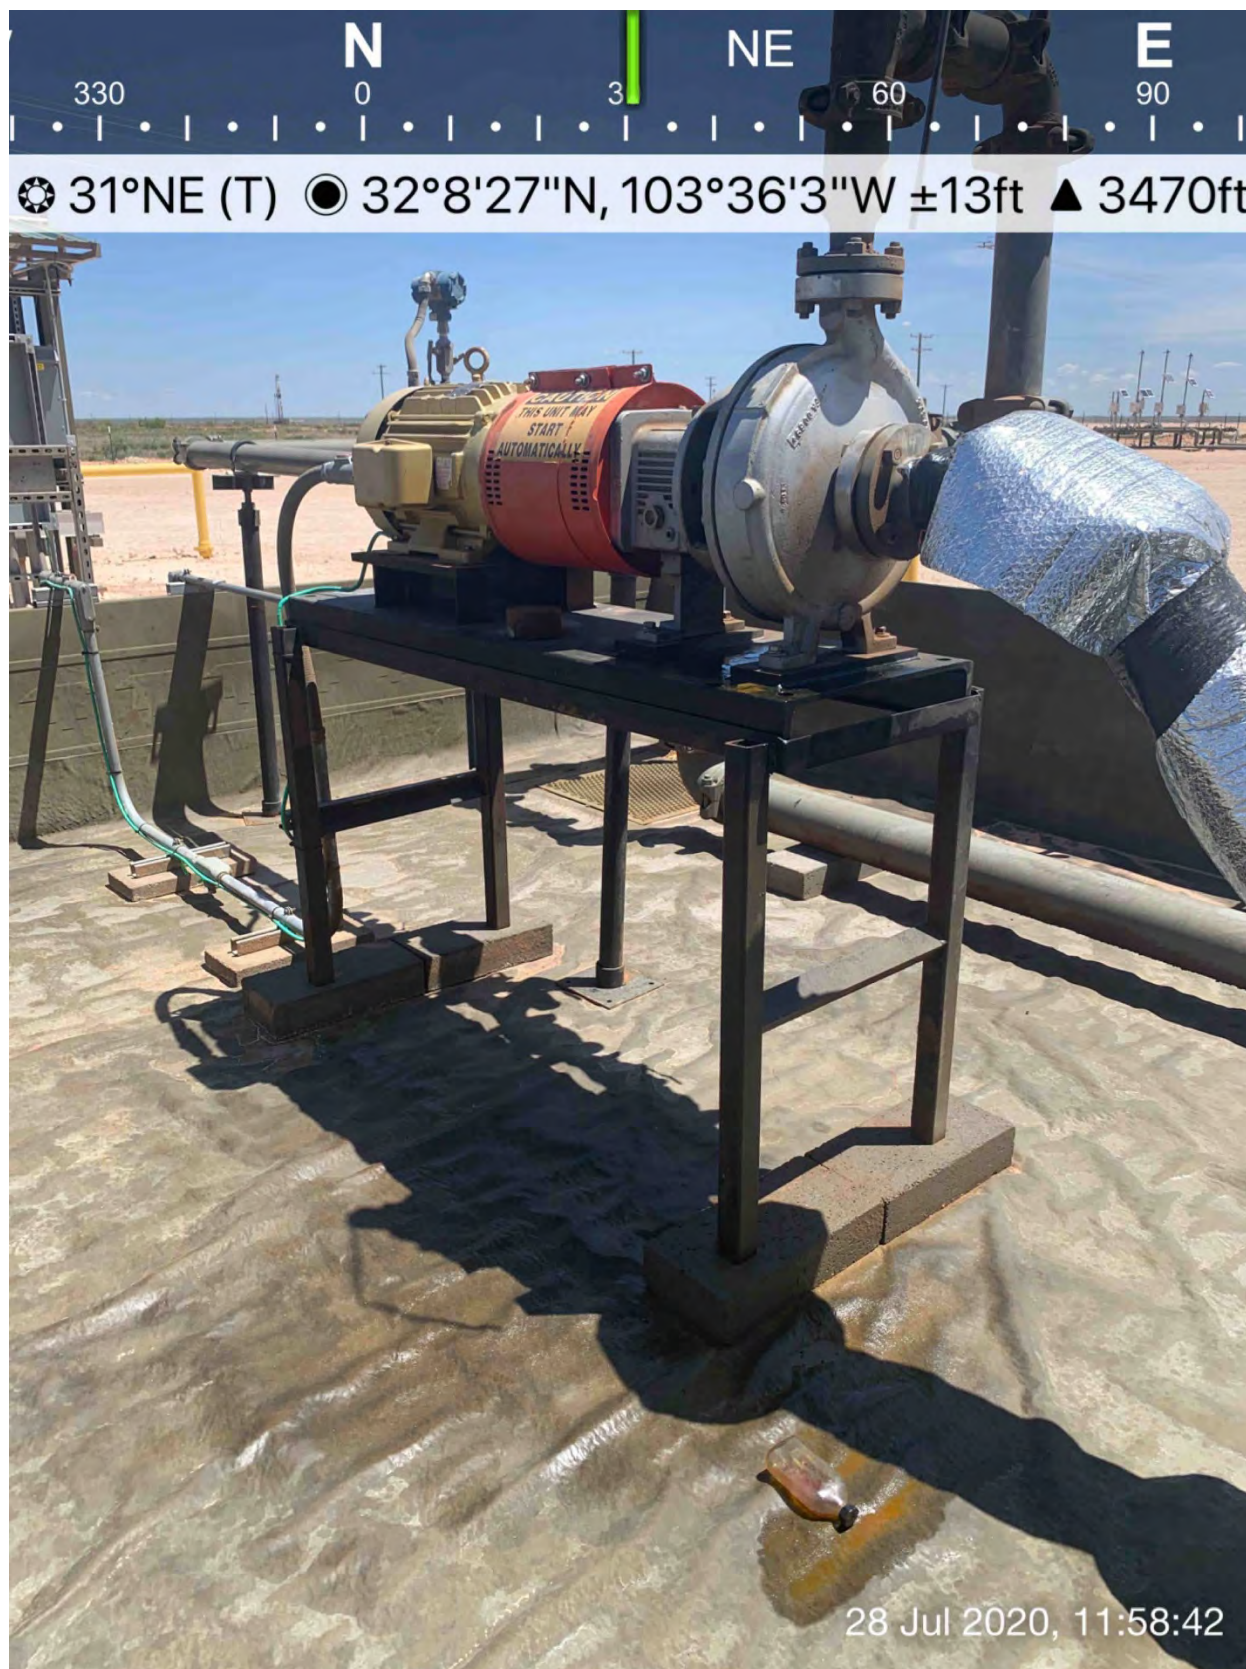
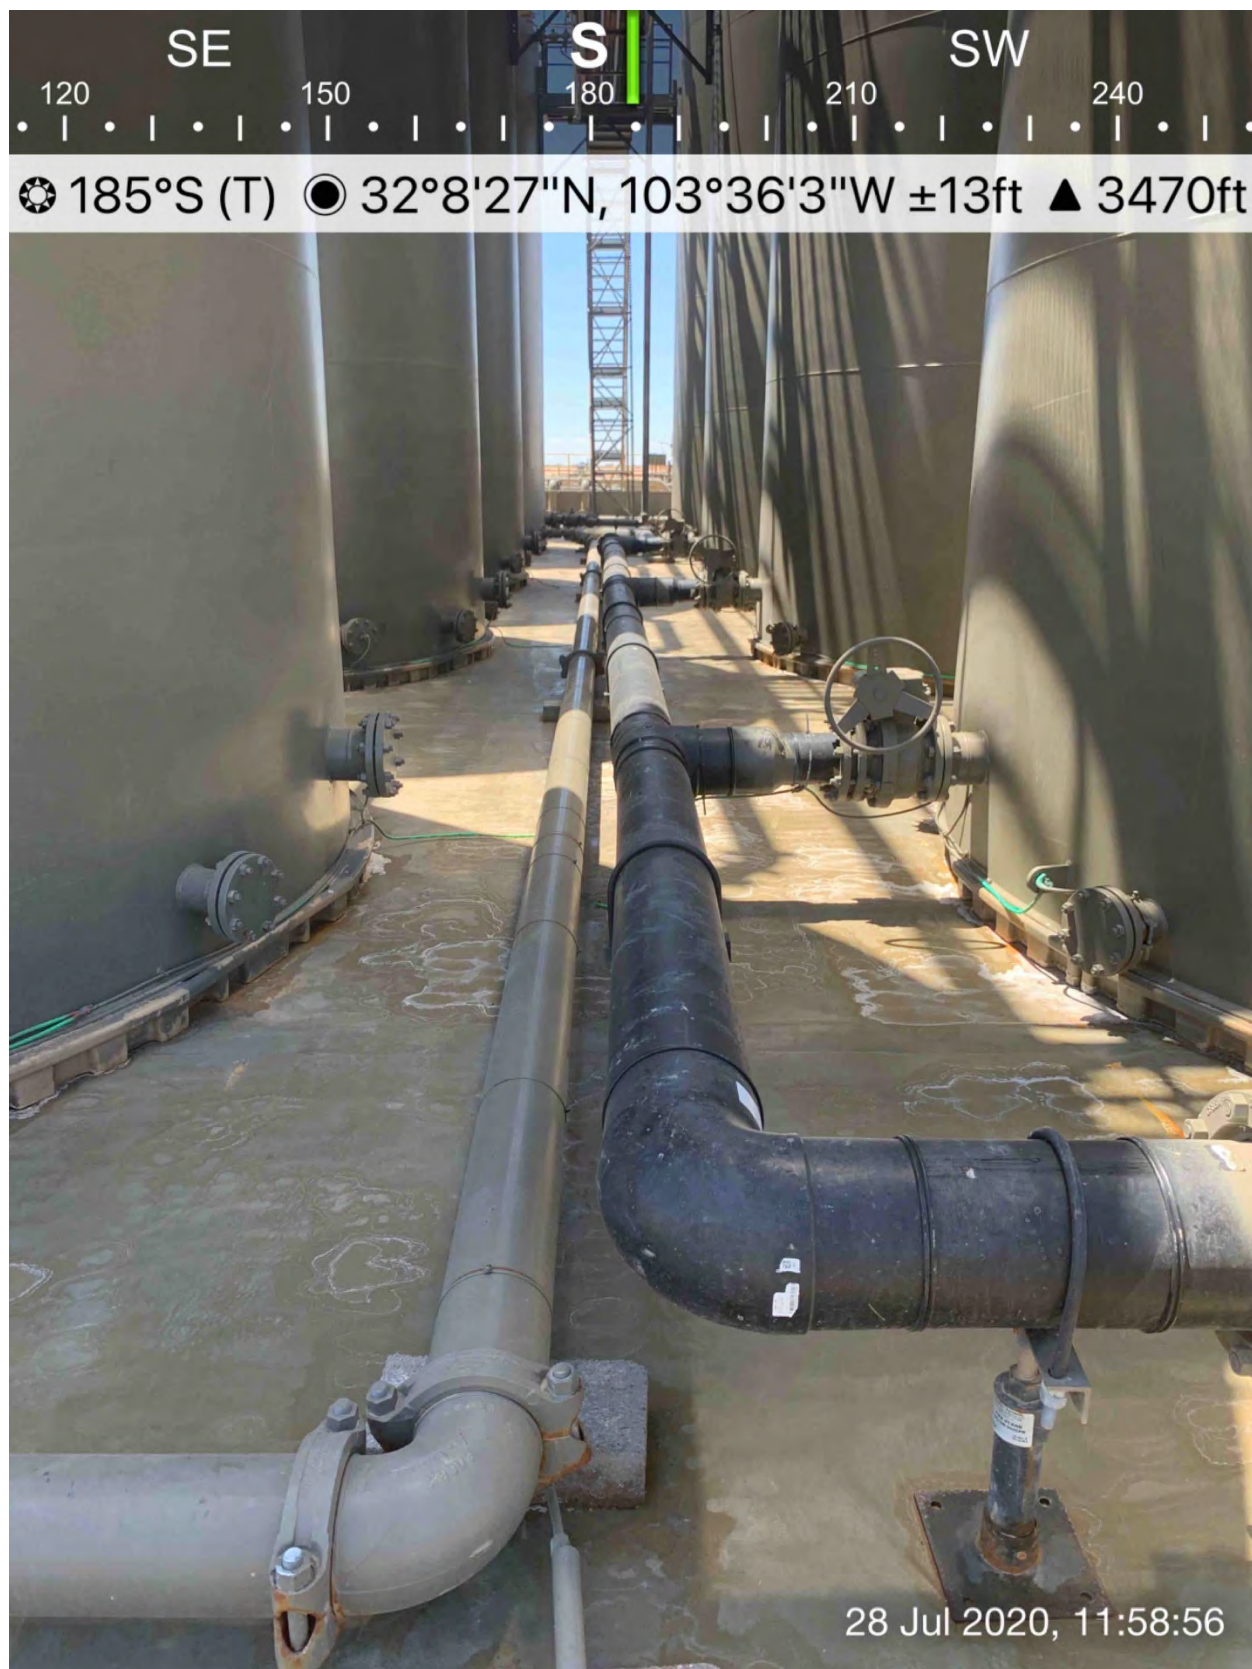
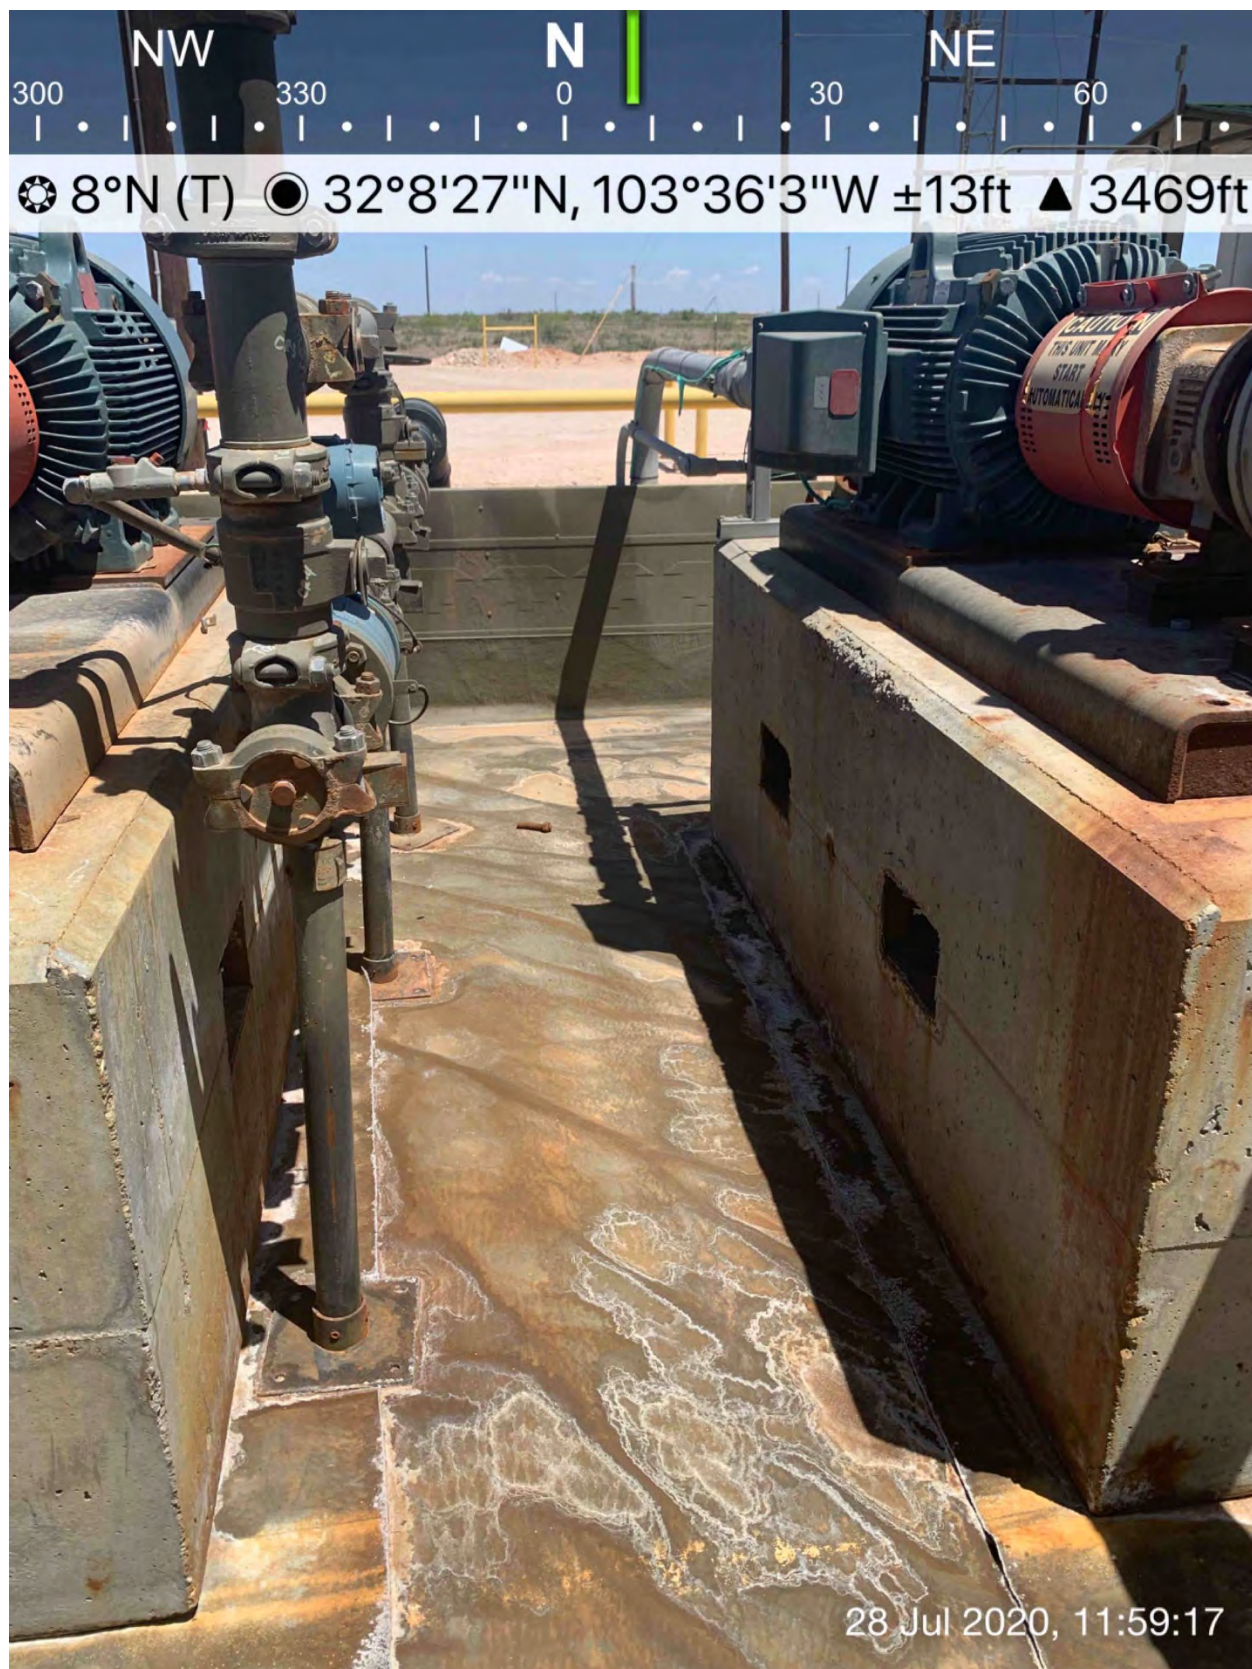
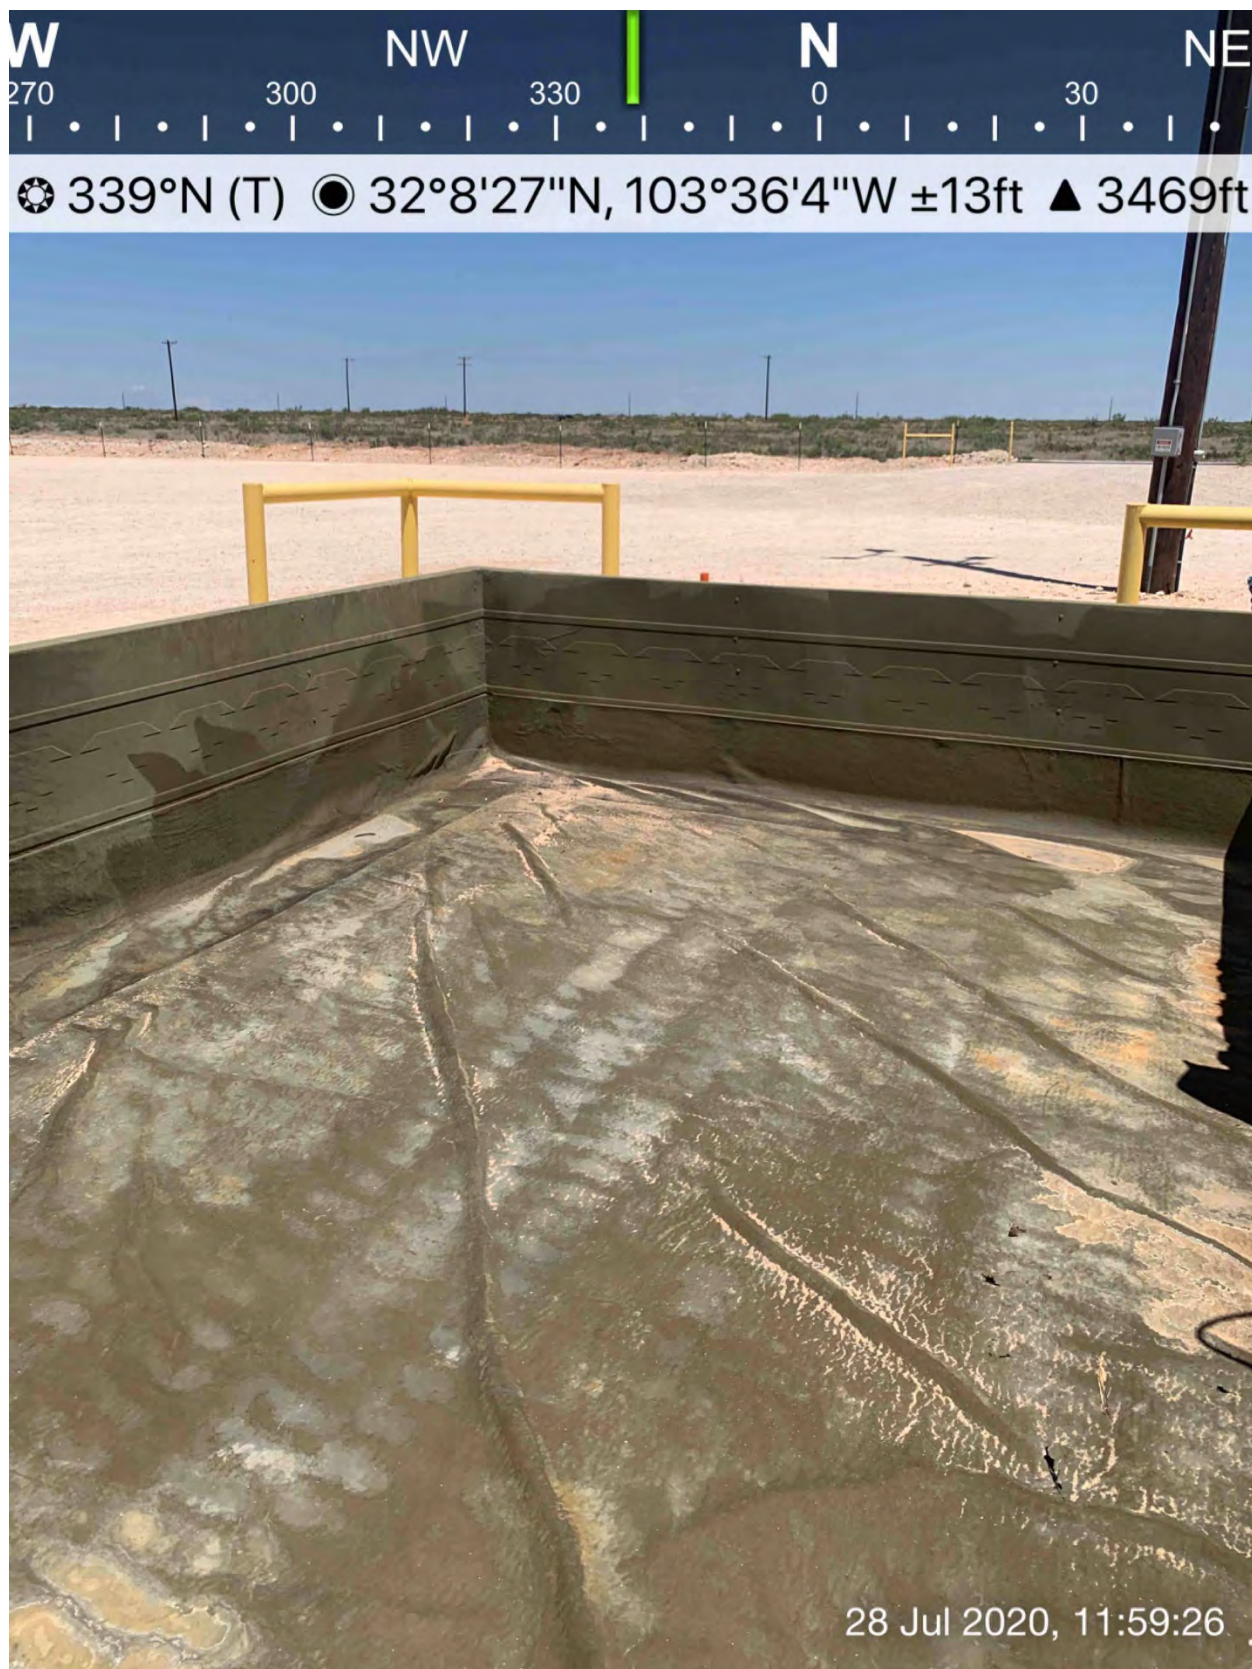
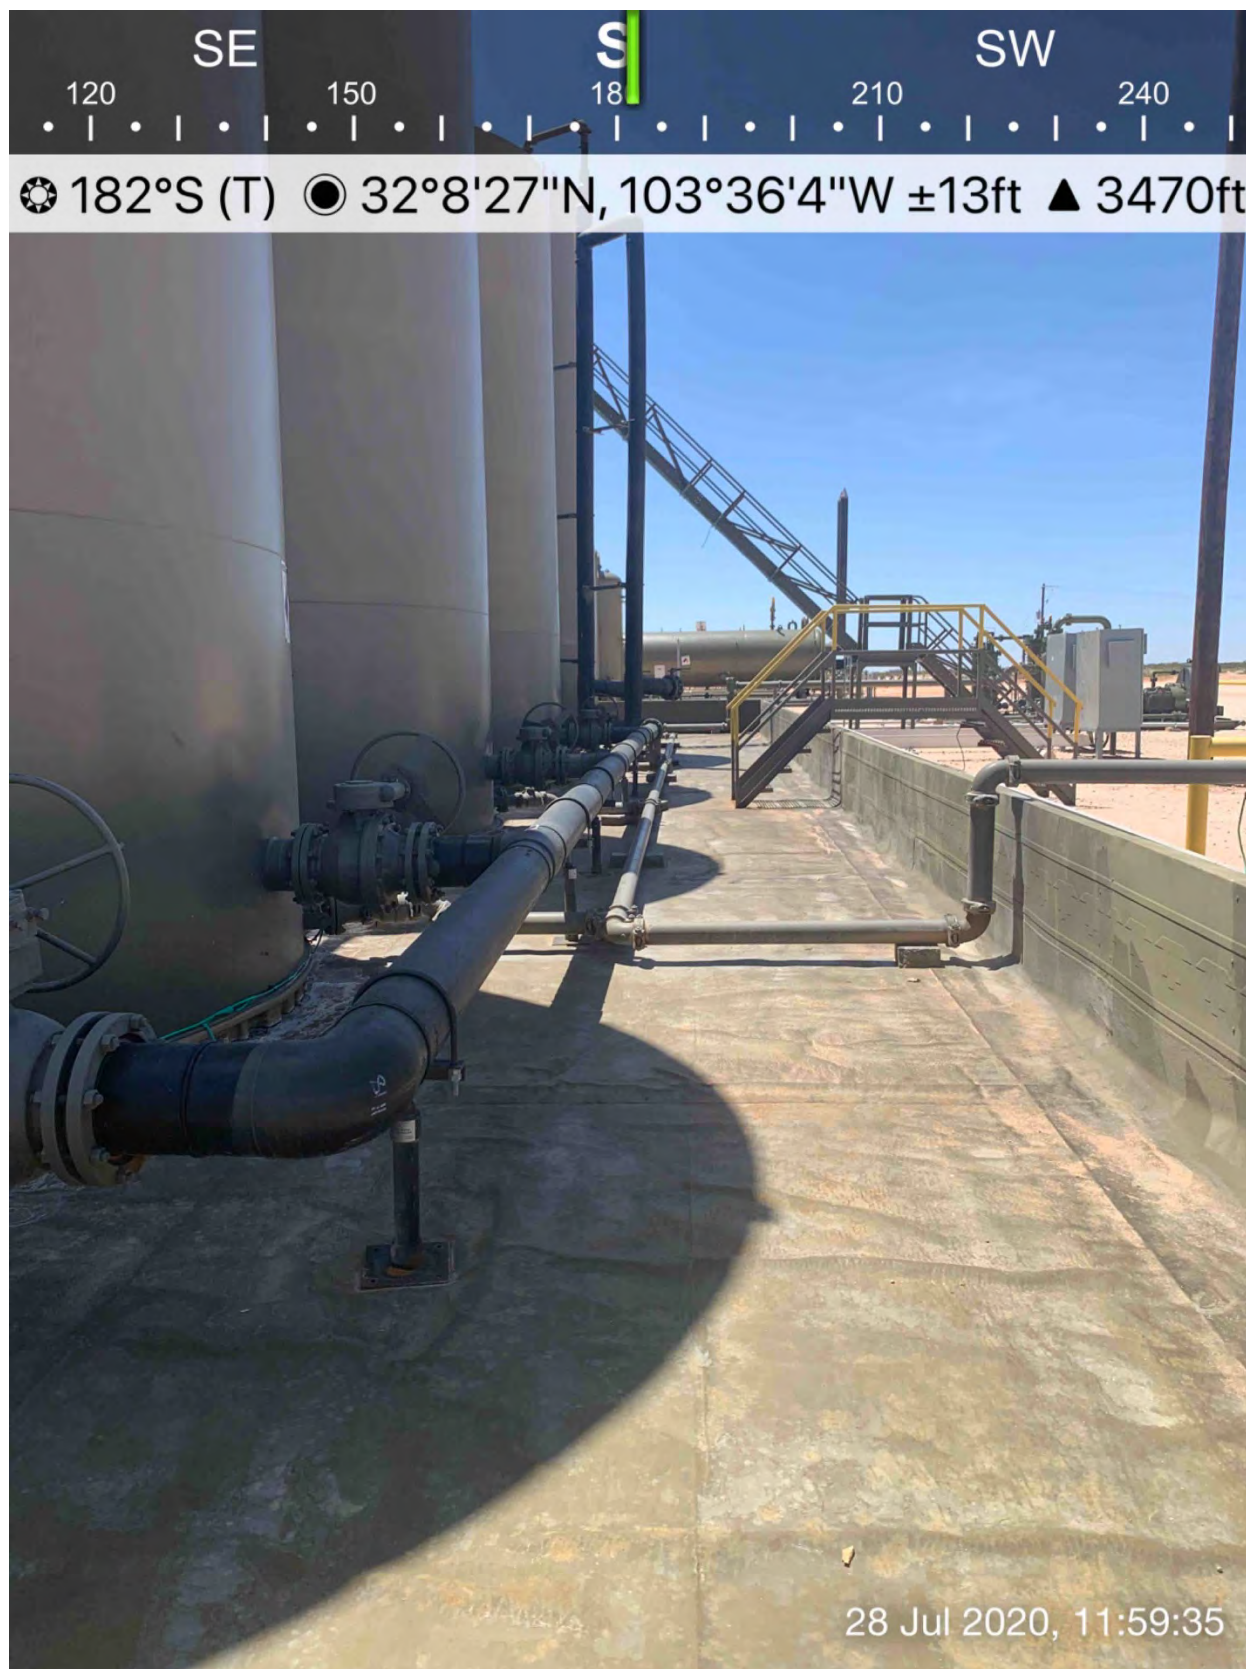
At the request of Devon, SMA conducted a liner integrity inspection per the requirements of 19.15.29.11.A(5)(a) NMAC. NMOCD was notified on July 27, 2020 that the liner inspection was to occur. After a thorough visual inspection of the liner within the tank battery containment, the liner appeared to be intact and had the ability to contain the leak in question and will continue to do so. The valve from which the release occurred was identified, and SMA verified that the release did not occur outside of the lined containment. A photo log and field notes of the inspection is included in Appendix A.

SMA recommends no further action for this release.
