# BURLINGTON RESOURCES

Re: San Juan 27-4 Unit #59 (30-039-20369) Bradenhead

# SAN JUAN 27-4 UNIT 59

## WellView - Schematic

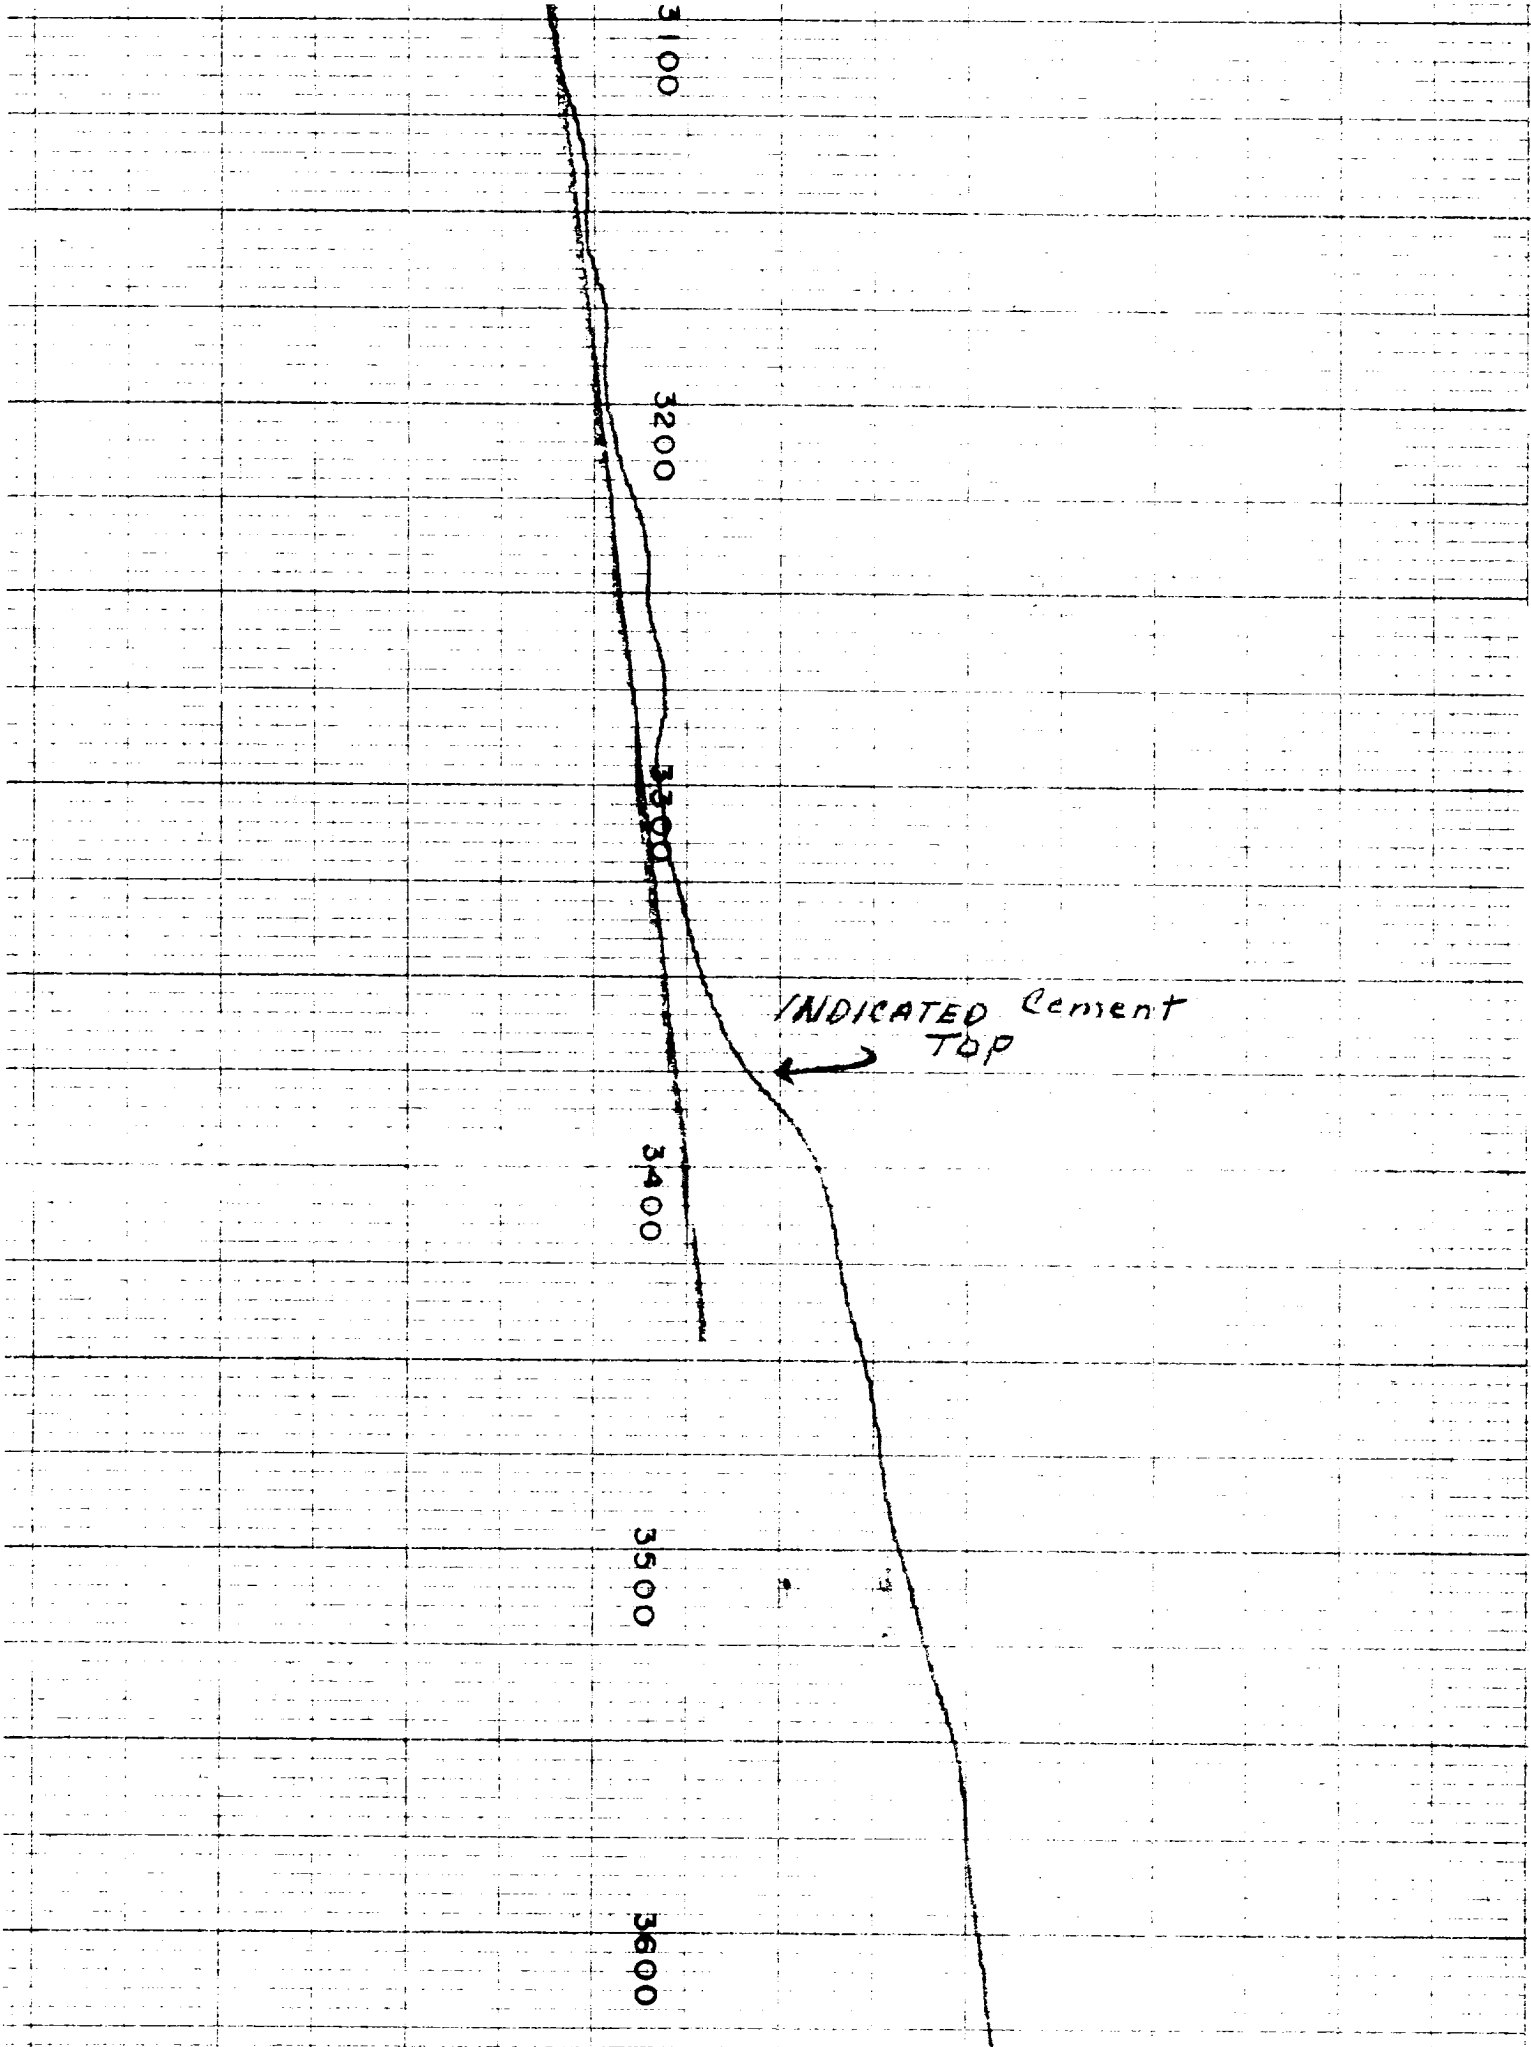
The attached wellbore schematic shows that the top of primary casing cement (3375') is well above the bottom of the 7" intermediate casing string (4536'). A copy of the temperature survey log is attached to show the top of cement. Since the top of cement is 1161 feet above the end of the intermediate casing string, a hydraulic seal should exist. This is confirmed by the bradenhead test because there is zero pressure at the Bradenhead. Therefore, the formation is protected and this well is in compliance with Rule 108.

INDICATED Cement  
TOP
