Well File
Howell B #3
S/W 3-30N-7W

MEMORANDUM

Subject: Howell B #3
Adjacent Well Data

Attached is the data concerning the wells adjacent to the Howell B #3. The data includes a schematic showing casing depths, cement tops, cemented intervals, and formation tops.

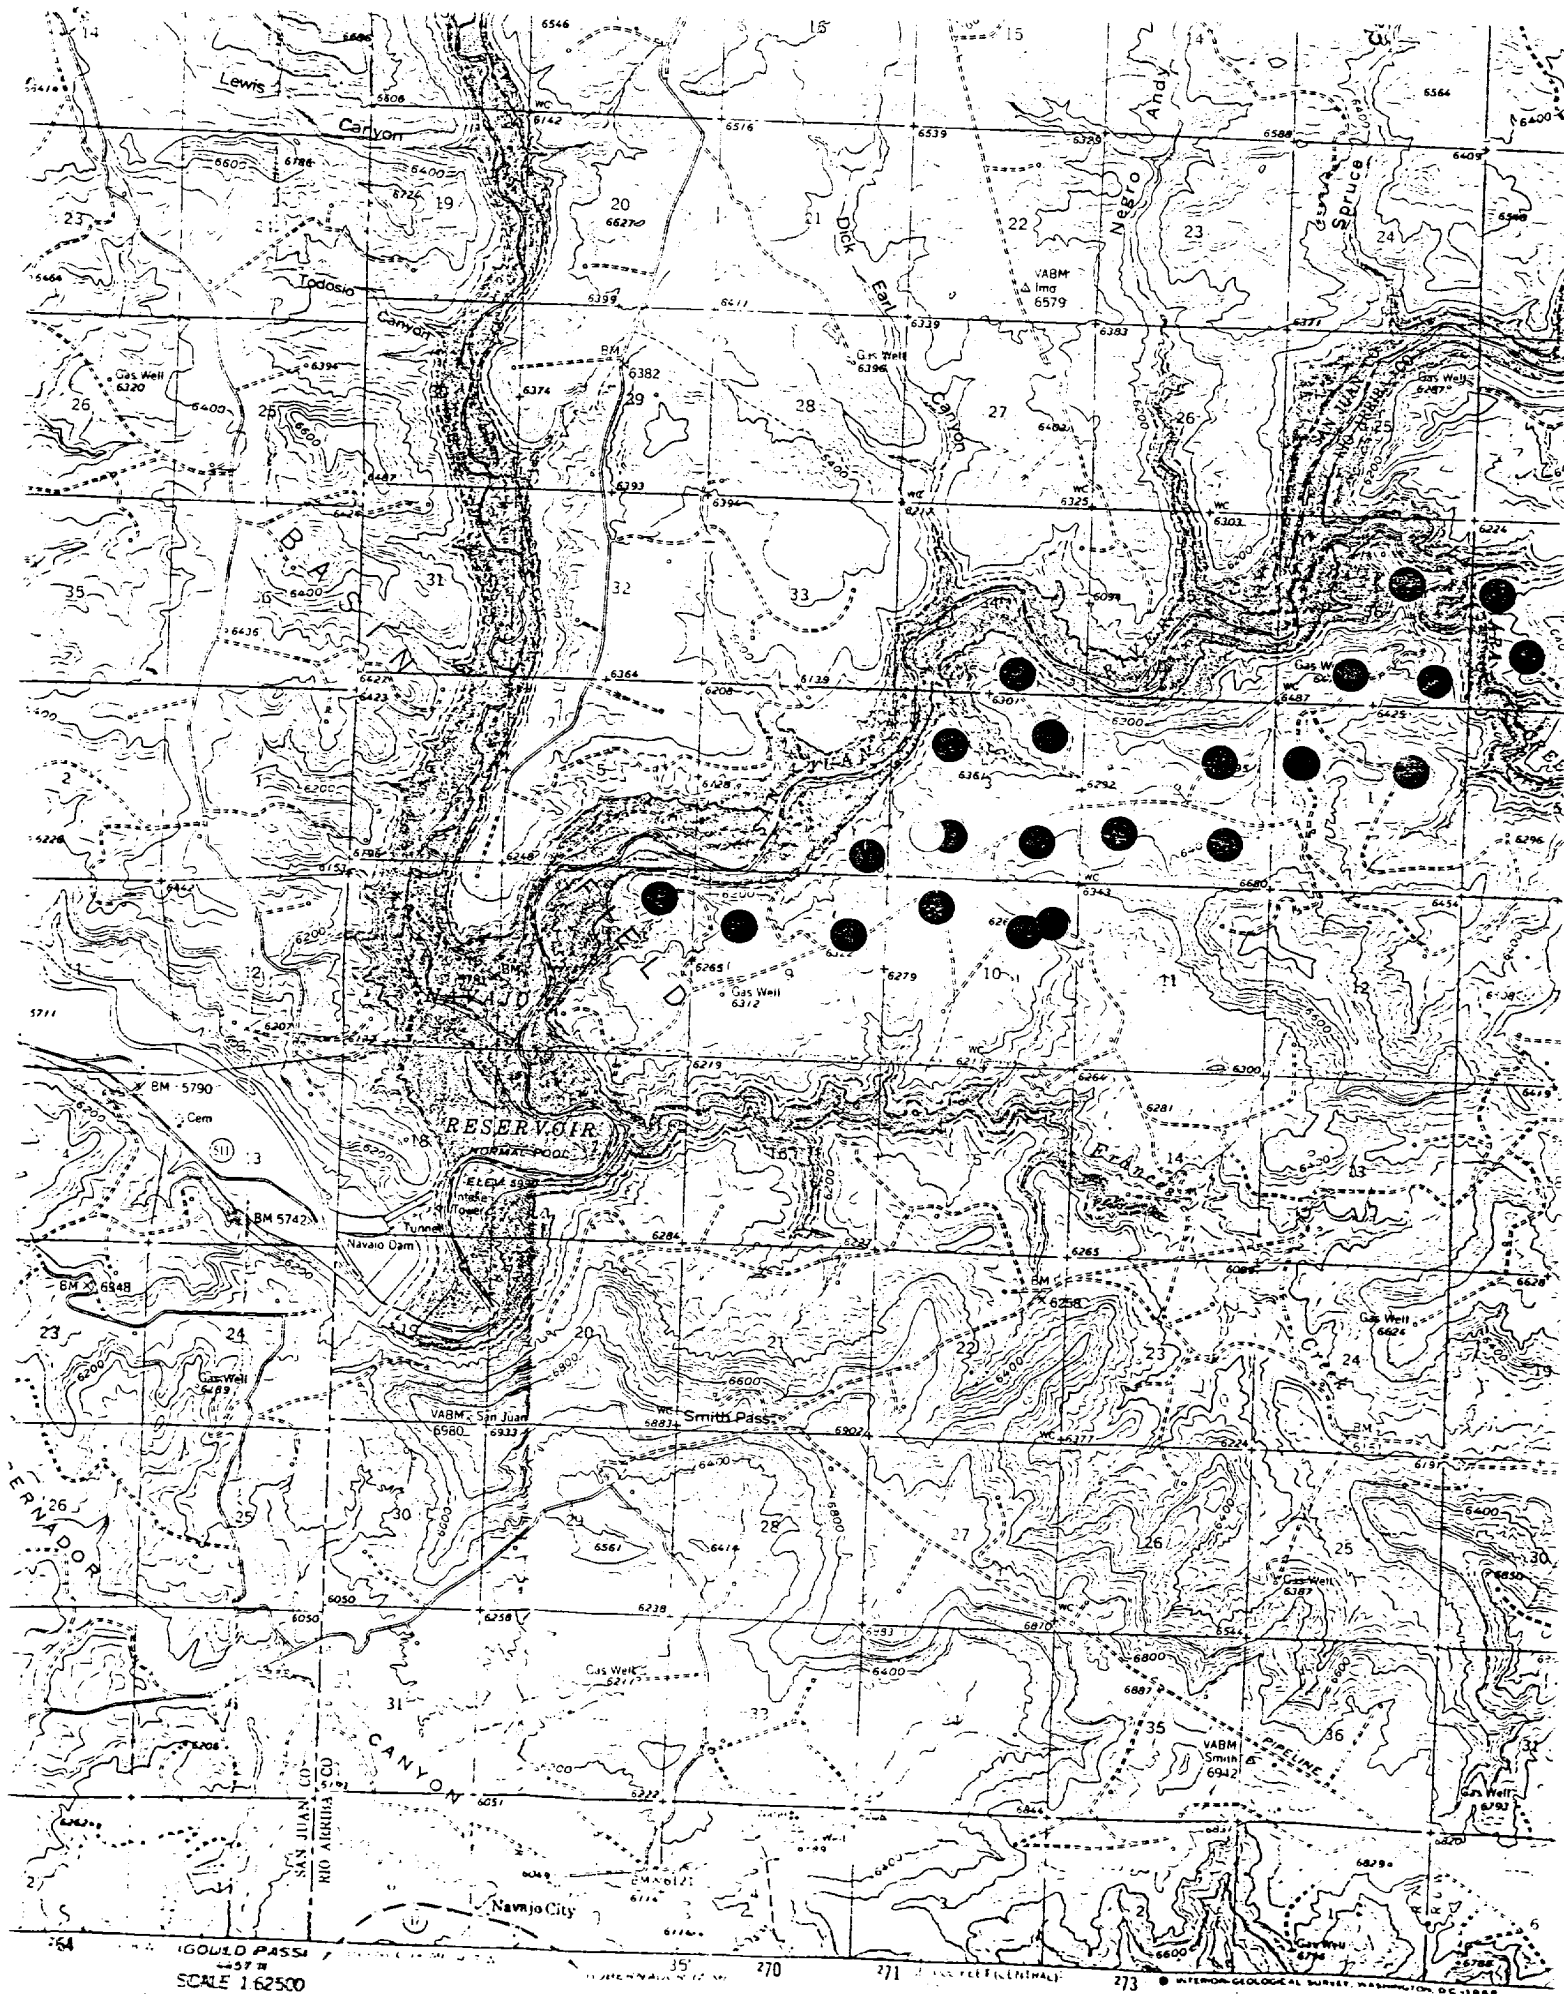
Northeast Blanco Unit #18
NE Section 9, T-30-N, R-7-W

This well was drilled and open-hole completed in September, 1954. In June 1966 the 2 3/8" tubing was pulled, but efforts to clean out the open hole section failed. The open hole and a casing failure at 1368' in 7" casing were squeezed. The well was whipstocked with a knuckle joint and 4 1/2" casing cemented in two stages. In March, 1982 the 2 3/8" tubing was pulled and the 4 1/2" casing was tested to 2000 psi, held okay. Two squeeze holes were shot in the 4 1/2" casing at 2550' and were squeezed with 350 sks. The annulus between the 10 3/4" and 7" casing was bradenhead squeezed with 150 sks. The casing was tested to 1000 psi, held okay. The tubing was then rerun. It is very unlikely that this well has a casing leak.

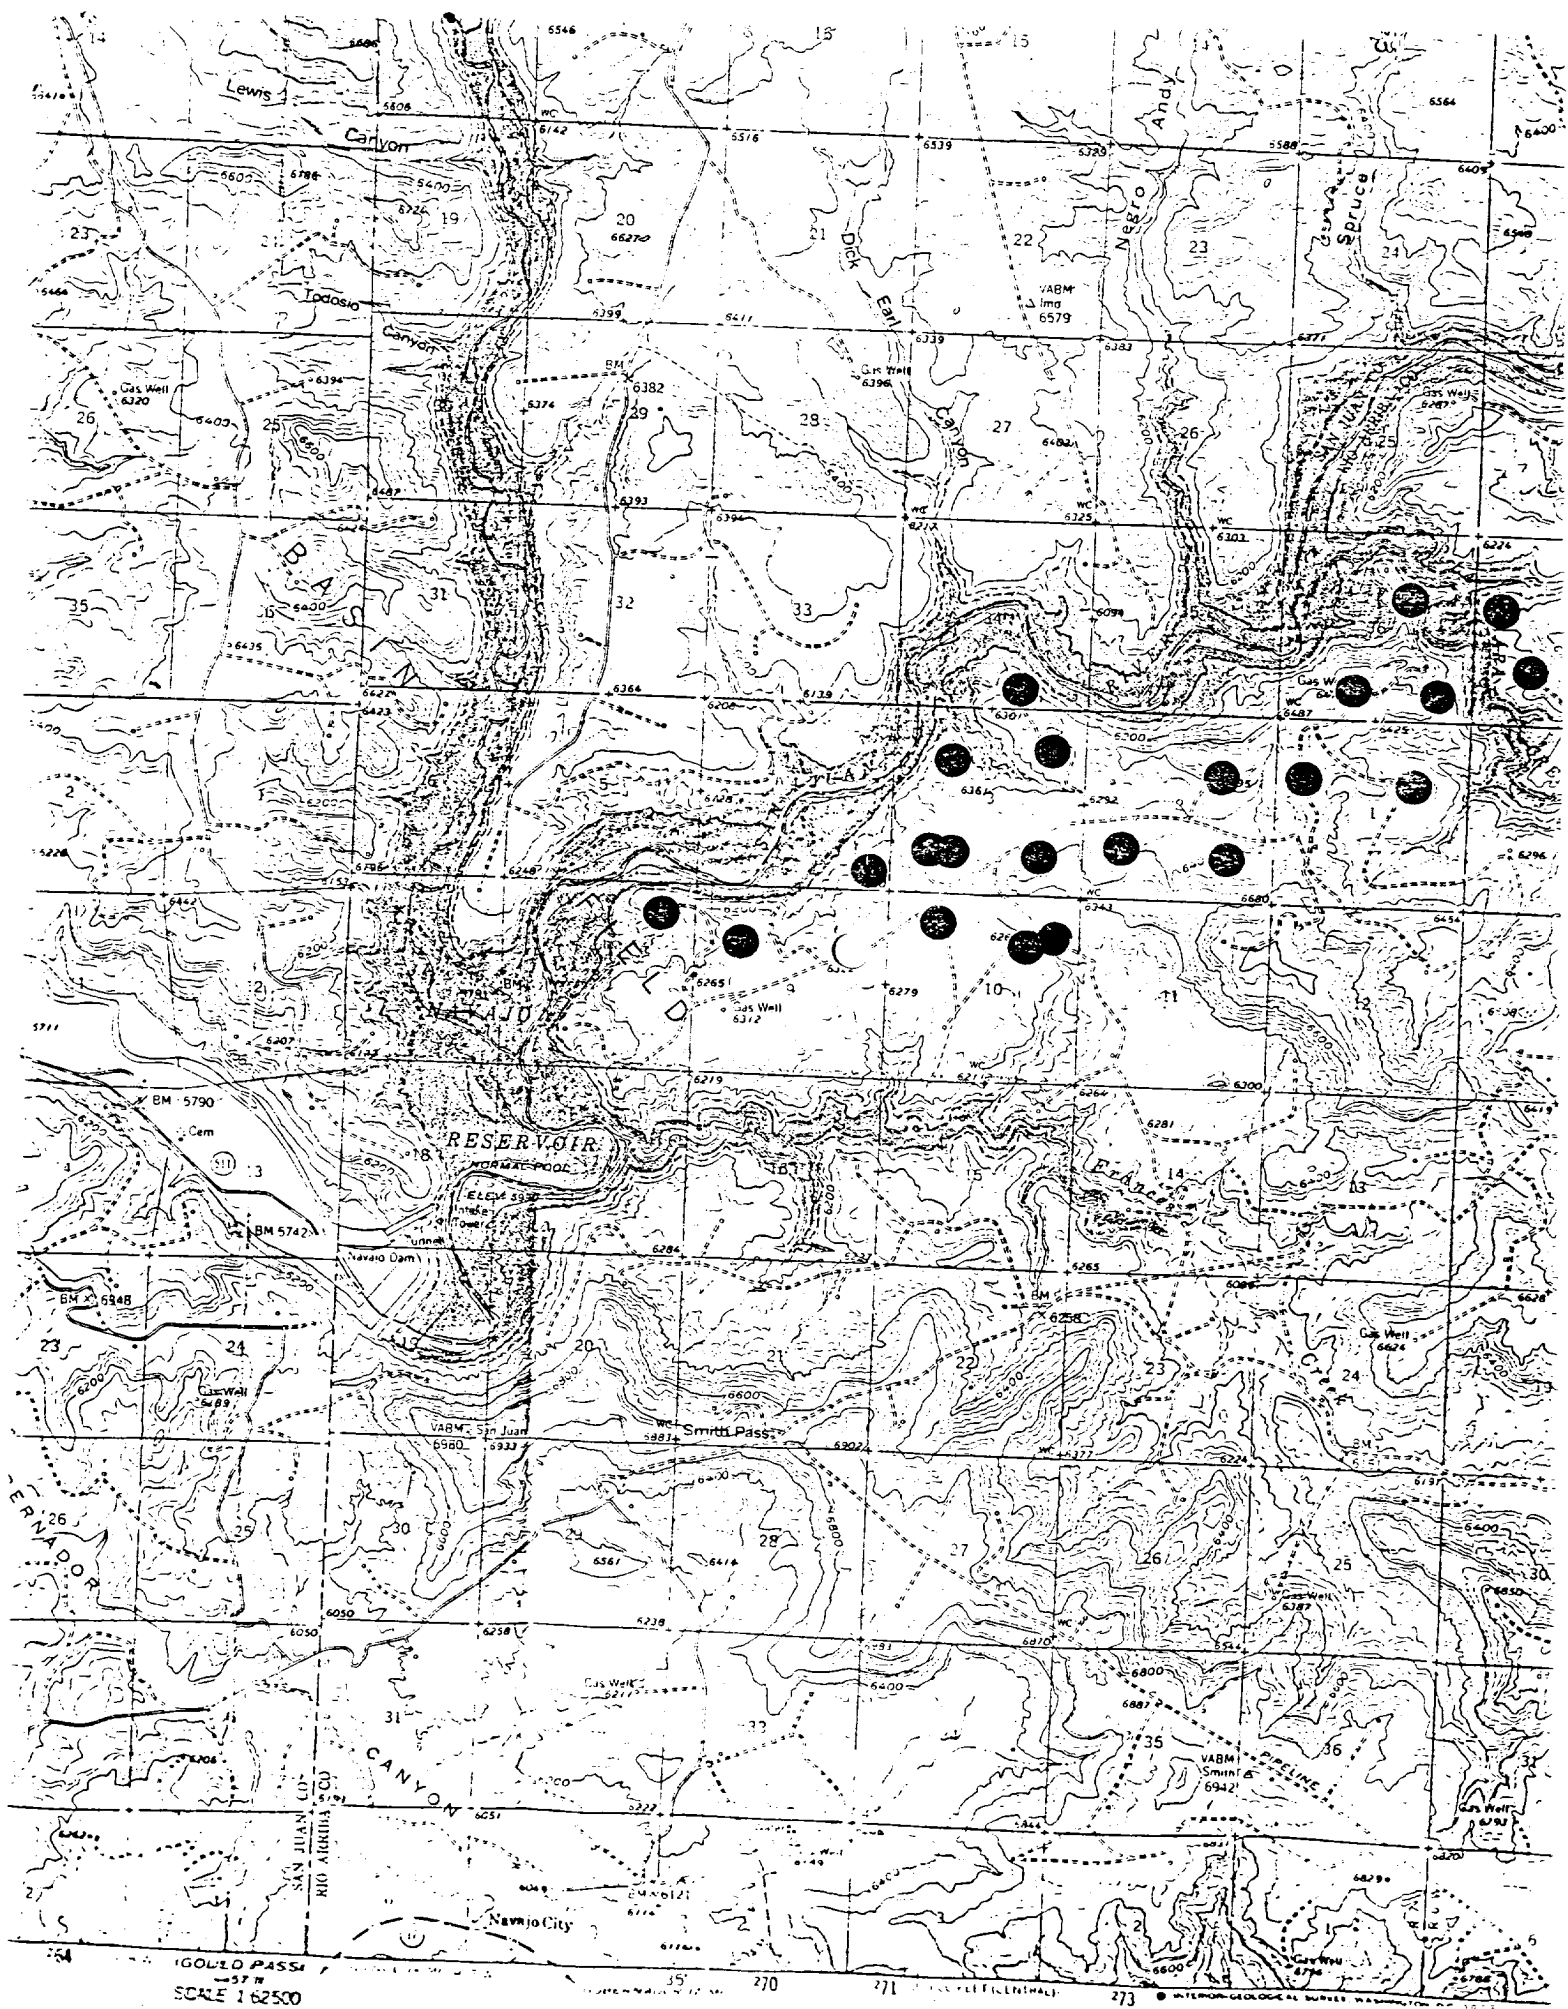
Northeast Blanco Unit #101
NE Section 10, T-30-N, R-7-W

This well, formerly the Howell B #1X, was spudded in August, 1957, and completed in October, 1957. In June 1972, holes were found in the 5 1/2" casing from 1520' to 1820' and were squeezed with 400 sks. Cement was circulated between the 7 5/8" and 5 1/2" casing. The casing was pressure tested to 1000 psi, held okay, and 2 3/8" tubing was rerun. During the past eleven years, the casing may have developed another leak. However, it is unlikely, considering the squeeze cementing, that the well is leaking gas to a shallow formation unless it is communicating with the plugged Howell B #1.

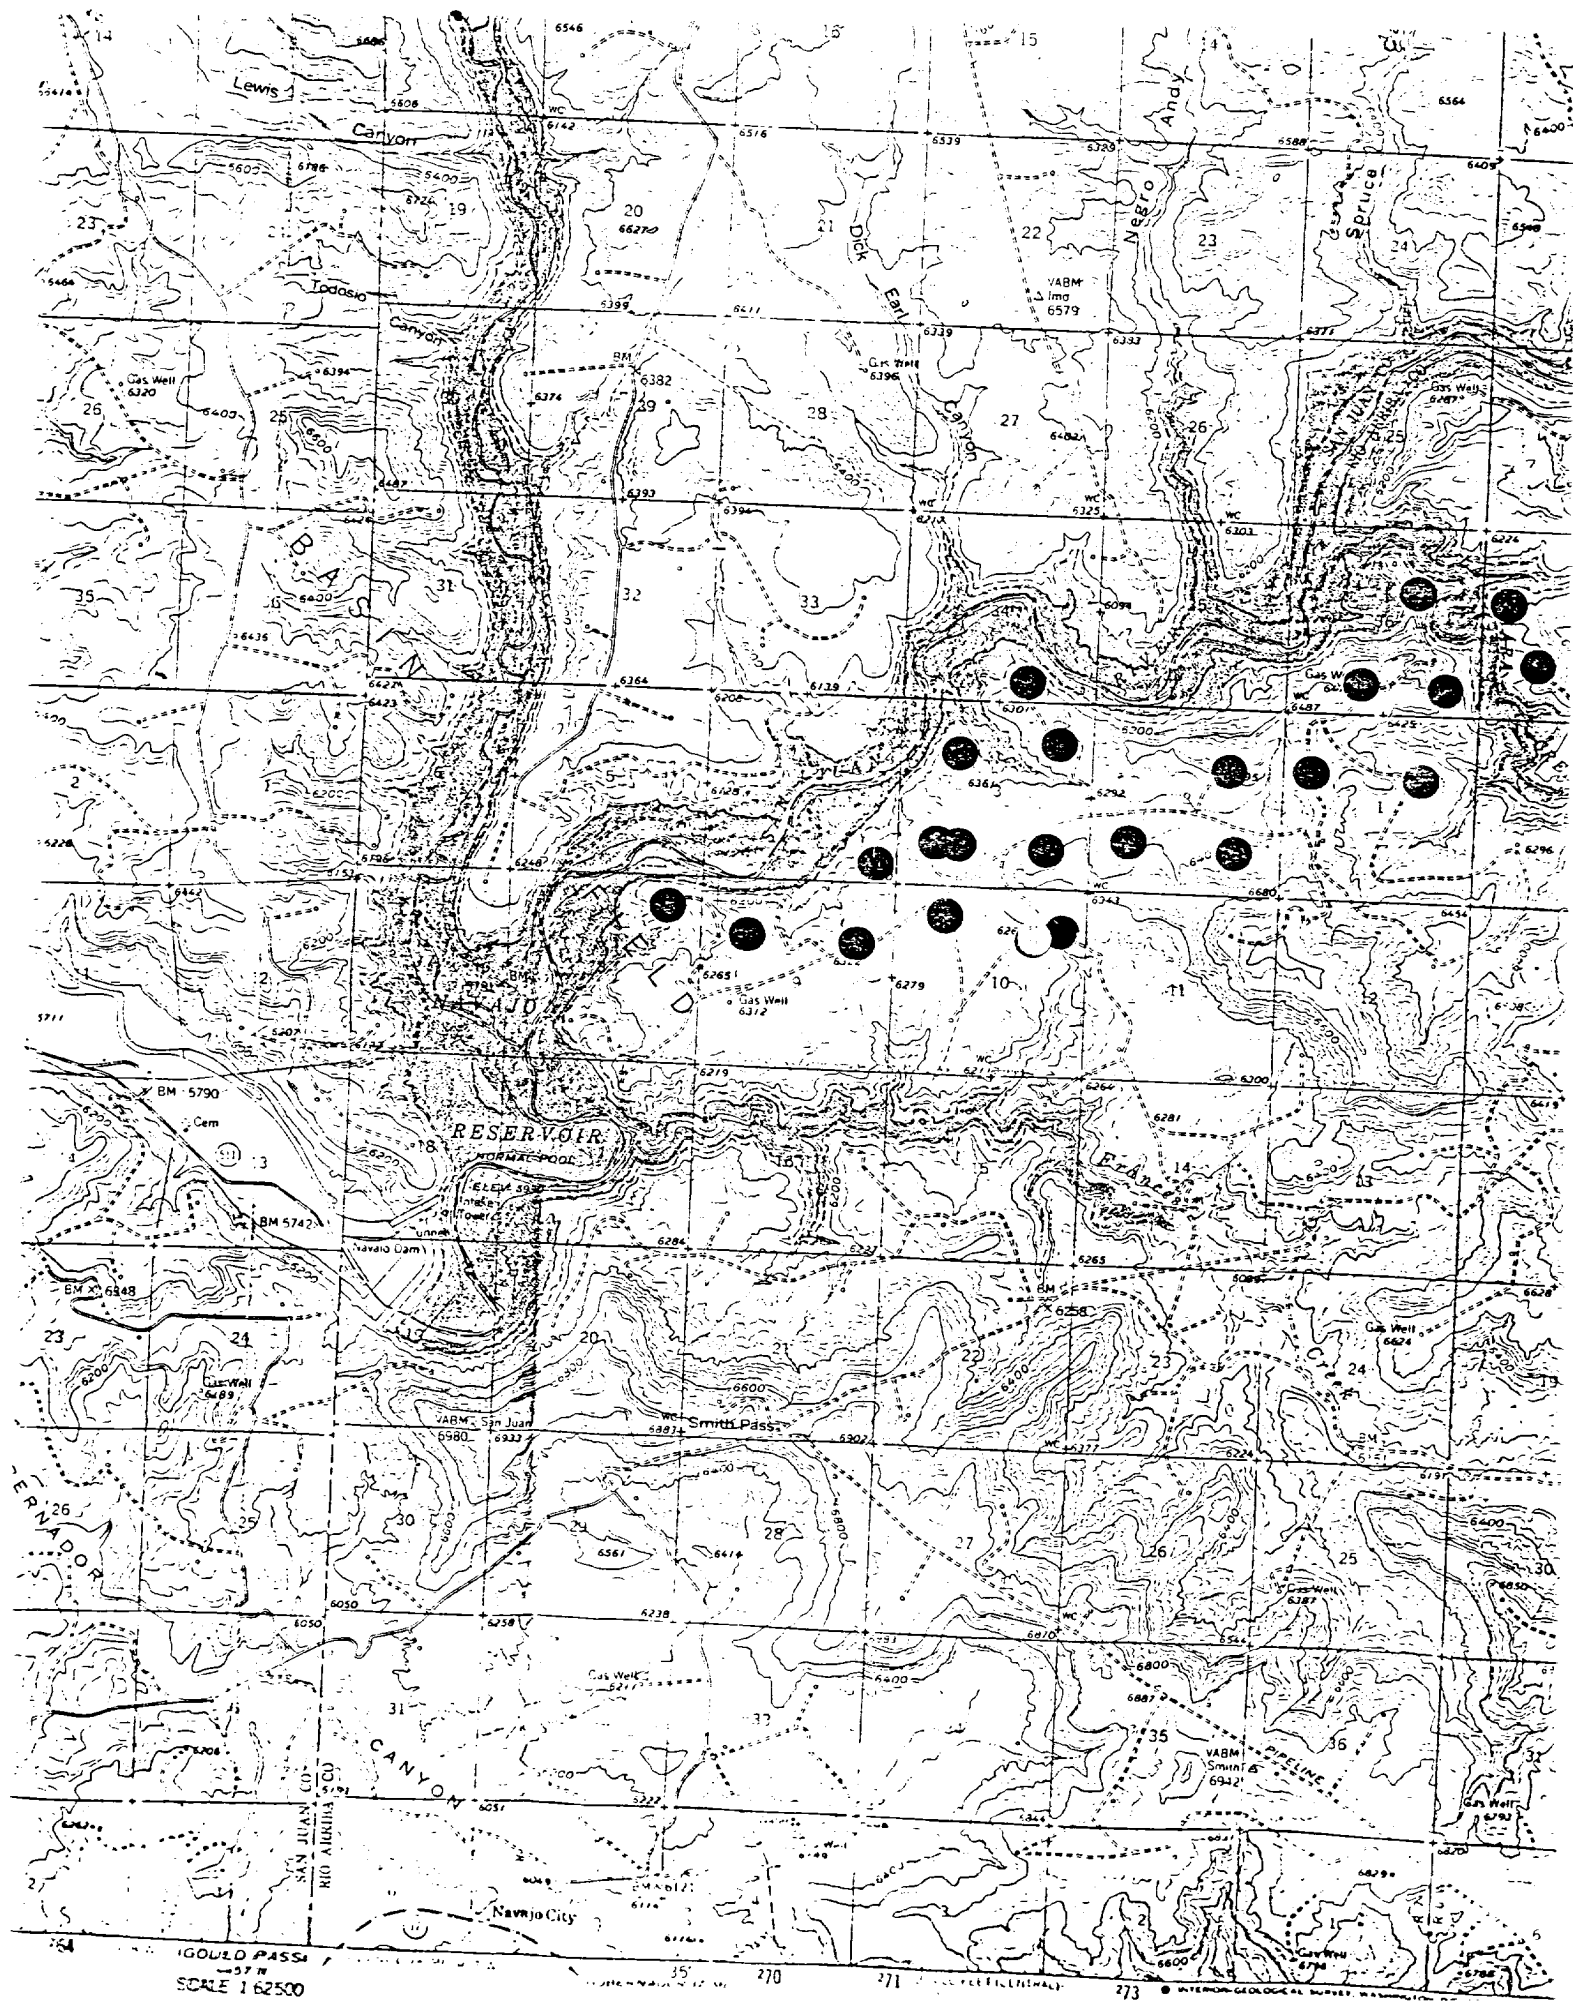
Northeast Blanco Unit #8A
NW Section 10, T-30-N, R-7-W

This well was drilled in 1978. The corrosive Ojo Alamo water is covered with cement according to temperature survey. The well does not have cathodic protection.

The tubing has not been pulled and the casing tested since completion.

It is unlikely this well is leaking gas; however, gas could be migrating in the 7" x 8 3/4" annulus if the 7" casing has failed.

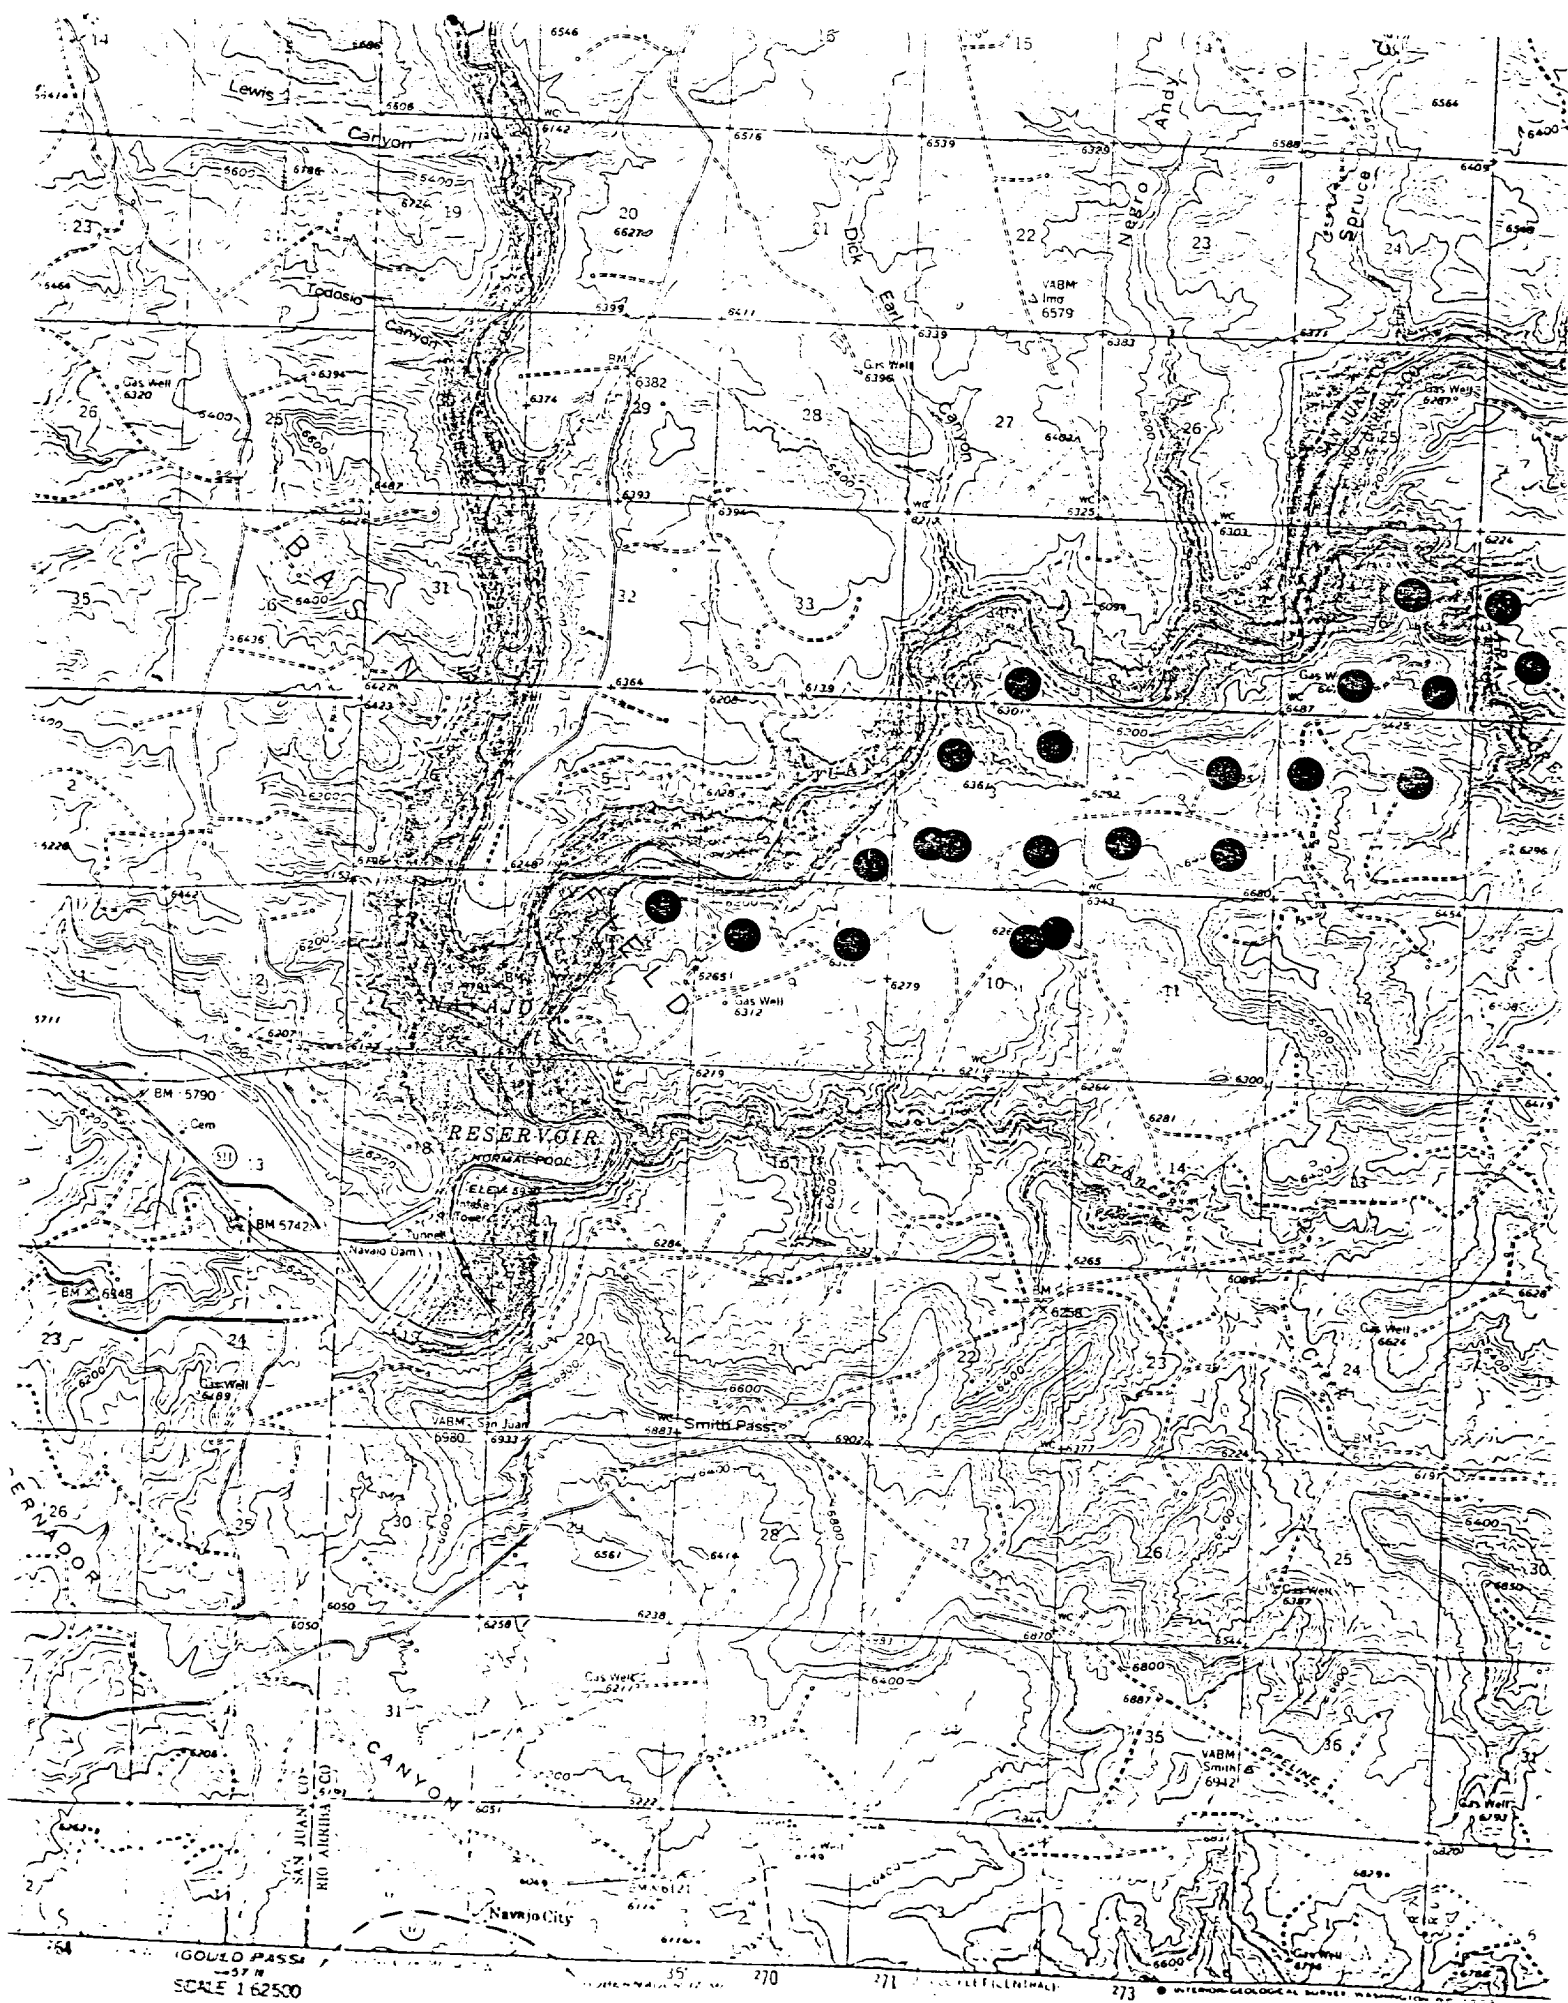
Howell B #1 (P&A)
NE Section 10, T-30-N, R-7-W

This well was drilled in 1951. The 7" casing collapsed and parted at 2259'. A retainer was set at 2125' and the well was squeezed with 100 sks. The well was temporarily abandoned until 1958 when the 7" casing was perforated at 200' and cement circulated to surface. The well was abandoned.

It may be assumed that the 100 sks. of cement pumped through the retainer at 2125' dropped to the open hole section from 4931' to 5523' and was lost into the fractured Point Lookout. This would allow Cliff House and Fruitland gas to migrate to shallow formations and into the lake.

This well does not have the Fruitland covered with cement.

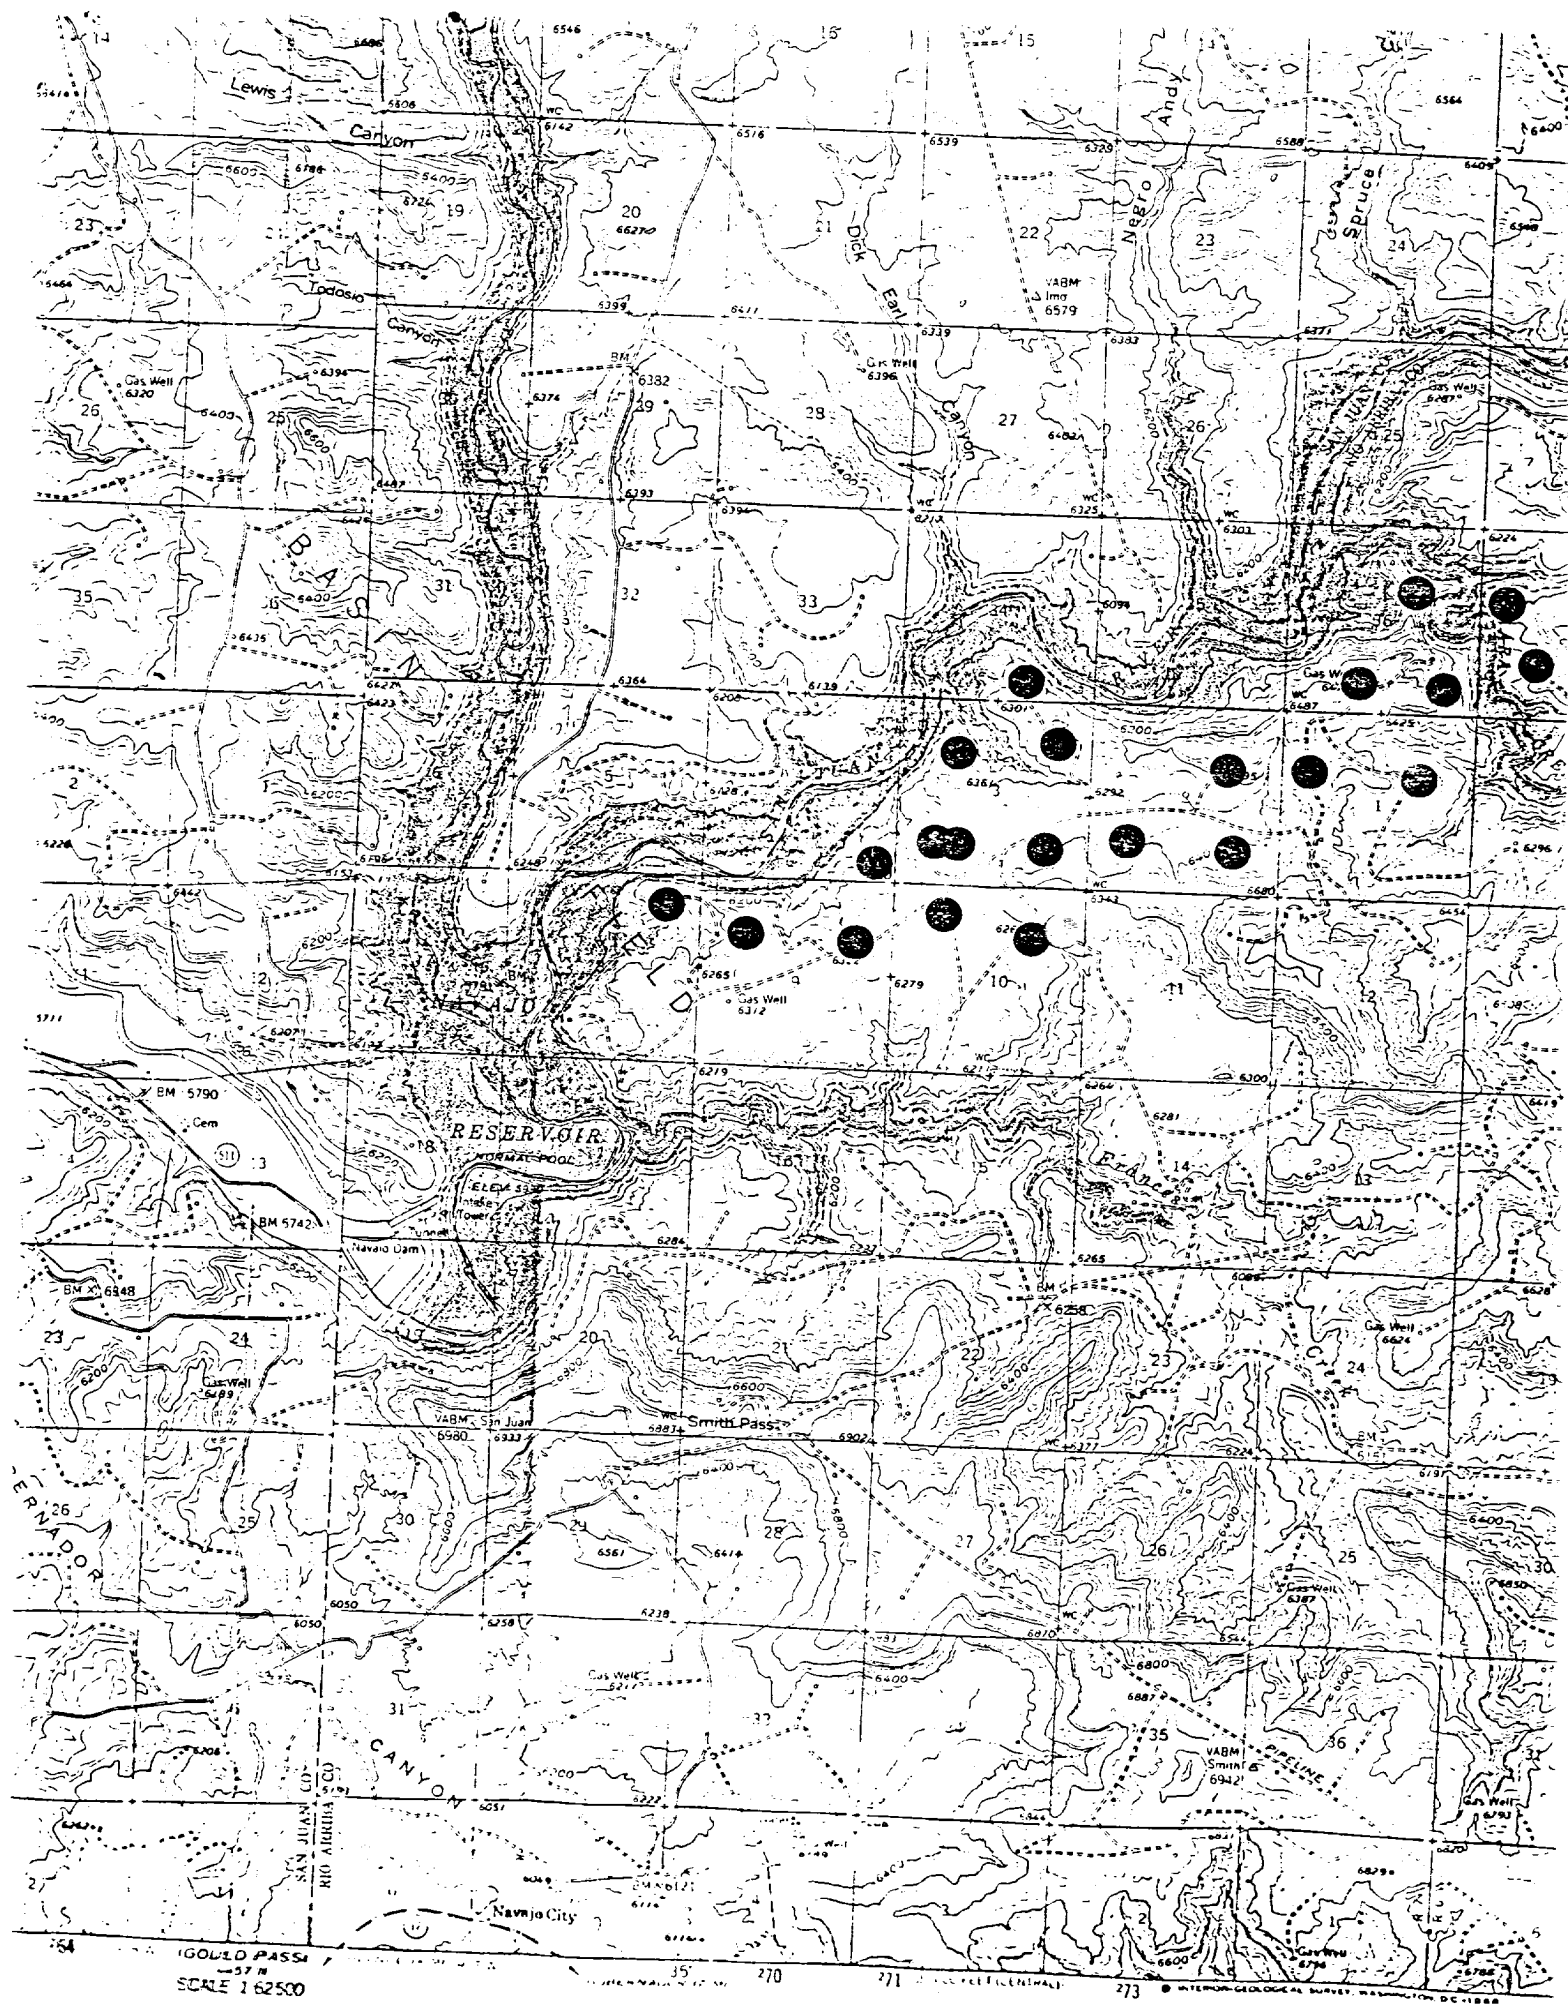
Northeast Blanco Unit #16
NE Section 3, T-30-N, R-7-W

This well was drilled and completed in July, 1954. In May, 1962, the tubing was pulled and the well was cleaned out to 5525'. A long string of 4" and 4 1/2" casing was set at 5510' with the change over at 4976'. A temperature survey showed the top of cement at 2450'. The 4 1/2" and 7" casing annulus was then cemented and circulated to surface. The casing was tested to 1500 psi and held okay. The well has not been entered since that time and appears to have good cement coverage.

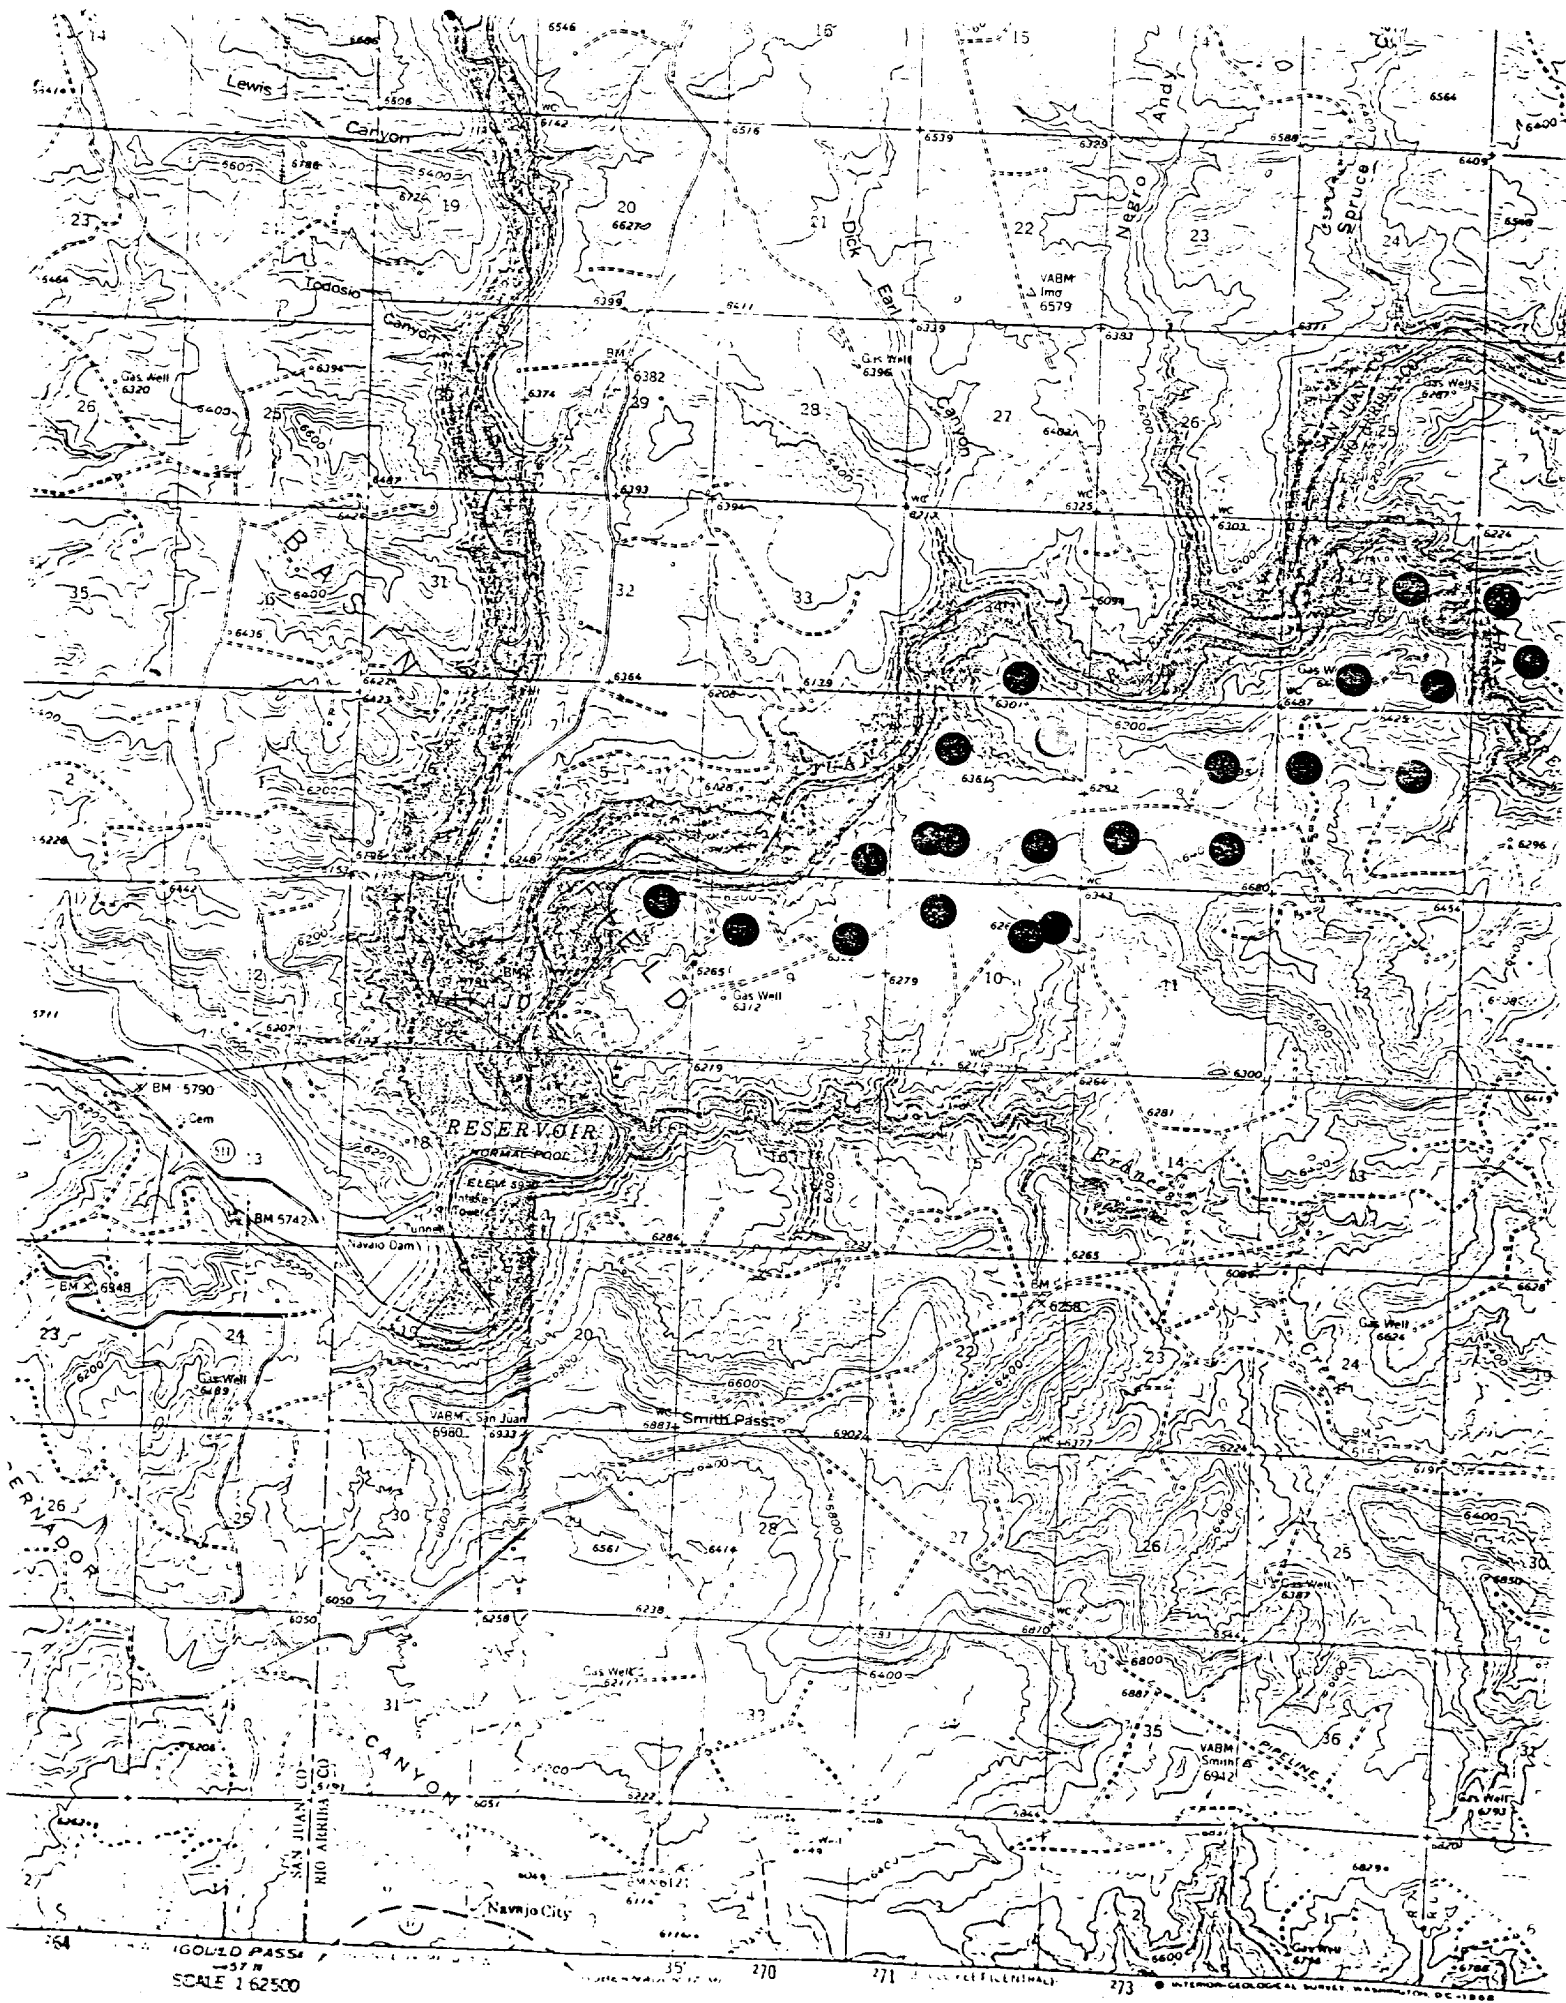
Northeast Blanco Unit #102
SW Section 3, T-30-N, R-7-W

This well, formerly the Howell #2B, was spudded in November, 1951, and completed in March, 1953. In May, 1958, the open hole was found to be caved in through the Menefee zone and the 7" casing parted at 1577'. A full string of 4 1/2" casing was set at 5624'. The initial cement job did not stop gas flow behind the casing and two days later was squeezed. Since May, 1958, the tubing has not been pulled nor the casing tested with a packer. During the past 25 years, it is likely that a casing leak may have developed. However, the condition of this well is such that if a casing leak has developed, migration of gas to shallow zone would not be likely.

The Ojo Alamo is not covered with cement nor does the well have cathodic protection.

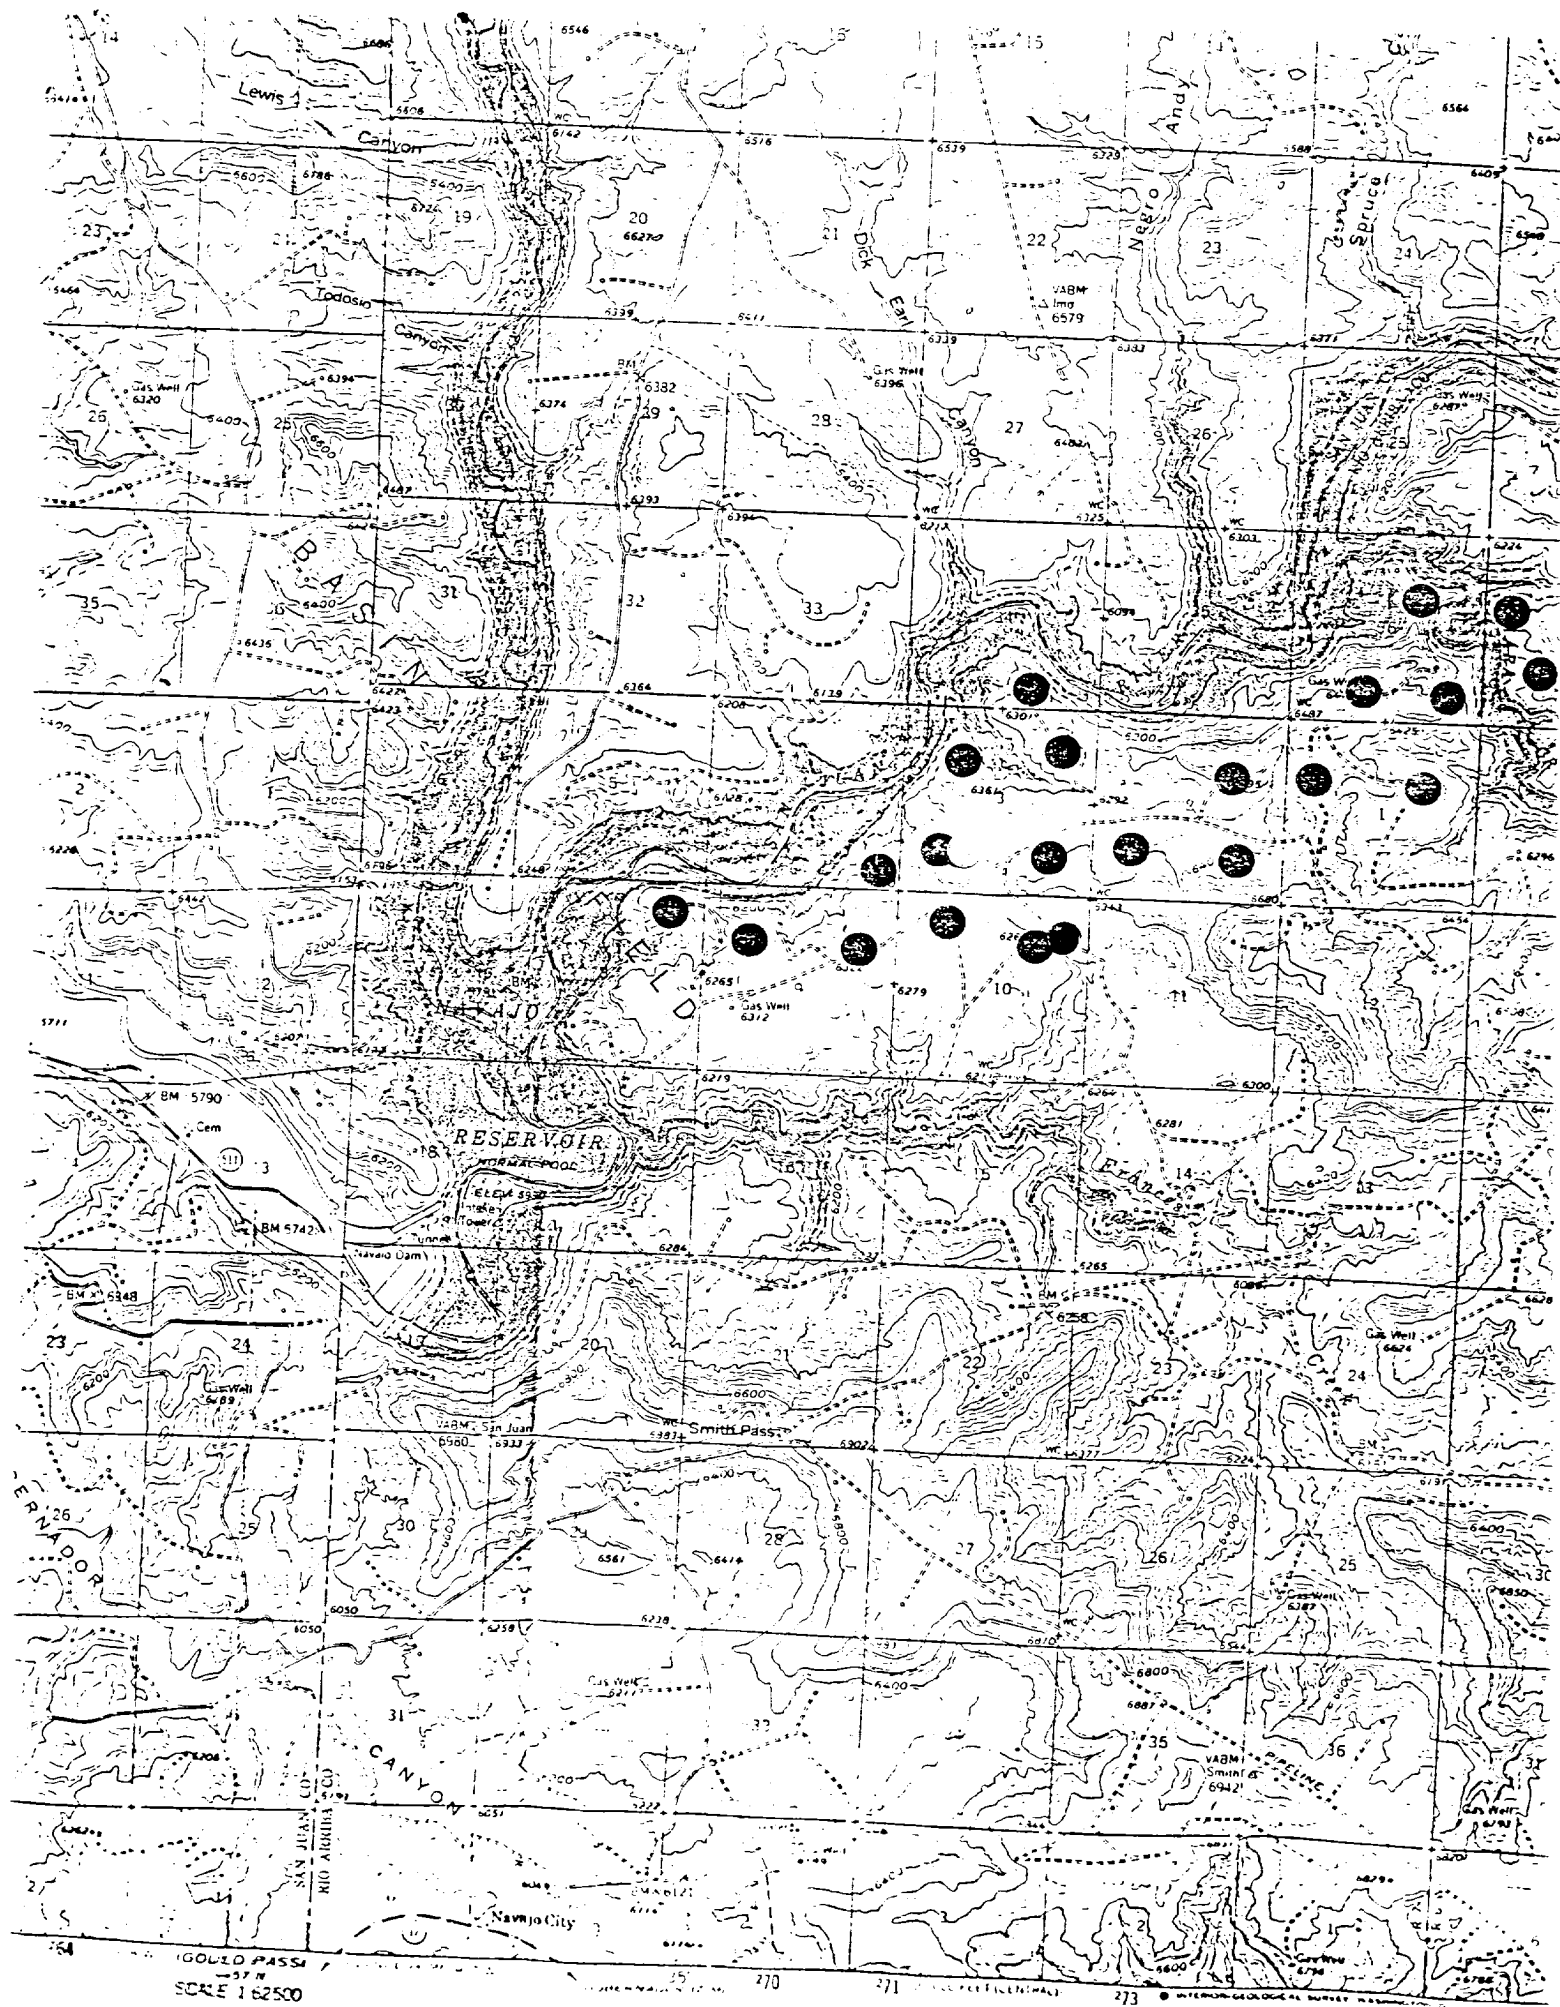
Northeast Blanco Unit #15
SW Section 2, T-30-N, R-7-W

This well was drilled and completed in May and June 1954. In July, 1966, the tubing was found to be stuck at 5300'. The tubing was cut at 5280' and the 7" was found corroded from 800' to 2440' with a hole at 870'. The casing was squeezed and the hole whipstocked at 4849'. A full string of 4 1/2" casing was set at 5640' and cemented in two stages. The Mesa Verde was completed in two stages and 178 joints of 2 3/8" tubing was run. Since 1966 the well has not been entered and may have developed a casing leak. However, it is not likely that a leak would migrate to a shallow formation.
