Well File
Howell B #3
S/W 3-30N-7W

MEMORANDUM

Subject: Howell B #3
Adjacent Well Data

Attached is the data concerning the wells adjacent to the Howell B #3. The data includes a schematic showing casing depths, cement tops, cemented intervals, and formation tops.

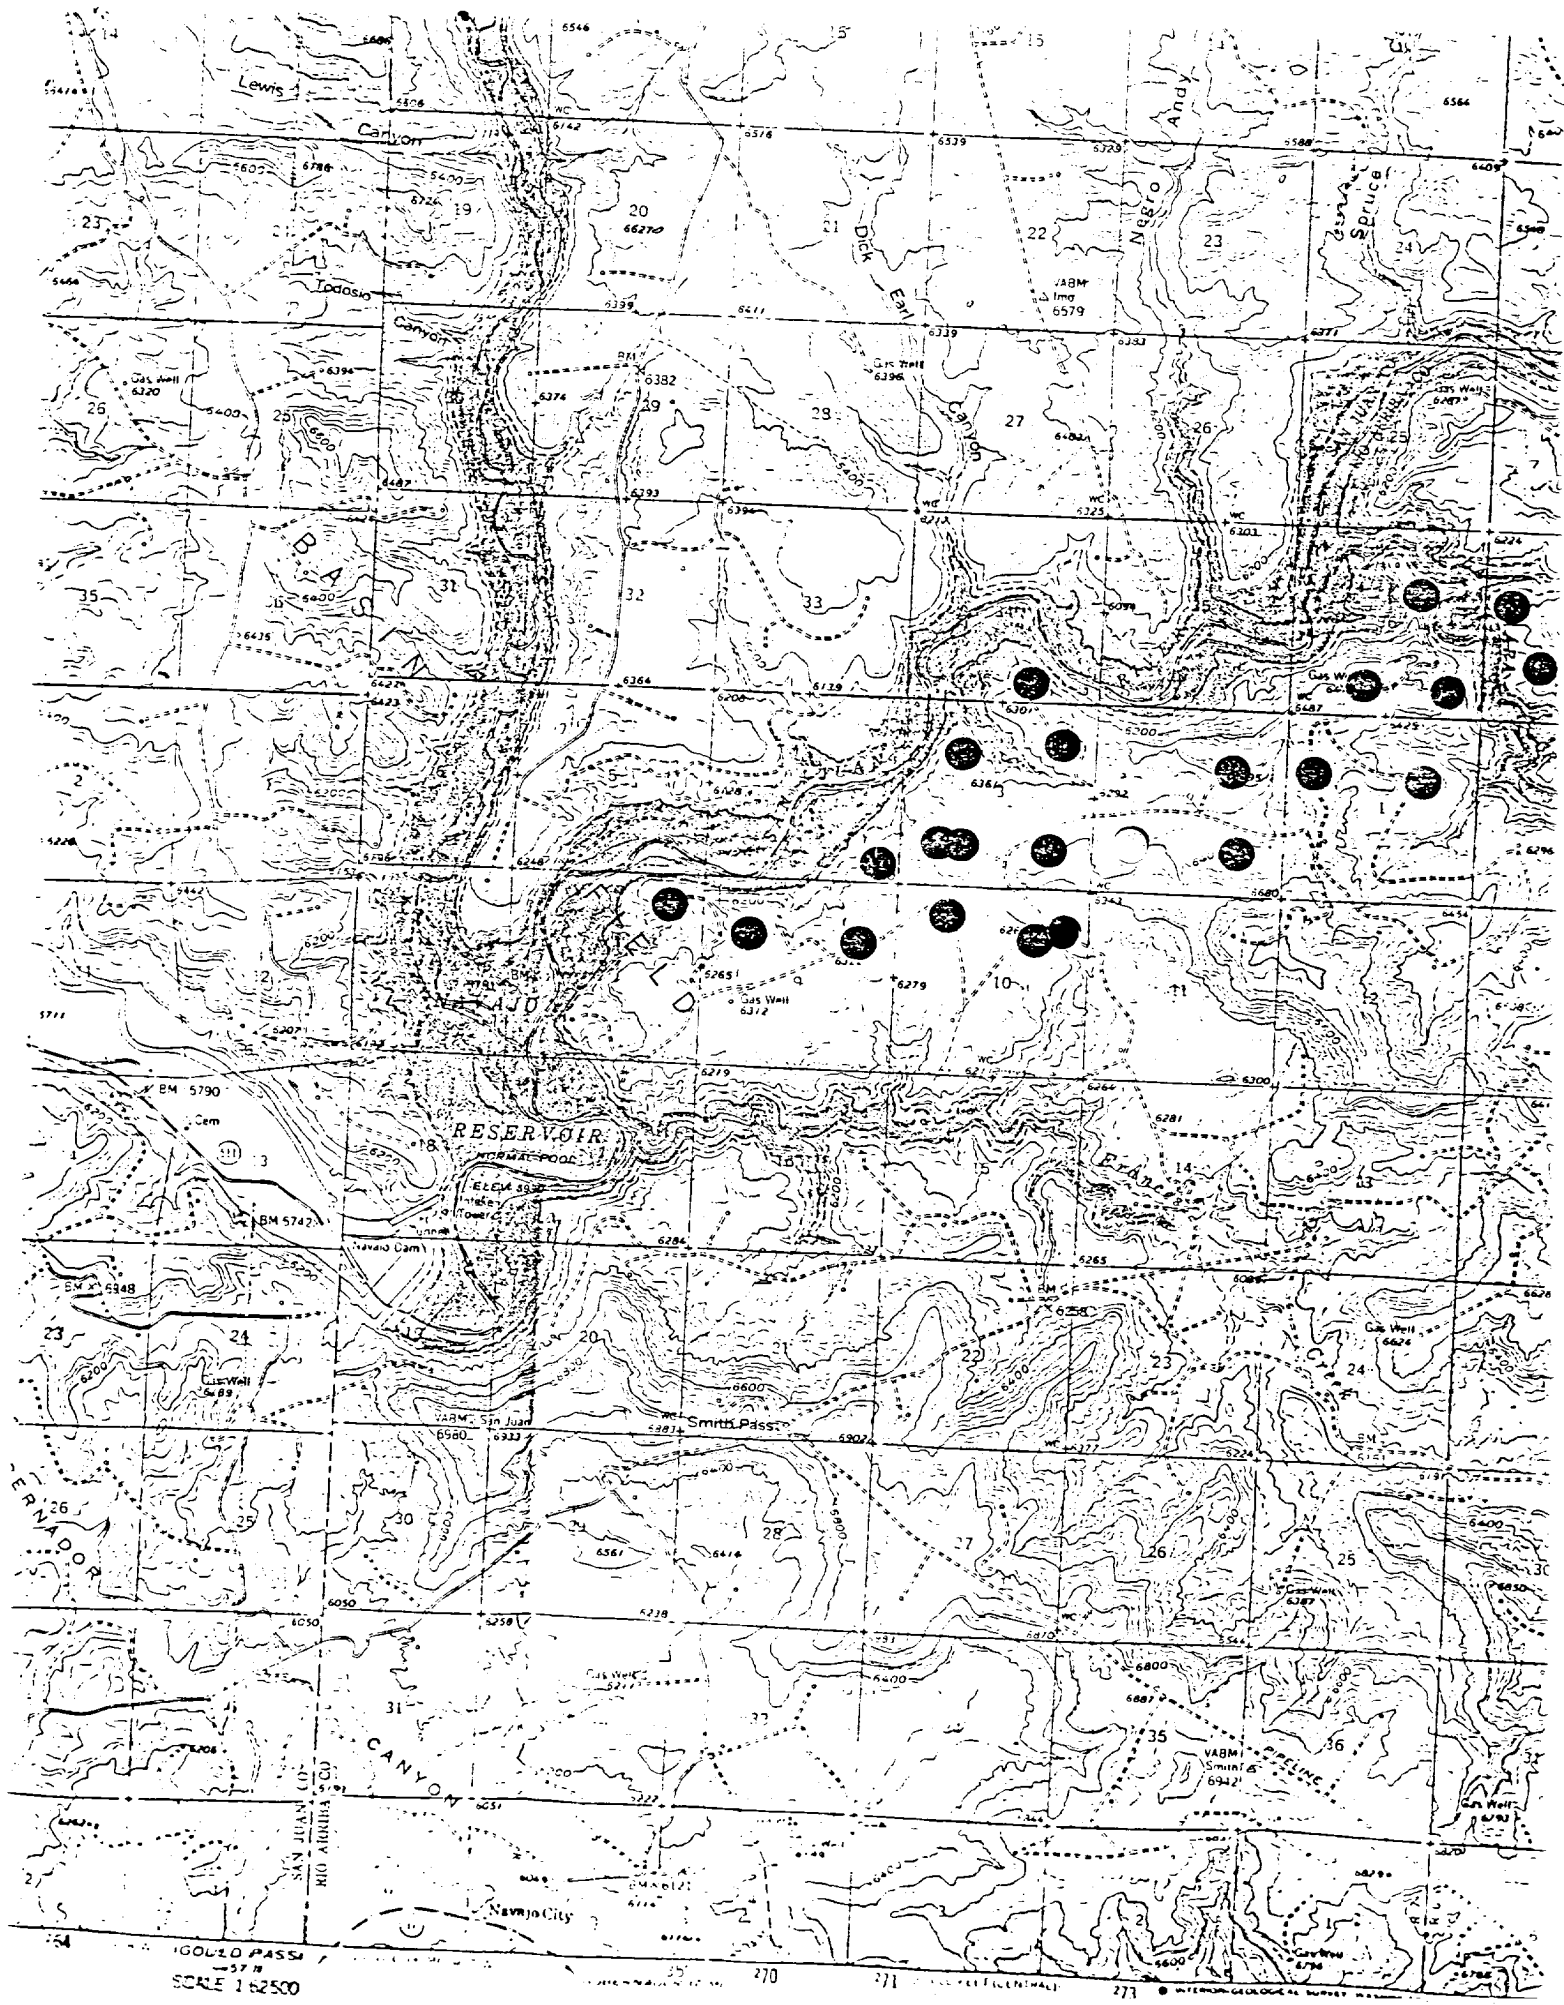
Northeast Blanco Unit #28
SE Section 34, T-31-N, R-7-W

This well was drilled and completed in October, 1955. In December, 1955, the tubing was pulled and the 5 1/2" casing was tested to 1200 psi, held okay. New hole was drilled to 5571' and a 4" flush joint liner was run from 5229' to 5570'. The liner was cemented with 35 sks. and then, two days later, squeezed through a perforation at 5436' with 75 sks. The Point Lookout and Cliff House were completed and 2 3/8" tubing run. Since that time, the well has not been entered and may have developed a casing failure. The Ojo Alamo is not covered.

This well would have to develop leaks in both the 5 1/2" and 7" casing strings to allow gas to escape to a shallow formation. This may be possible since the Ojo Alamo is not covered with cement nor does the well have cathodic protection.

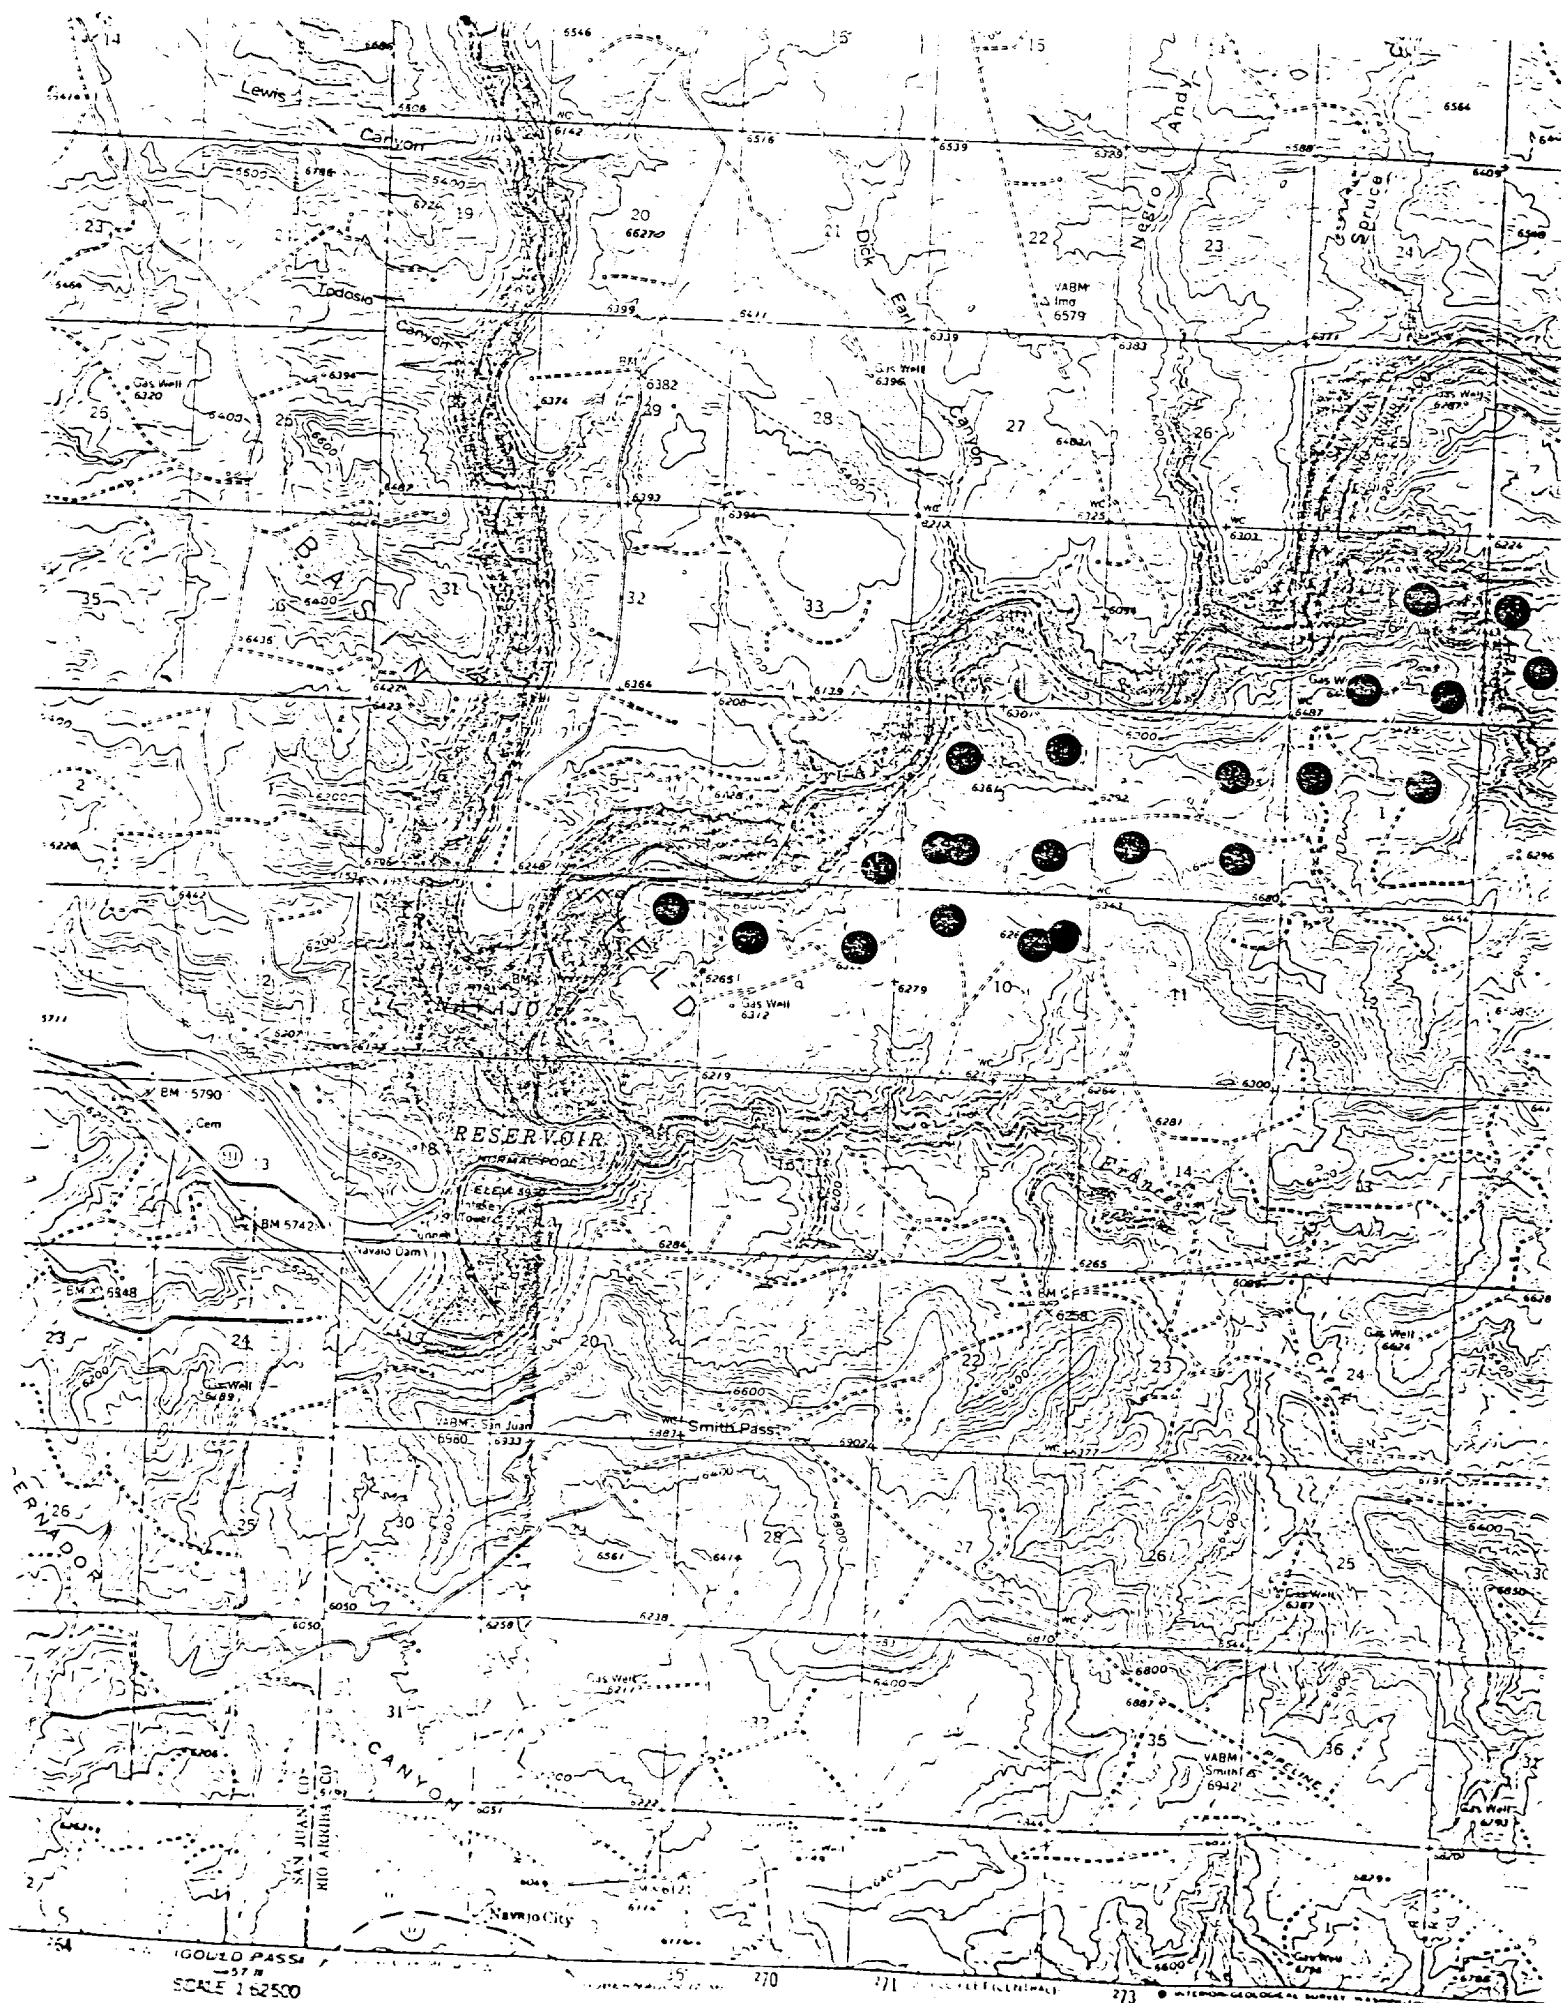
Northeast Blanco Unit #27
NE Section 8, T-30-N, R-7-W

This well was drilled in 1955 and has not been re-entered since. The calculated top of cement indicates coverage of the Ojo Alamo water. Cathodic protection is not installed on the well.

There is no record of testing the 5 1/2" x 7 5/8" annulus.

This well could be leaking and/or allowing gas migration to a shallow formation where it might eventually break out into the lake in the SE/4 of Section 3.

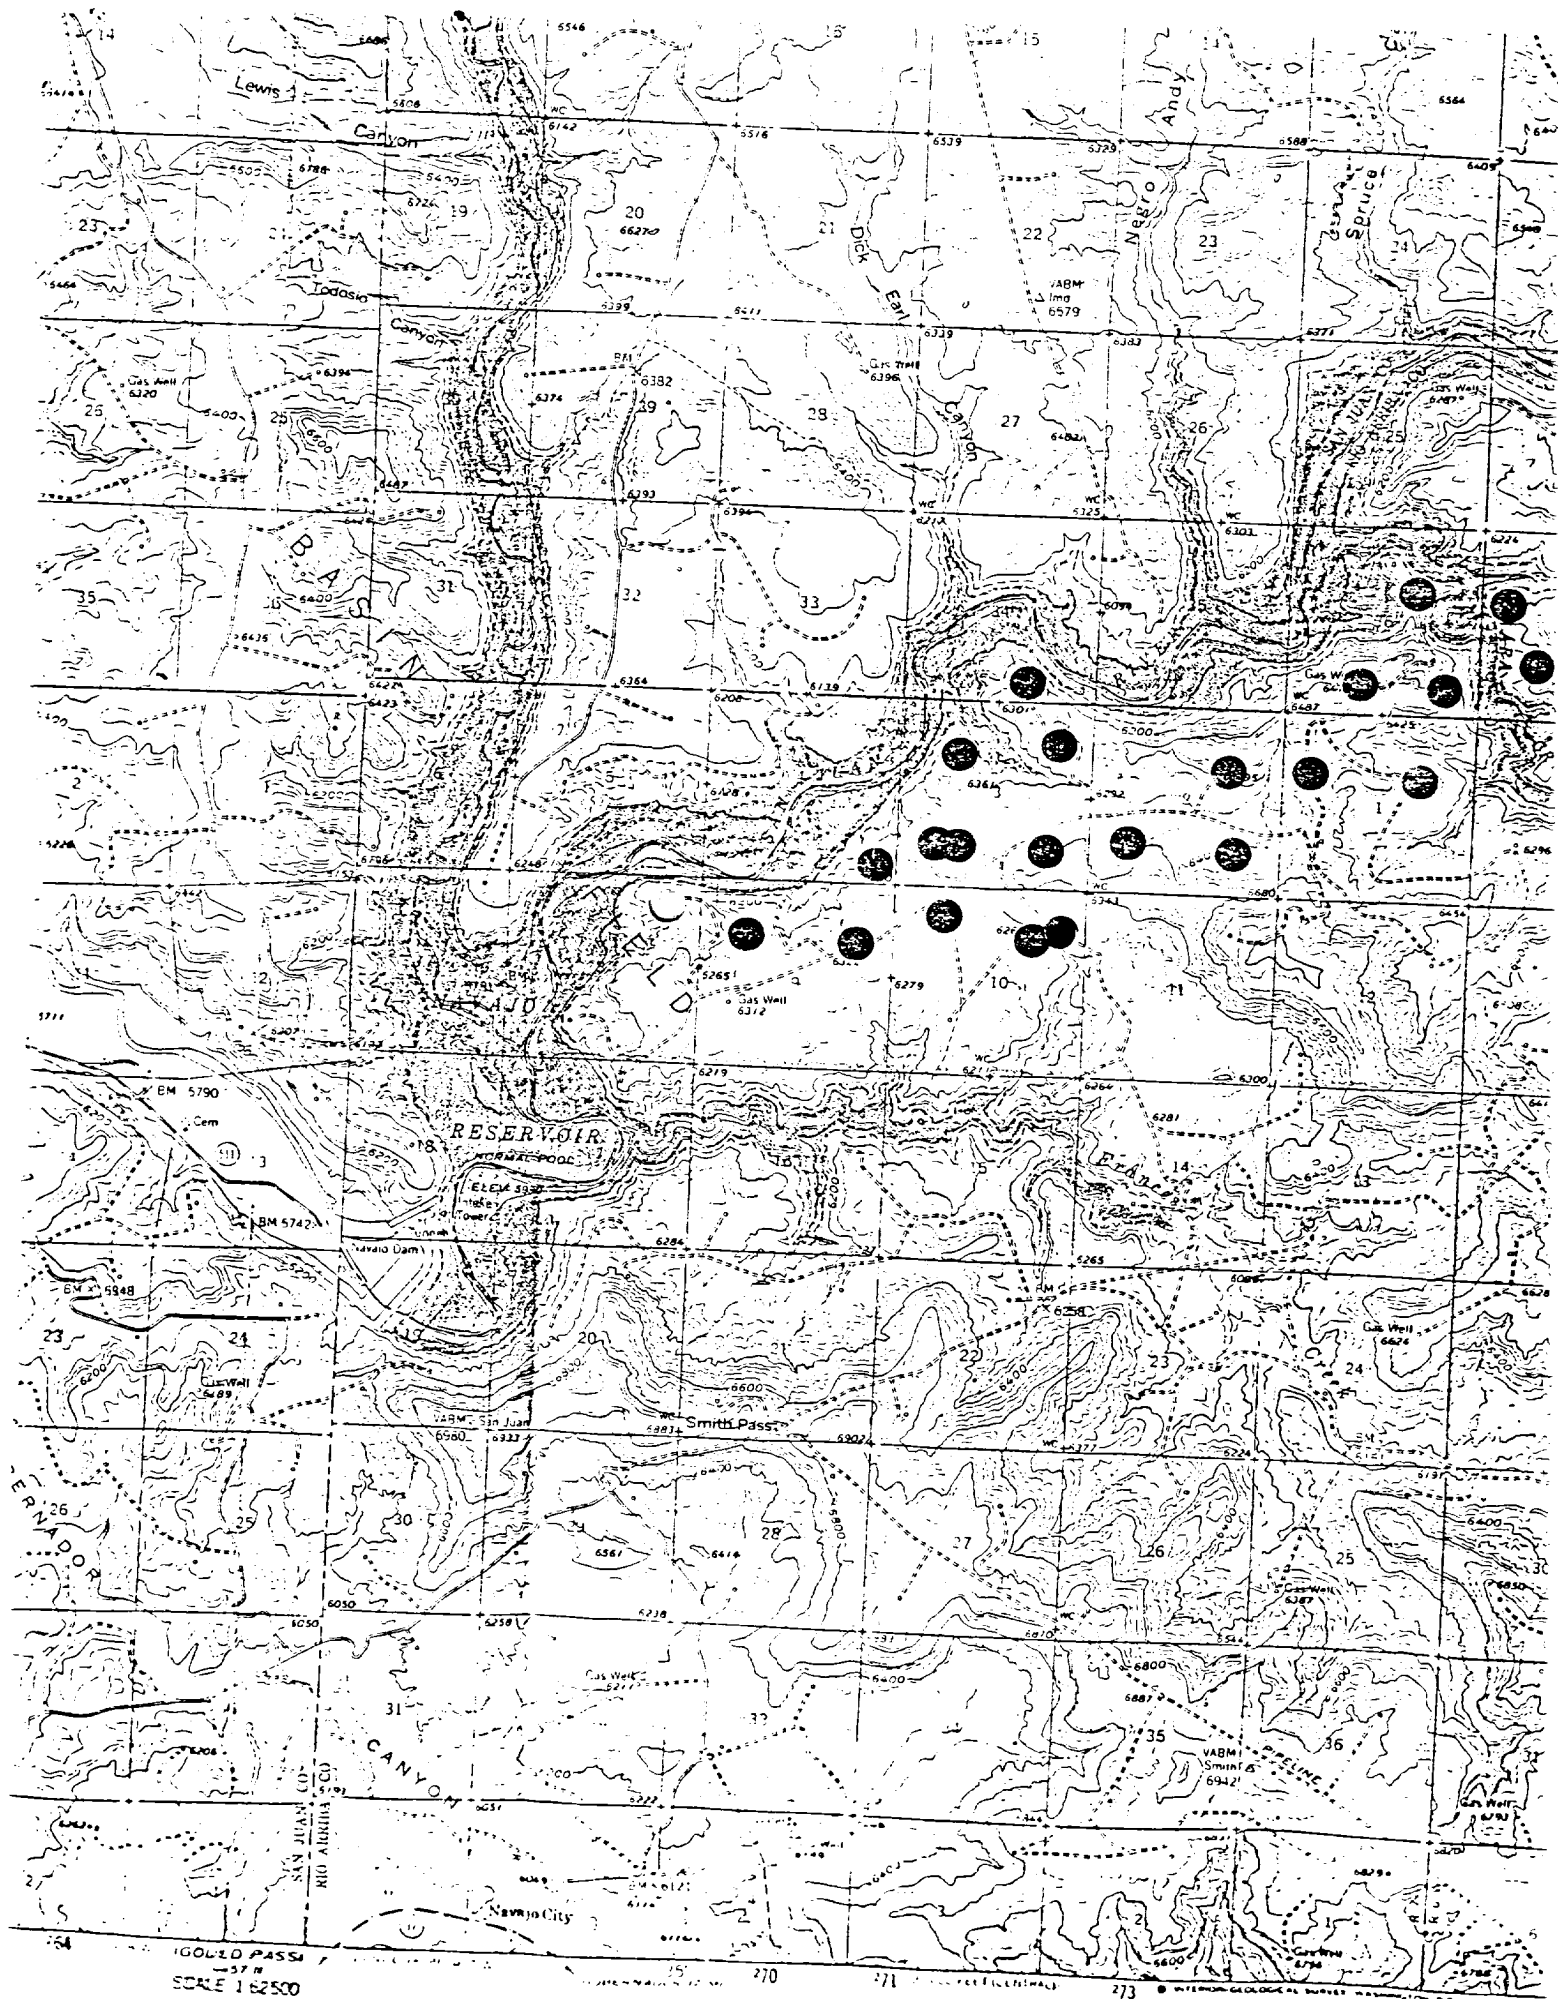
Northeast Blanco Unit #16A
SE Section 3, T-30-N, R-7-W

This well was drilled in 1978. The corrosive Ojo Alamo water is covered with cement according to temperature survey. The well does not have cathodic protection.

The tubing has not been pulled and the casing tested since completion.

It is unlikely this well is leaking gas; however, gas could be migrating in the 7" x 8 3/4" annulus if the 7" casing has failed.

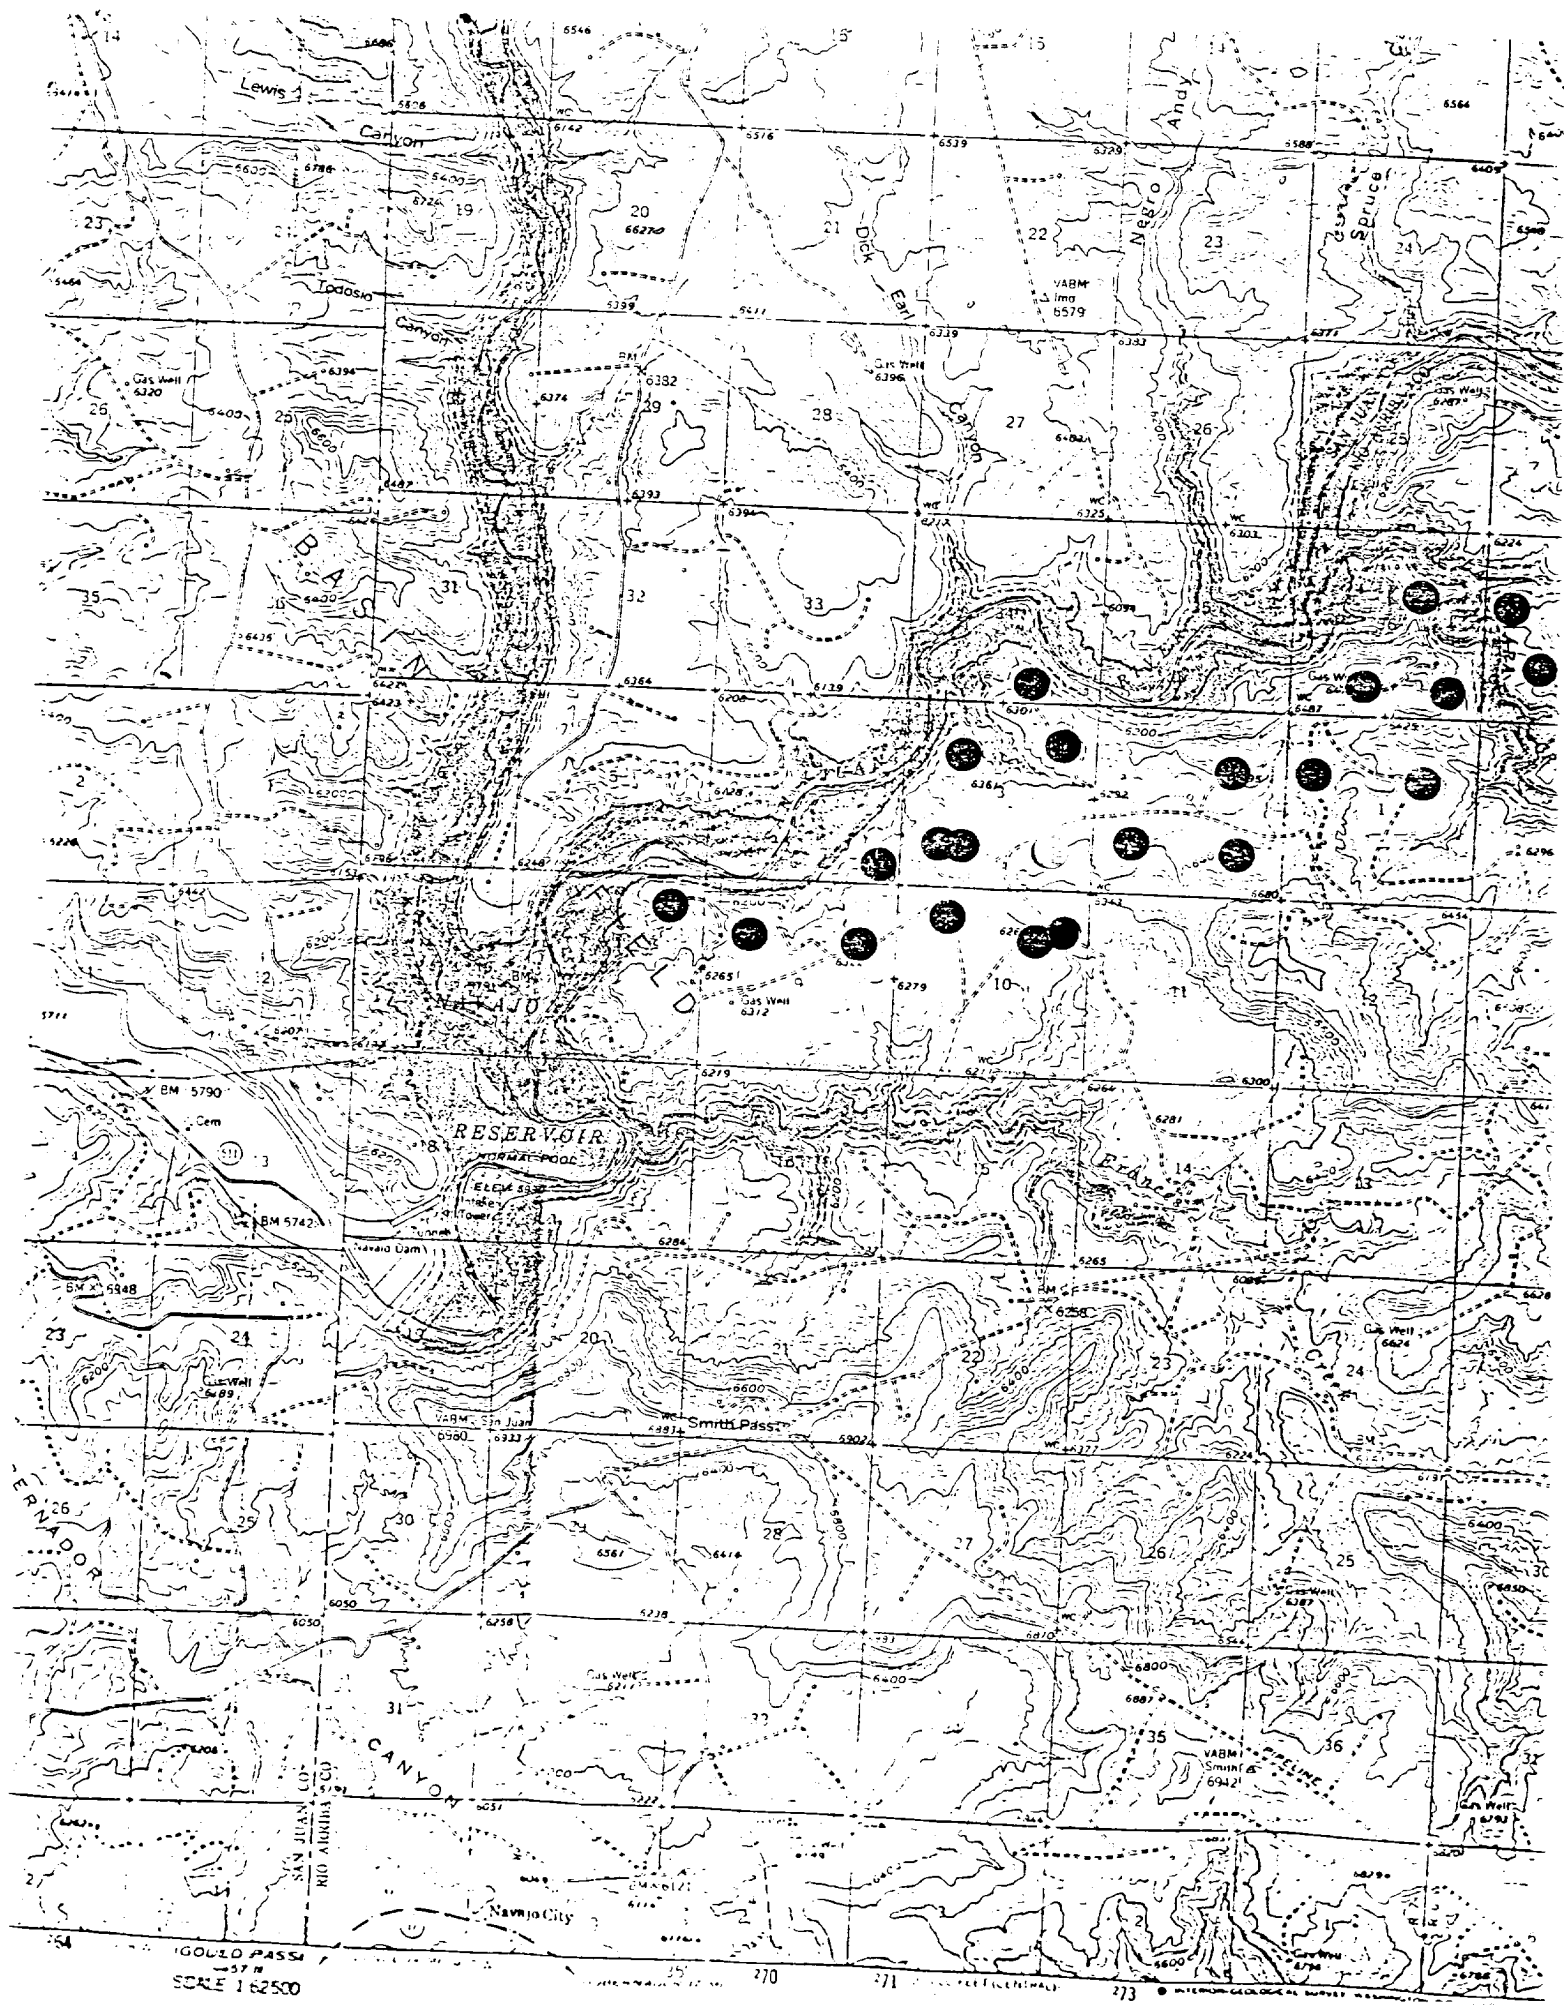
Northeast Blanco Unit #102A
NW Section 3, T-30-N, R-7-W

This well was drilled in 1978. The corrosive Ojo Alamo water is covered with cement according to temperature survey. The well does not have cathodic protection.

The tubing has not been pulled and the casing tested since completion.

It is unlikely this well is leaking gas; however, gas could be migrating in the 7" x 8 3/4" annulus if the 7" casing has failed.

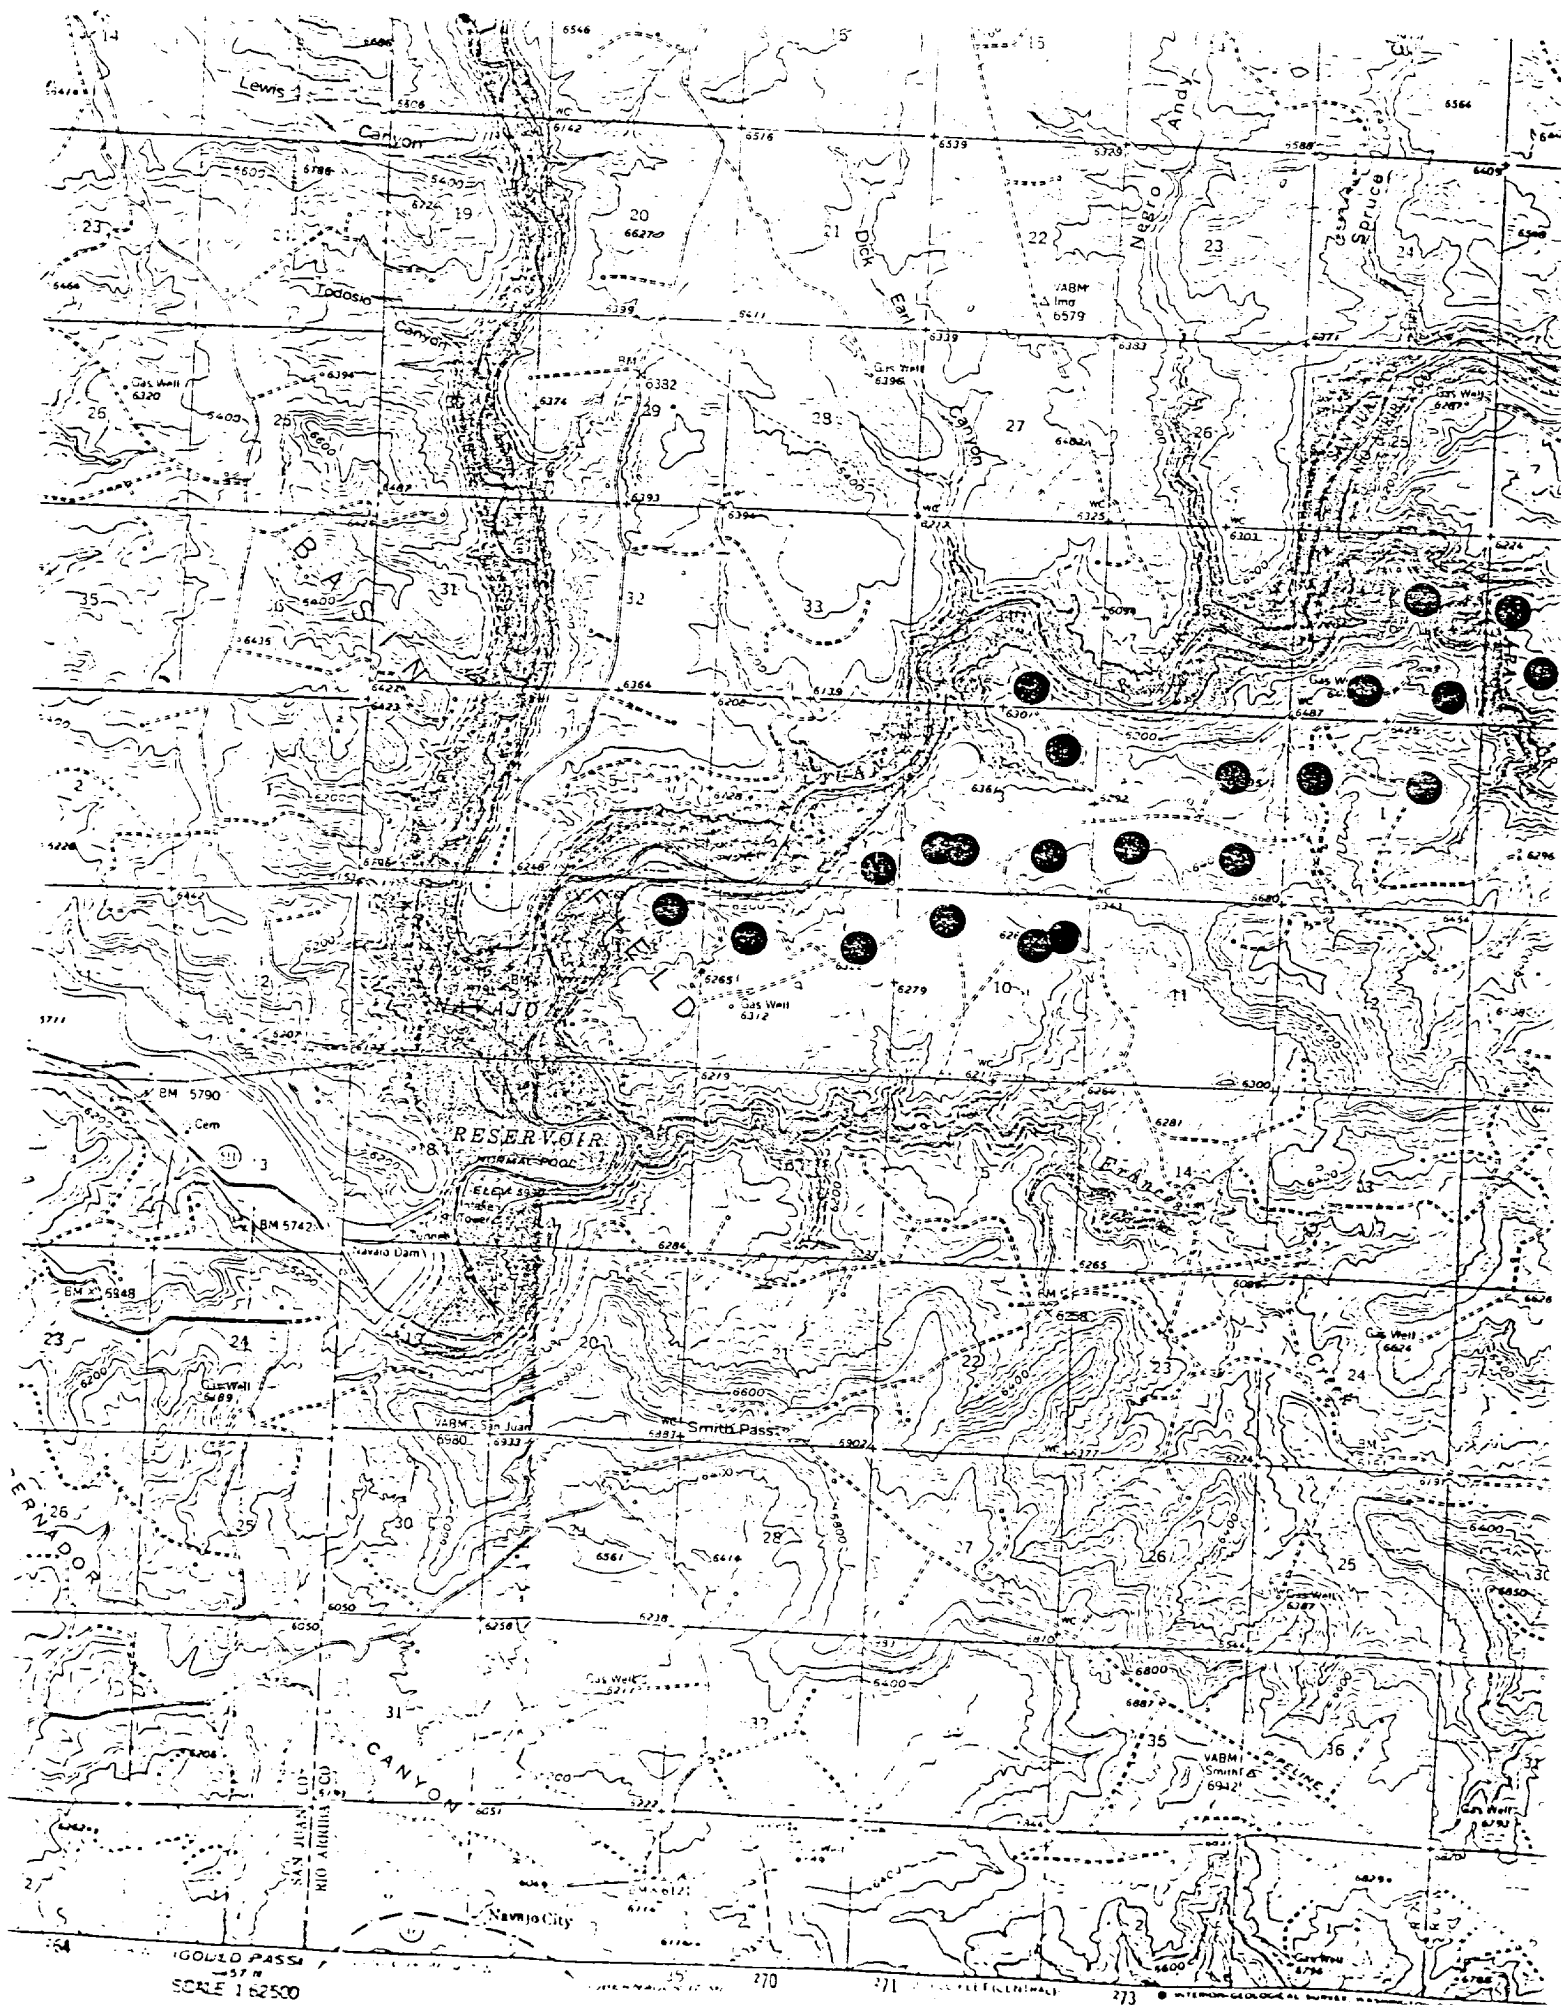
Northeast Blanco Unit #17A
NW Section 9, T-30-N, R-7-W

This well was drilled in 1978. The corrosive water of the Ojo Alamo are covered with cement. The well does not have cathodic protection. The tubing has not been pulled and the casing tested since completion. It is unlikely this well is leaking gas but gas could be migrating in the 7" x 8 3/4" annulus if the 7" casing has failed.

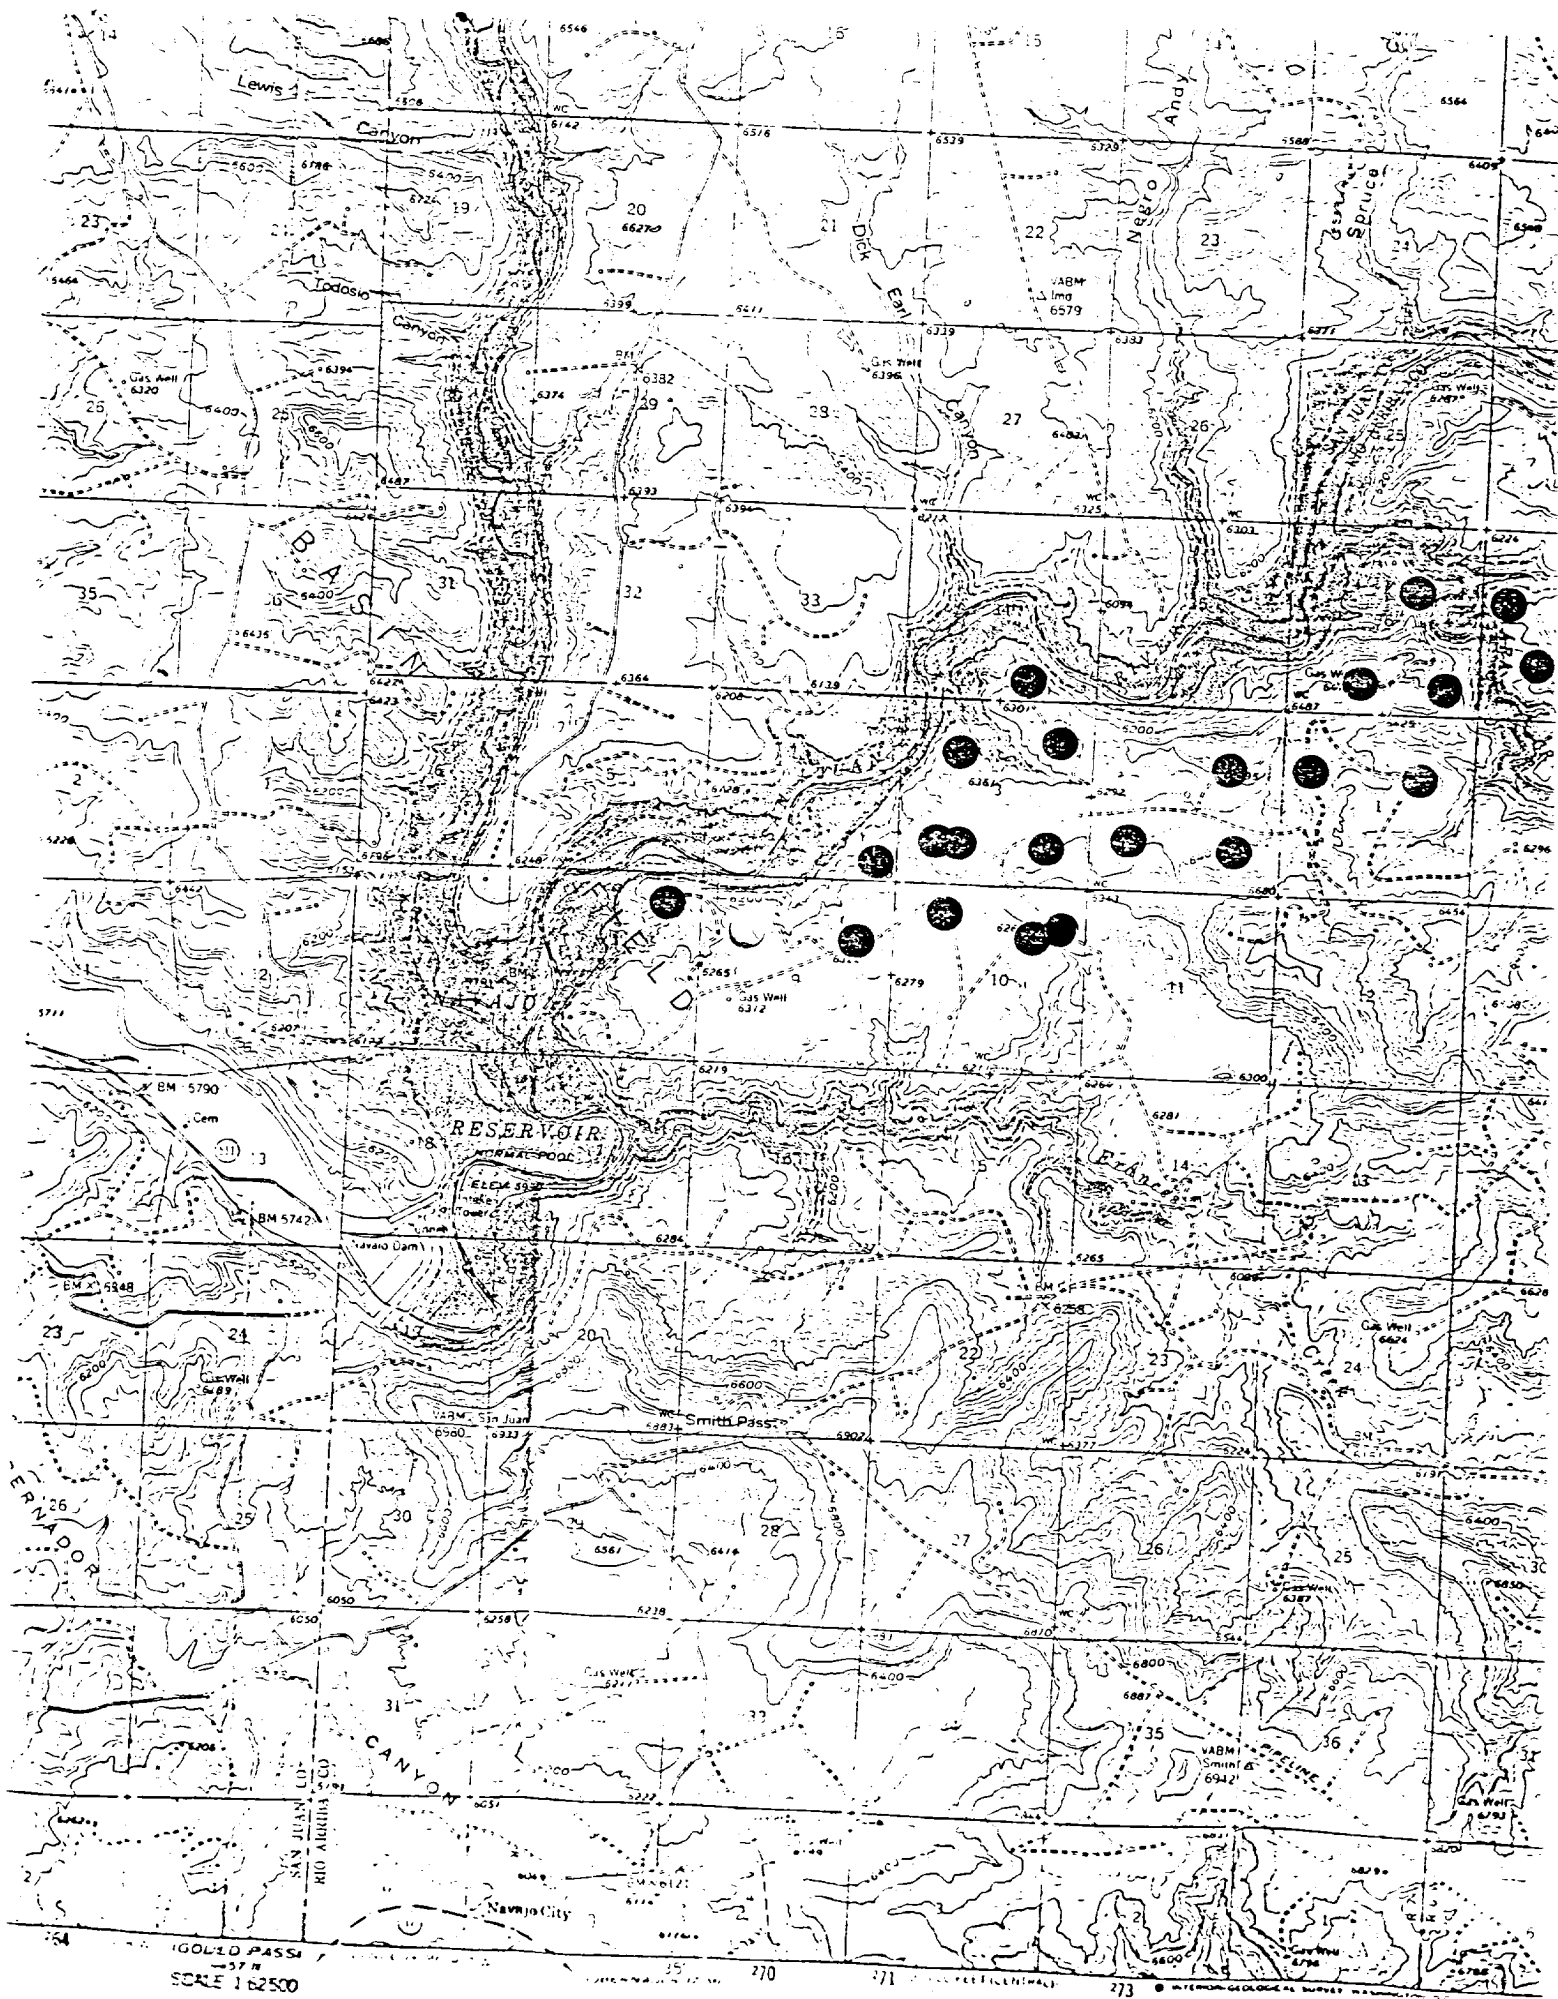
Northeast Blanco Unit #44A
SE Section 4, T-30-N, R-7-W

This well was drilled in 1978. The corrosive Ojo Alamo is covered by cement according to temperature survey. The well does not have cathodic protection.

The tubing has not been pulled and the casing tested since completion.

It is unlikely this well is leaking gas; however, gas could be migrating in the 7" x 8 3/4" annulus if the 7" casing has failed.

This well is in close proximity to the gas leak in the lake in the SE/4 of Section 4.
